DATE: APRIL 2018

Positive communication failures result in collisions

This safety bulletin provides safety advice for the NSW mining industry.

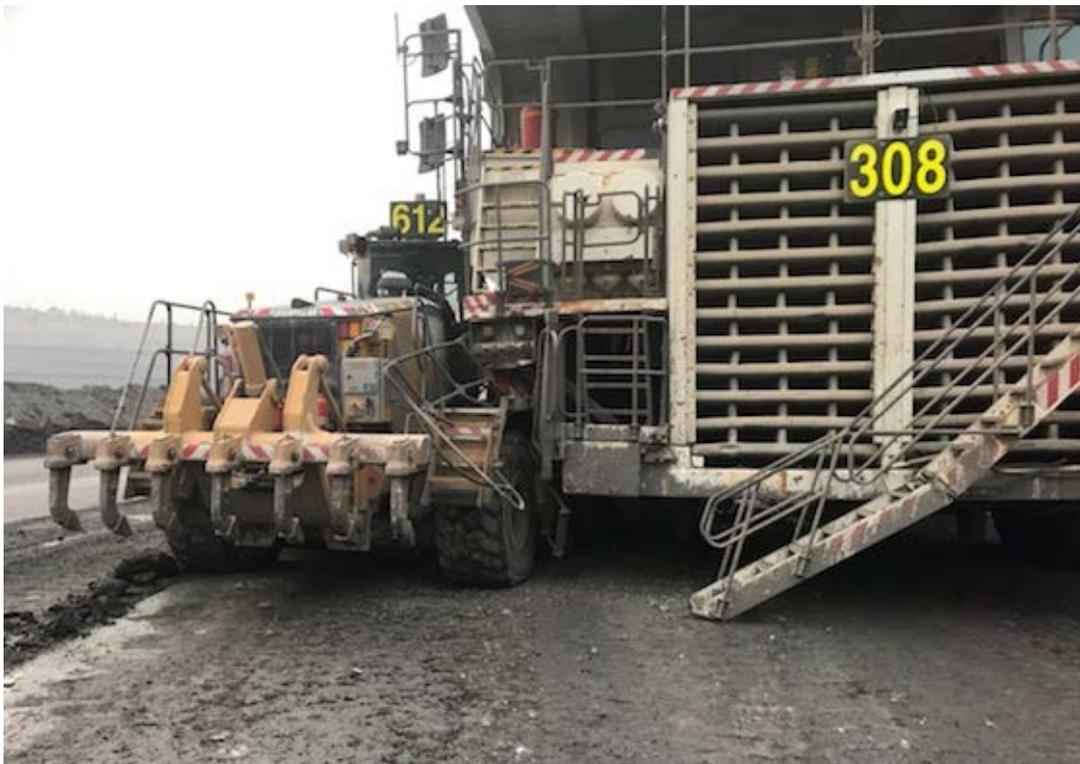
Incident 1: A collision occurred this month when a loaded haul truck attempted to pass a stationary grader. The haul truck operator approached the grader believing he had received instruction to proceed. No instruction by the grader operator to this effect nor verification from the haul truck operator was recorded on the radio communication recordings. No injuries were received but heavy damage was caused to each machine, including a burst tyre.

Figure 1 – A haul truck collided with a grader while trying to pass (SInNot-2018/00553). Photo courtesy of the mine.

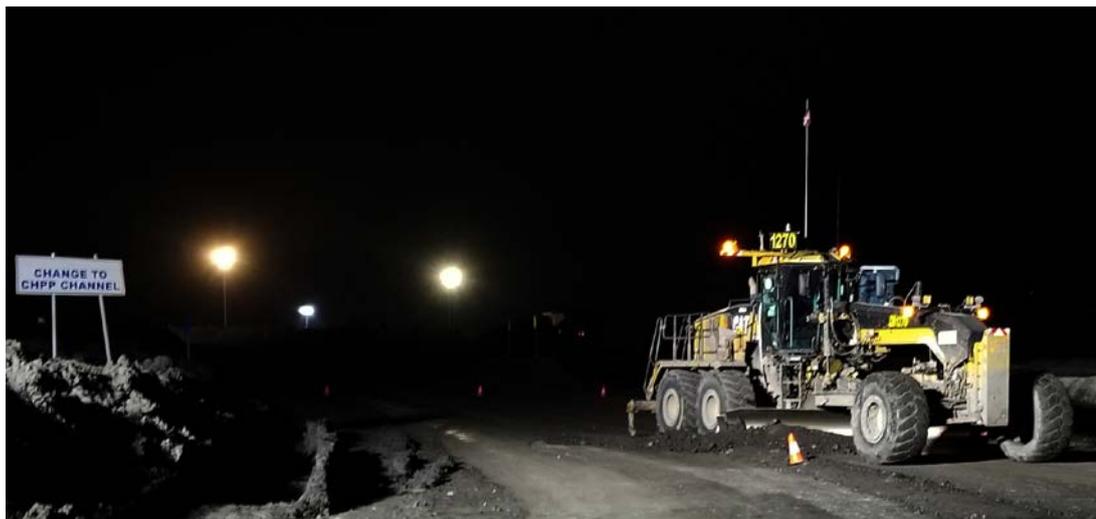
Incident 2: A collision occurred this month between a slow-moving haul truck that was passing a stationary grader between the right-hand side of both machines. Seeing the collision about to occur, the grader operator tried to make radio contact with the truck driver, who was on a different channel. No injuries were reported.

Figure 2 – A haul truck contacted a grader while passing (SInNot-2018/00528). Photo courtesy of the mine.

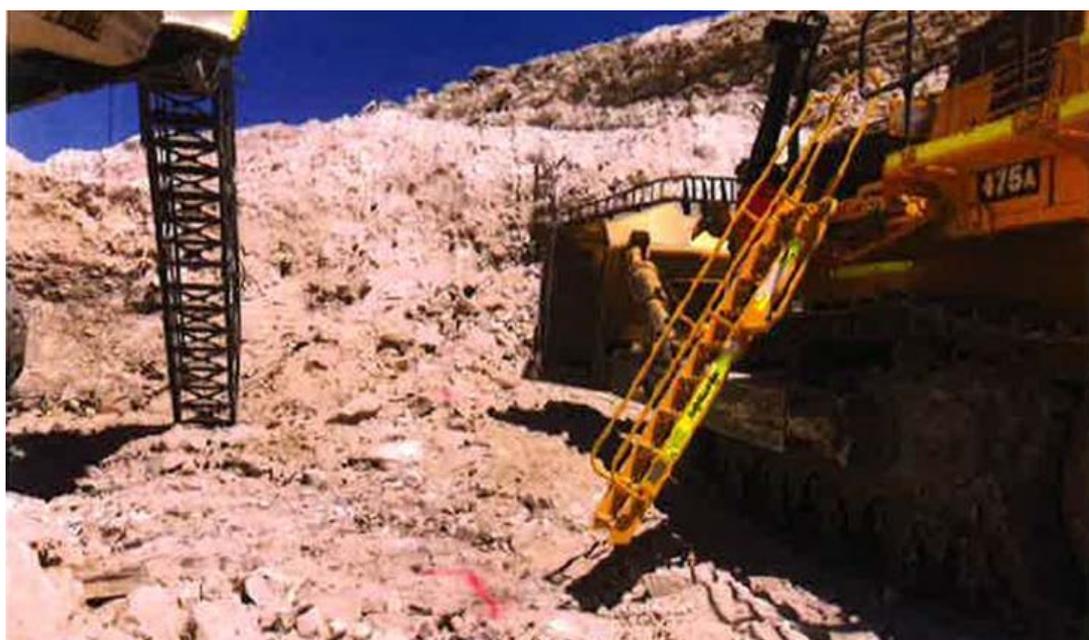
Incident 3: An excavator reversed into a dozer in March, resulting in damage to the dozer's lift cylinder. The dozer operator drove behind the excavator. When he realised the excavator was moving towards him, he attempted to make contact by radio. The radio was busy at the time, which prevented the dozer operator from making contact. The camera and proximity system fitted to the excavator were not working at the time.

Figure 3 – Excavator reverses into dozer (SInNot-2018/00355). Photo courtesy of the mine.

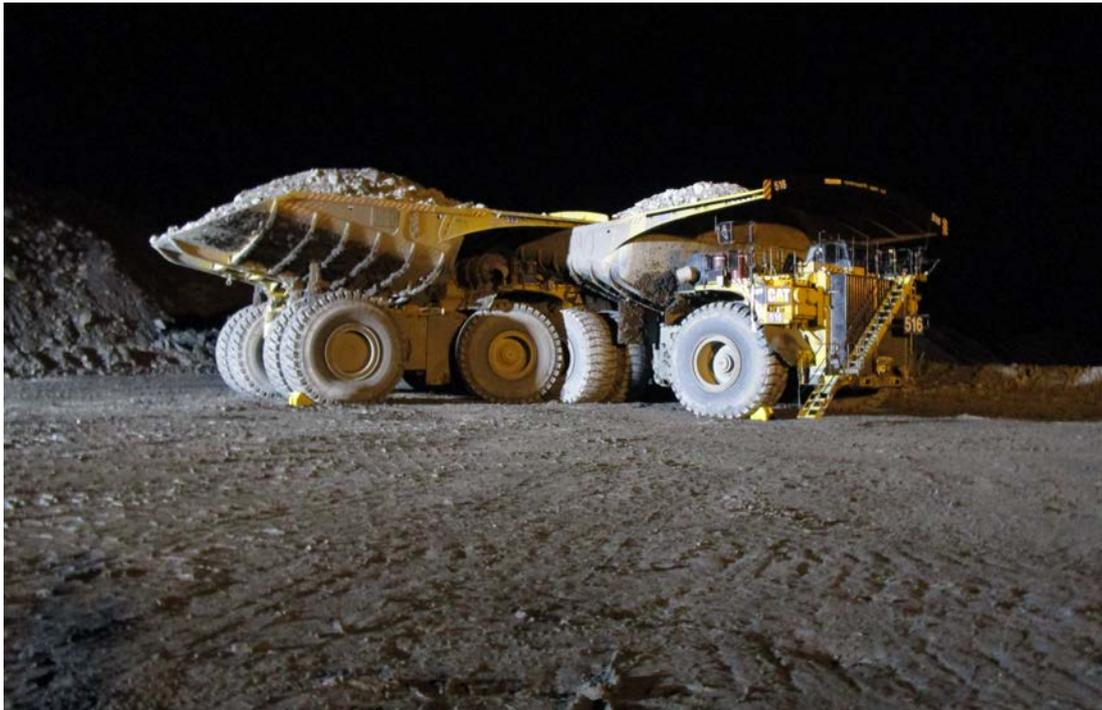
Incident 4: Two trucks operating in the same dump collided while under direction by a dozer at a site in February 2016. One of the trucks began reversing when instructed to dump and struck the second truck, which had entered the dump area. The operator of the second truck attempted to make radio contact to alert the reversing truck but was unable to prevent the collision.

Figure 4 – Two trucks collide (SlnNot-2016/00218). Photo courtesy of the mine.
