SAFETY BULLETIN

AUGUST 2019

Brake coupling disintegrates, ejecting components

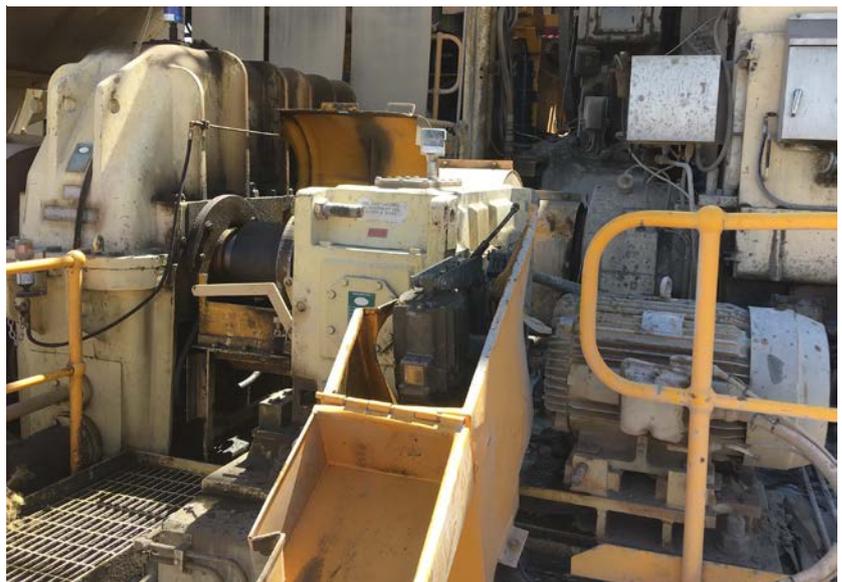
The drum was out of balance because some of the liner plates had been removed. The unbalanced load transmitted sufficient force through the drive train to overcome the holding brake force. Consequently, the drum spun in the reverse direction under gravity. This rotation of the drum drove back through two gearboxes, with a combined ratio of 700 to 1, (refer to figure 1) brake coupling and electric motor. The inching gearbox over revved and seized.

The brake coupling disintegrated. Metal fragments were ejected more than 40 metres away. One piece travelled 35 metres, penetrating through a steel shed and into a 200 litre oil drum stored inside.

Figure 1 The drive assembly showing two gearboxes (left and right), motor and failed brake assembly

It was found that the brake spring tension was initially set to 600 Nm (the site's procedure) however the site could not identify how 600 Nm was determined or if the spring tension was rechecked as part of the repositioning process and associated multiple brake applications.

A third-party technical expert was consulted to calculate the required spring tension to hold the out of balance drum. For the incident scenario where liners were removed, it was calculated that a spring tension of 1350 Nm was required to achieve a suitable factor of safety.

1. Mine operators must ensure that when conducting maintenance on ball mills and breaker drums, that the drum is prevented from moving in an unplanned manner, in such a way that the risk of harm to workers is reduced to as low as is reasonably practicable.
2. If a braking system is used to hold the drum, the force necessary to hold the drum in a locked position must be calculated by a competent person. The assessment of the required braking force must consider:
 - a. assessing for the worst-case scenario for an out-of-balance drum position.
 - b. applying an appropriate factor of safety when calculating the braking force.

- c. the braking force required to hold the drum must be calculated for each individual ball mill and breaker.
3. Mine operators must ensure that the braking components are inspected and adjusted by a competent person before using the brake for holding the drum in a locked position. This should be included in project schedules, when repeated use of the brake is planned.
4. Check the brake components and adjustment regularly, when conducting multiple applications of the brake unit.
5. Update mine procedures with any changes identified in the recommendations.
6. Review procedures for liner replacement. The procedures should consider/minimise the effect of drum imbalance.
7. Conduct refresher training for workers in any changes to procedures.
