Incident Title:

Isolation Breach

Friday, 21st June 2019

190713

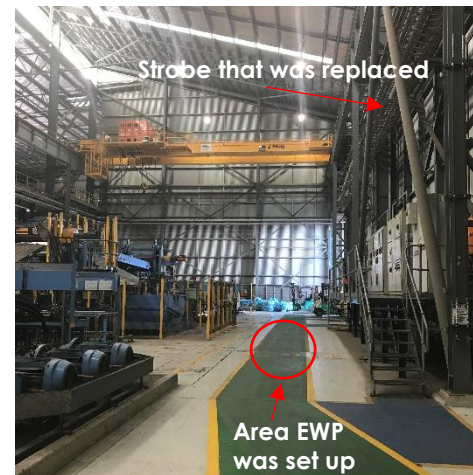
Two electricians were conducting a strobe change in an EWP. An overhead crane was isolated to prevent movement as the maintenance was being conducted in the crane's line of travel (Figure 1). The isolation was observed with only one personal lock on the isolation point, however, there were two people in the work team (Figure 2).

Figure 1. Work location.

- Always verify and tag all energy isolations prior to commencing work.
- Where applicable, work packs are to be developed for all work including emergent work.
- When the JSA is amended, it must be reviewed and signed by all personnel when the scope of work changes.
- All work team members must be aware of the location where personal locks are to be secured.
- Team members should confirm with each other that personal locks are in place before commencing work.

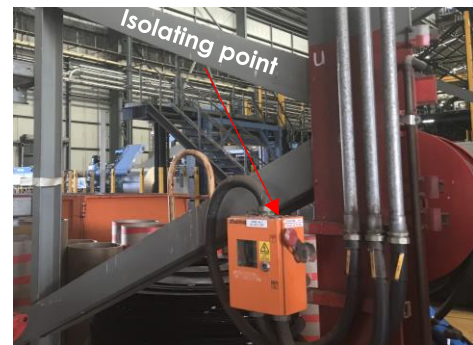
The investigation found no work pack was provided to the work team and only one work team member was shown the location for their personal locks.

Figure 2. Isolation point (location for personal locks)
