SAFETY BULLETIN

DATE: JULY 2019

Objects entering cabins of underground mobile plant

This safety bulletin provides safety advice for the NSW mining industry.

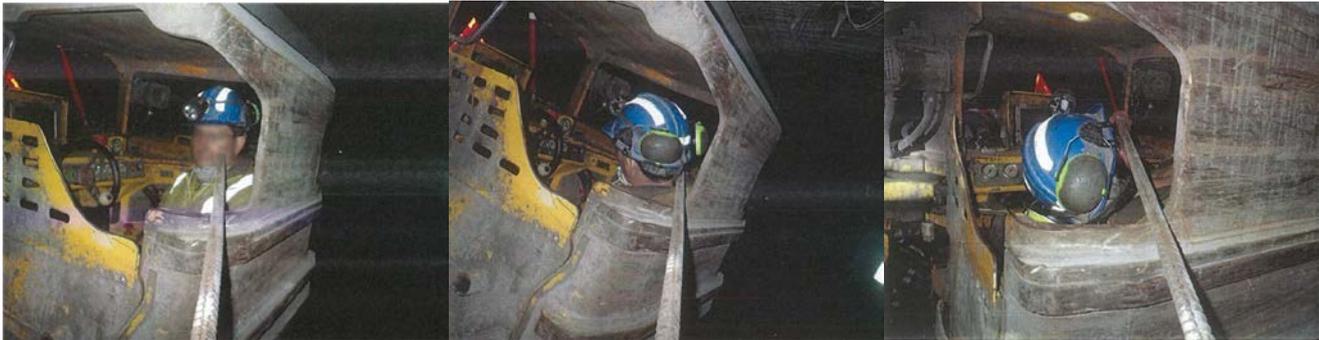
An underground coal mine load haul dump (LHD) operator suffered a fractured cheek bone, as well as severe head and neck lacerations resulting from a protruding roof bolt that was stowed in the rib side mesh. The operator's arm and shoulder were also injured when his body was forced onto the LHD door by the roof bolt.

The operator said he did not see the protruding roof bolt and that he didn't touch the rib with the vehicle but the roof bolt entered into the operator's cabin at head height and hit him.

Figure 1 Simulation of the roof bolt entering the operator's cabin and hitting the operator on the cheek bone (left photo). As the LHD moved forward, the bolt went behind the operator's head (middle photo). As the LHD moved further forward, it pivoted on the LHD canopy and forced the operator onto the LHD door (right photo) (IncNot0034693)

- a. identify and remove, or clearly delineate, potential hazards to mobile plant in vehicle roadways
- b. provide and enforce rules for mobile plant to pass in underground roadways
- c. specifically review mobile plant with extended loads, over-hanging loads, or towing loads to ensure that any load that is outside the standard machine design is adequately delineated for visibility by other drivers
- d. review training competencies of mobile plant operators and conduct toolbox talks to improve operator awareness of the hazards of operating mobile plant in underground roadways as highlighted in this safety bulletin.

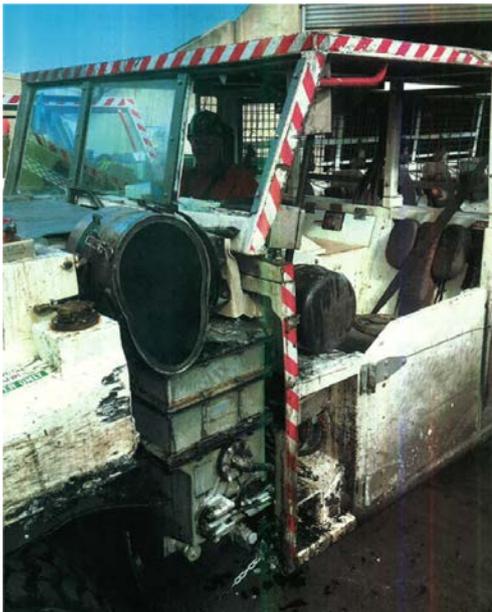
The driver said that a single 2.4 metre roof bolt entered through the passenger windscreen and went through the cabin divider mesh and landed on the rear seat of the transport vehicle. The bolt entering the cabin caused the driver to hit the rib side.

Figures 2 Damage to side of personnel transporter

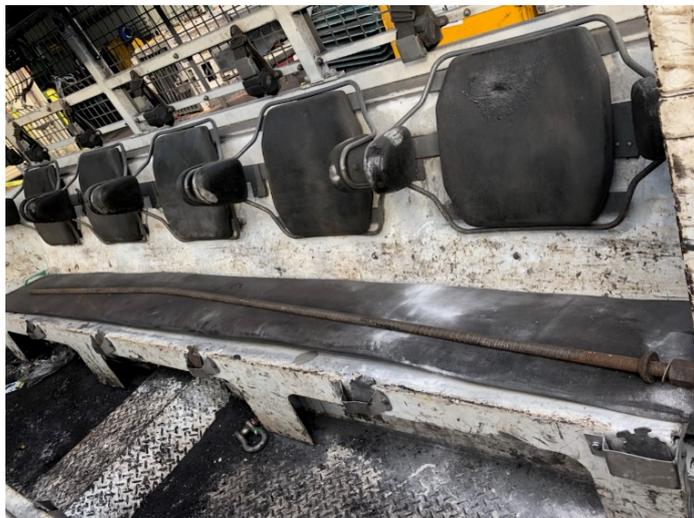
Figure 3 Post-incident simulation of the final location of the roof bolt on the personnel transporter rear passenger seats (IncNot 0034483)

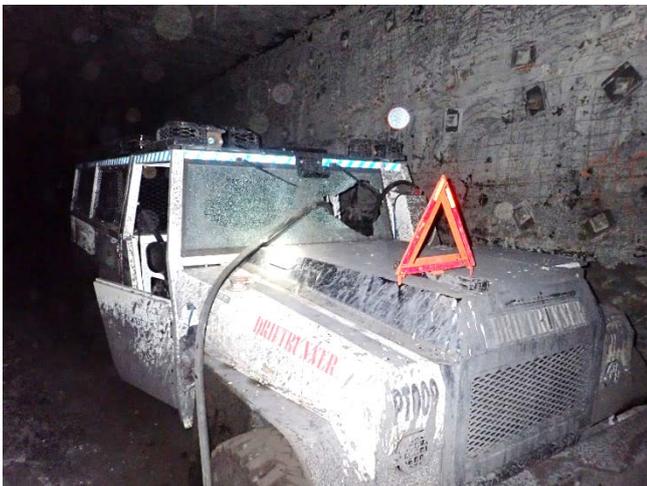
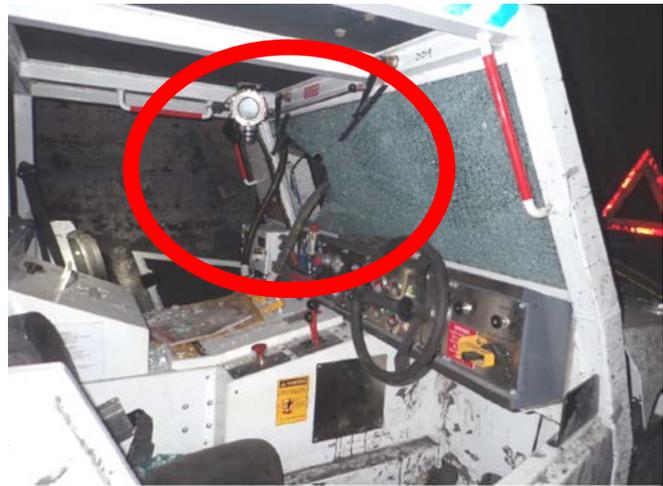
The driver saw the hose clear the roof racks and continued to reverse. The driver heard a loud bang and noticed that the air hose connector fitting had shattered the front windscreen and entered the cabin. The driver had driven underneath the hose the previous day with two different types of mobile plant without incident.

Figures 4 and 5 The damaged windscreen, air hose and fitting that entered the personnel transporter cabin (IncNot0034486)

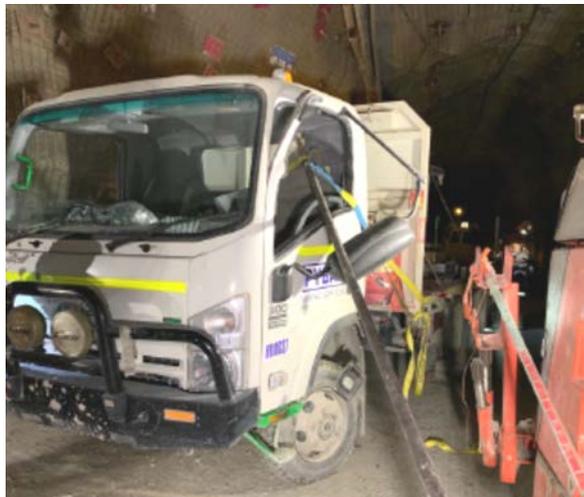
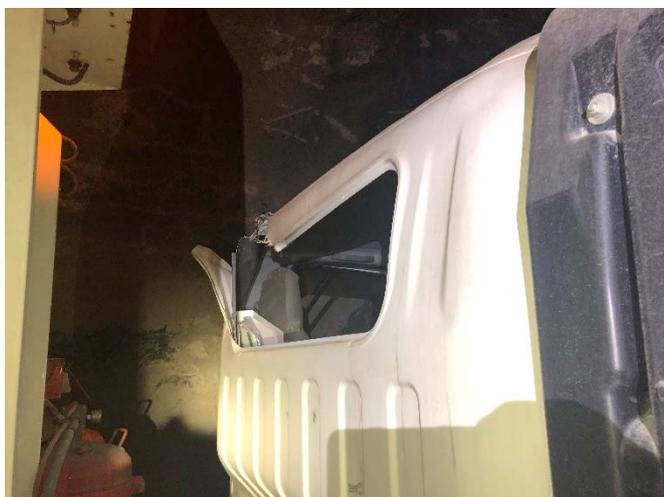
The drill steel continued through the passenger side window, over the head of the passenger and pierced the metal cabin shell above the back window. The back window was pushed out.

The tip of the drill steel lodged against the headframe of the truck tray. The drill steel was compressed against the truck bulkhead and the stored energy was released when the bottom plate of the Jumbo steel holder frame bent. This caused the drill steel to be ejected from the truck, landing about 14 metres away.

Figure 6 and 7 (left) Post-incident simulation of the drill steel entering the truck cabin from the Jumbo. (right) Damage to the back of the cabin body above the passenger seat caused by the drill steel entering the cabin (IncNot 0034365)
