Significant Incident Report No. 266

Subject: Underground operator struck on the head by a high pressure air line

Date: 23 August 2018

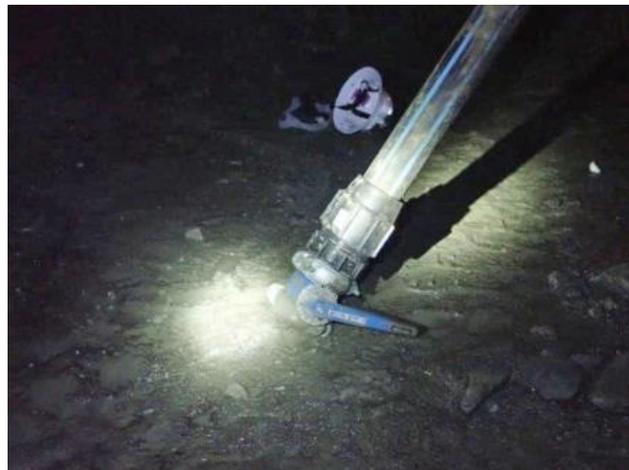
View of the failed coupling.

- The coupling used to connect the poly pipe was not fit-for-purpose.
- The coupling supplier could not provide the requested coupling normally used and recommended an alternative as being fit-for-purpose with the fittings and adapters in use. The recommendation was made without adequate assessment.

- Review couplings currently in use for connecting services to confirm they are fit-for-purpose.
- Review procurement policies and procedures to confirm that new plant is assessed as fit-for-purpose by a competent person before being made available for use.
- Confirm services are adequately secured to prevent their uncontrolled release.
- Remind workers to raise any concerns about equipment, particularly if it is new to the site.
- Research sources of information for past incidents, product alerts and worker reports when conducting hazard identification and risk management.

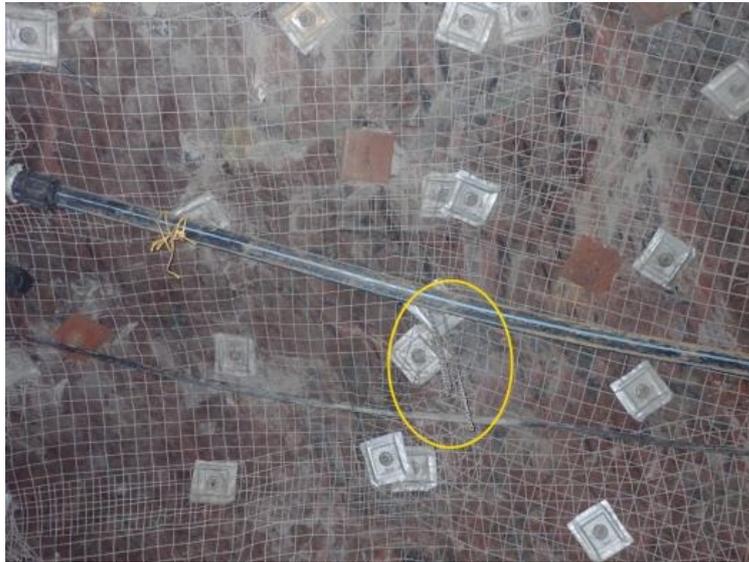
- When the coupling failed, a large section of the line started to whip around with sufficient force to break the holding chain. Early investigations indicate that the chain may have been installed too far back from the end of the pipe.
- Underground operators reportedly noticed problems with the coupling before the incident, but did not report their concerns to their supervisors.

View of the failed chain installed to secure the air line to the backs.
