Causal investigation: catastrophic engine failure in underground coal mine

- **Incident date:** 4 July 2017
- **Event:** Catastrophic failure of diesel engine system
- **Location:** Wongawilli Colliery, Wollongong, NSW

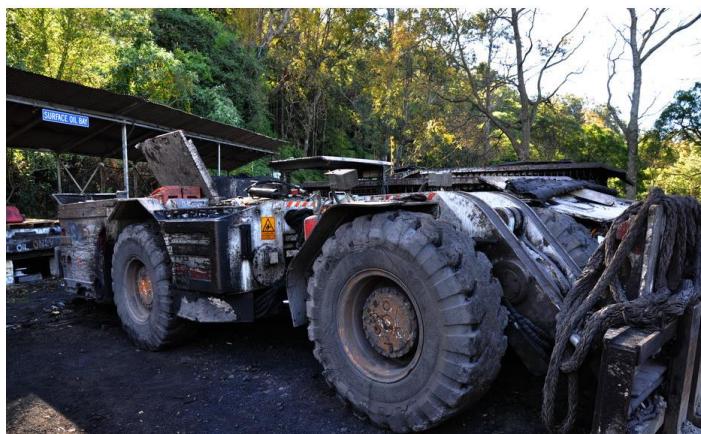
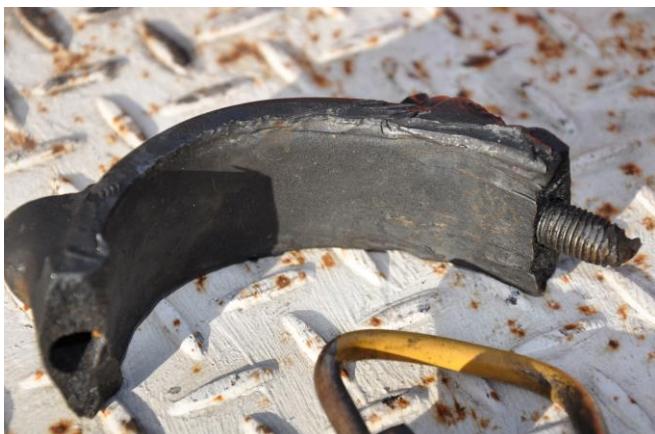
The incident occurred on 4 July 2017, and involved the failure of an unloaded Bucyrus 3126DITC engine, operating in the main intake airway. The failure caused internal engine components, such as the conrod cap, to be exited from the engine block, exposing the mine atmosphere to the high-temperature engine components and possibly the combustion chamber. No person was injured as a result of the incident.

Engine failure: The FBL10 involved in the incident (left), and internal engine components (right). Photos: Resources Regulator.

A scene preservation notice was issued to enable the plant to be removed off-site for inspection by an independent assessor. A preliminary investigation indicated a damaged oil supply pipe, possibly as a result of or as a precursor to, a big-end conrod damaging the engine block. The focus of the causal investigation will centre on the exact causes of the failure.

- mine operators ensure maintenance of diesel engine systems and inspection and testing of the safety related controls be carried out in accordance with the vehicle and the engine manufacturers' recommendations
- when designing explosion-protected diesel engine systems, it is essential that consideration of the likelihood for a rare malfunction be given in the design ignition risk assessment. Refer to [MDG 43 Technical Standard for the design of diesel engine systems for use in underground coal mines](#).
