INVESTIGATION INFORMATION RELEASE

DATE: AUGUST 2019

Causal investigation initiated after worker injured by pin ejected under pressure

Location: Ravensworth Open Cut Coal Mine, Singleton NSW

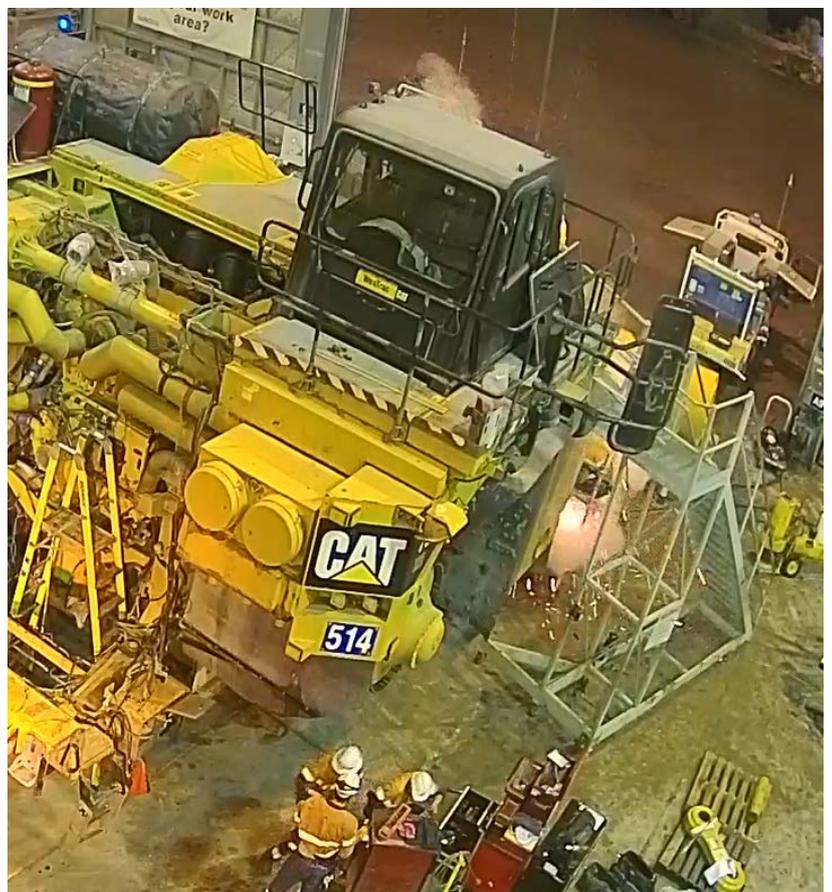
The incident occurred while quenching the pin with water shortly after making a hole through the centre of the pin with a thermal lance.

Figure 1 Image from video footage of workshop at time of the incident

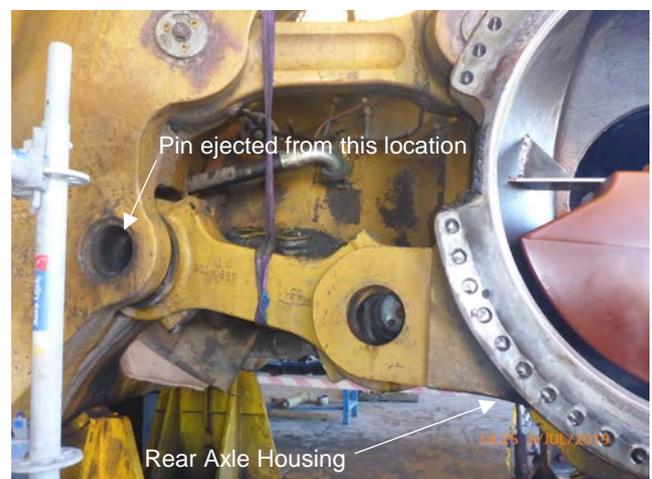
On 8 July, fitters were working to remove the pins from the lower left-hand suspension link, known as a 'dogbone'. They had managed to partially withdraw both front and rear pins prior to handing over to night shift.

Night shift fitters then successfully removed the rear pin but realised after several hours the front pin appeared to be seized. The night shift fitters then requested a boilermaker to conduct thermal lancing of the pin, to remove it.

Figure 2 Lower Suspension Link (Dogbone) supported by crane as preserved following the incident

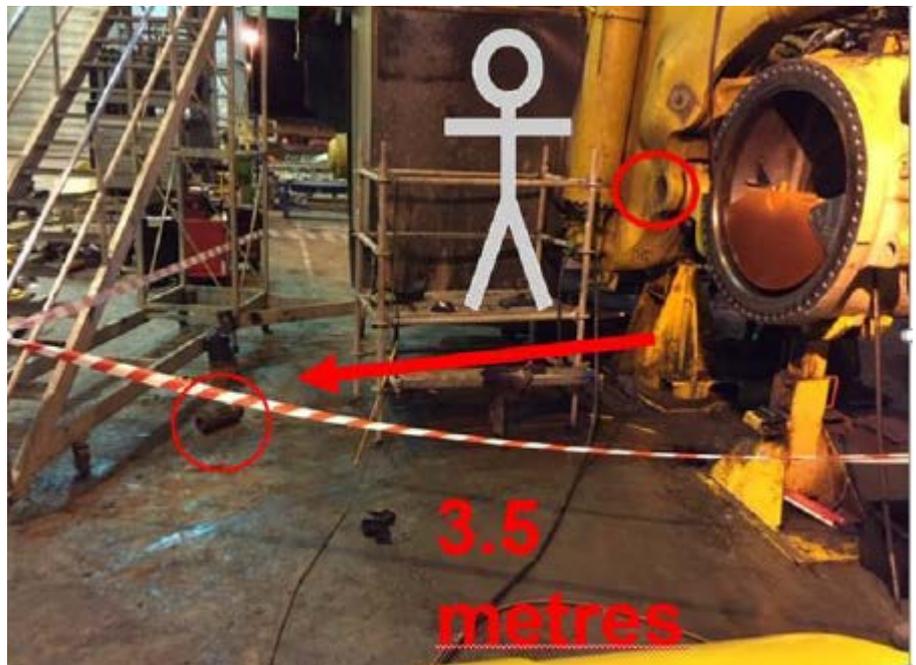
for the process to be repeated. Lancing began for the second time for about six minutes to enlarge the hole through the pin. Standing on the scaffold, the boilermaker turned off the lance and began using a water hose, initially to cool the area behind the pin clevis, then the pin itself. The ejection occurred seconds after quenching the pin.

The pin was violently ejected, hitting the boilermaker on the left side of his body, resulting in a large hematoma to his left hip, a greenstick fractured left thumb and minor facial and eye injuries from the slag spray. The spotter, who was working with him, was propelled backwards from the force, but was not injured.

Figure 3 Boilermaker work position when struck

- Mine operators should review risk assessments, and as necessary, revise control measures for undertaking thermal lancing, considering the potential for a steam or hydrocarbon explosion event, confinement and safe standing zones and PPE for protection against being struck by projectile pins and slag spray.

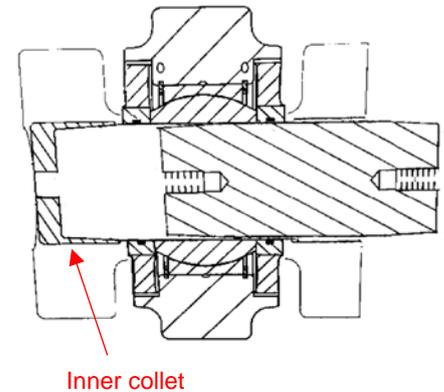
- The outer pin retaining collet had been removed by hot work gouging. The inner collet remained in position.

- The pin – weighing 46.7kg – was withdrawn by mechanical means about 70 millimetres from its installed position before starting lancing, forming a pocket or void behind the pin.

- A second lancing operation took about five minutes to further open up the hole through the pin, also without incident.
- Post-incident evidence found slag build-up in the void between the rear of the pin and inner collet, with the slag blocking one of four holes in the collet.

Figure 4 - CAT 797F Pin Assembly

Initial investigations and testing suggest the primary cause of the incident was most likely due to the rapid expansion of steam from the quenching water being applied to the hot pin and slag. The team is also considering other factors such as the presence of grease and other hydrocarbons. The final report will provide details of other factors at the completion of the investigation.

- Mine operators should review procedures for removal of pins with prioritisation of mechanical means of removal over thermal removal (lancing). The review should consider original equipment manufacturer (OEM) procedures, as well as what to do when those procedures are unsuccessful.
- Mine operators should consider the availability and suitability of tools and equipment used for the mechanical removal of pins. Mines should consider OEM recommended tooling, as well as tooling for alternate methods developed when other methods fail.
- Mine operators must ensure the provision of training in the safe use of tools and equipment. Tools and equipment must be used for their intended purpose and within design limits, in accordance with the procedures, unless a suitable change management process is followed.
