## INCIDENT ALERT

LOCATION:	ON-HIGHWAY	ALERT STATUS:	Normal
ACTIVITY:	TRANSPORT / DELIVERY	DATE ISSUED:	08/08/2017 10:43:48
SUB ACTIVITY:	ON-HIGHWAY	INCIDENT No:	01463

#### 60t Crane Rollover

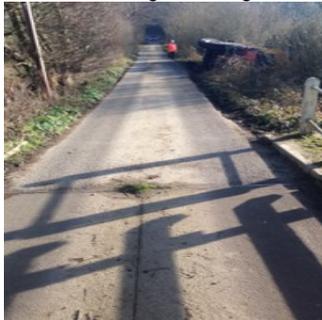
Access Road

The road is very narrow with foliage on one side, and a soft verge and 5 foot deep ditch on the other. A rut had developed at the roadside and it appears that the front wheel of the crane dropped into this.

- Effective journey planning would have identified a different route to site

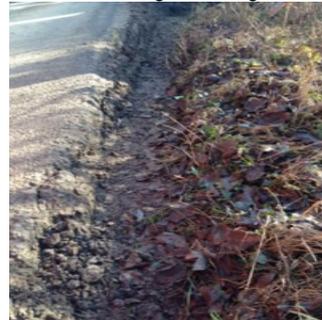
The driver continued onwards and tried to steer the crane out of the rut, but was unsuccessful; the trailing wheels also dropped into the rut and eventually the soft verge gave way, causing the crane to overturn.

Rut to side of road

- Keep away from unmarked edges and soft roadside verges

- Remind drivers about the dangers of soft verges, and how easily a vehicle can roll over.

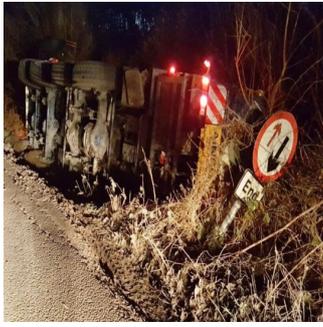
**Overturned Crane**

- Journey Planning should be undertaken for all deliveries, and could identify where an alternative / safer route is necessary. In this case a movement order had been applied for but had not been issued. The Police had instructed the crane provider to use an alternative route but this had not been communicated to the driver.
