Significant Incident Report No. 201

Subject: Loss of control following failure of steering tie rod coupling on EWP

Date: 30 June 2014

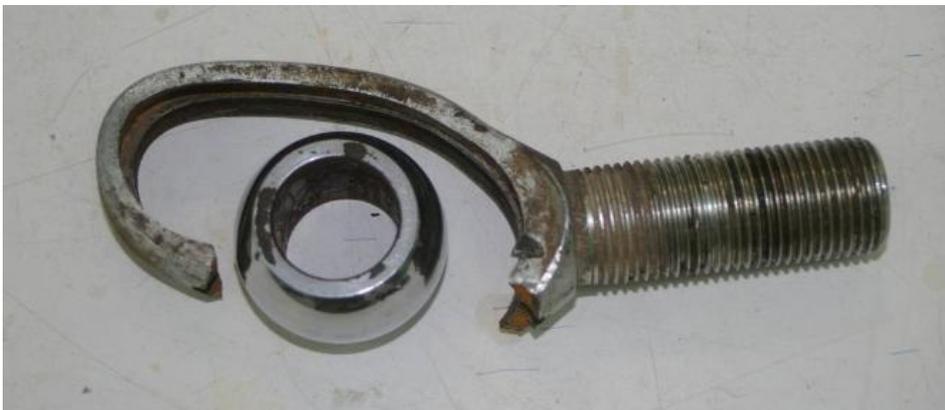
Detailed metallurgical analysis and examination of the steering component showed that it was made of low quality steel containing internal defects, and this had significantly reduced the strength and toughness of the tie rod coupling.

Damaged steering tie rod coupling from the EWP

- An inferior tie rod coupling was used as a replacement component on the steering arm of the EWP.

- The third-party tie rod coupling used was visually matched to the size and thread requirements of the original part, but not to the rating specification or part number of the original equipment manufacturer (OEM).

- indicate a means of checking the rating of original or third-party components to ensure:
 - OEM's specifications are met and the spare parts supplied are fit for purpose
 - where specifications are not met, there is a system to remove plant from use until the part has been replaced
- require the investigation of recurrences of similar incidents or repairs to plant to establish whether there is a common underlying cause that should be addressed.
