Week ending 19 December 2018

This incident summary provides information on reportable incidents and safety advice for the NSW mining industry. To report an incident to the NSW Resources Regulator: phone 1300 814 609 24 hours a day, 7 days a week.

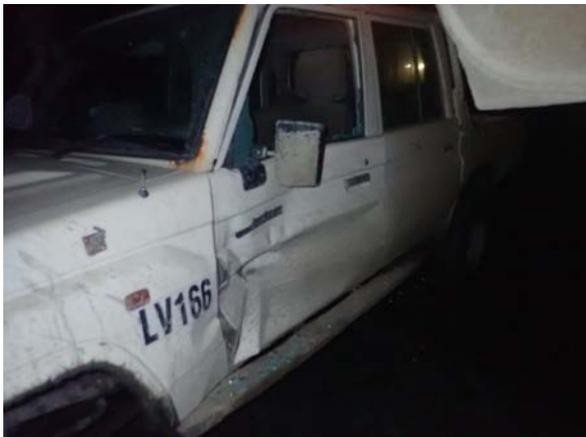
Incident type	Summary	Recommendations to industry
Dangerous incident IncNot0033382	<p>A collision occurred between an underground haul truck and a light vehicle in an underground metalliferous mine. The truck was being loaded when the light vehicle entered the area. Positive communication procedures were not followed. After the truck was loaded, it moved away and hit the light vehicle door. No-one was injured.</p>

<p>Review the verification systems that are in place at your mine. Confirm that workers are meeting the operator's positive communication requirements. Supervisors must continuously monitor workers' compliance.</p>

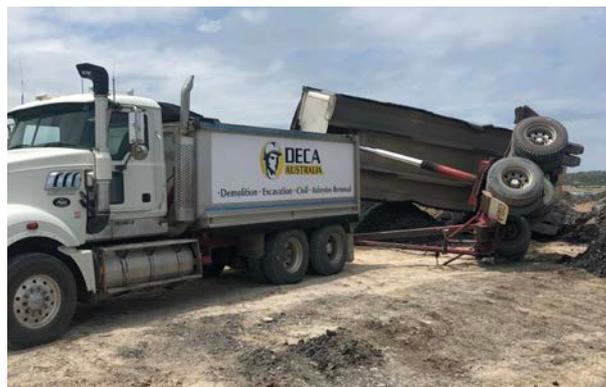
A dog trailer overturned when it was unloading at a sand mine. The driver had emptied the trailer and was reversing to tip the load. The front axle of the trailer rode up a pile, rolling the trailer.

Tip areas should be designed with enough room for trucks to safely perform tipping operations and to account for trailer position and procedure when unloading truck and dog combinations.

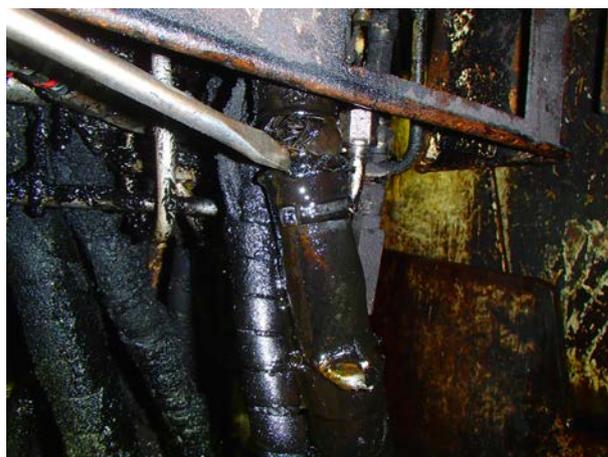
A worker was sprayed with hydraulic fluid when a hose failed on a continuous miner drill rig in an underground coal mine. The worker was transported to hospital where he was cleared of injury.

[MDG41 Fluid power systems](#) section 3.4.4 requires designers to consider fitting guards to prevent fluid release from entering a work area. Mines should review guarding of hoses in work areas and correct any deficiencies. When buying new or overhauling equipment hydraulic hoses in work areas should be eliminated where practicable or appropriately guarded.
