Week ending 6 December 2017

This incident summary provides information on reportable incidents and safety advice for the NSW mining industry. To report an incident to the NSW Resources Regulator: phone 1300 814 609 24 hours a day, 7 days a week.

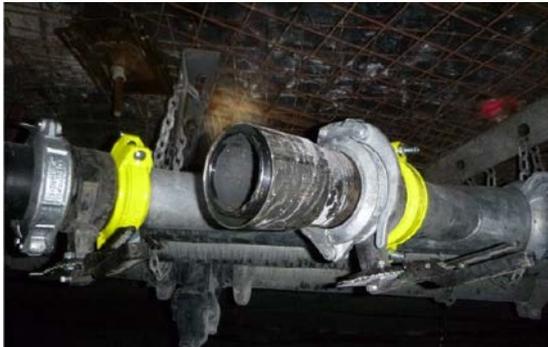
<p>the fire and he left the dozer without incident.</p>	<ul style="list-style-type: none"> • rubbing and abrasion of cables and fluid conductors • clamps and fixings of cables and fluid conductors • segregation and separation of mechanical services and electric cables and devices • location of and value of maximum surface temperature • location of fire suppression activation points • fire risk assessment • compliance with <i>Australian Standard 5062:2016 – Fire protection for mobile and transportable equipment.</i>
<p>Dangerous incident SinNot-2017/01903</p>	<p>During a longwall pump station relocation, a 100 mm diameter flexible water hose with a crimped Victaulic fitting has come apart at the feral. The water hose swung down and hit a worker on the head. He was taken to hospital for treatment.</p>

<p>Mine operators should ensure hoses and cables are adequately supported to reduce loads on hose end fittings, particularly where suspended over pedestrian accesses.</p> <p>Manufacturers of hose assemblies should review assembly and proof testing procedures as part of their quality systems.</p>
