Significant Incident Report No. 247

Subject: Drill fitter crushed between drill head and rod centraliser arm - fatal accident - update

Date: 12 September 2016

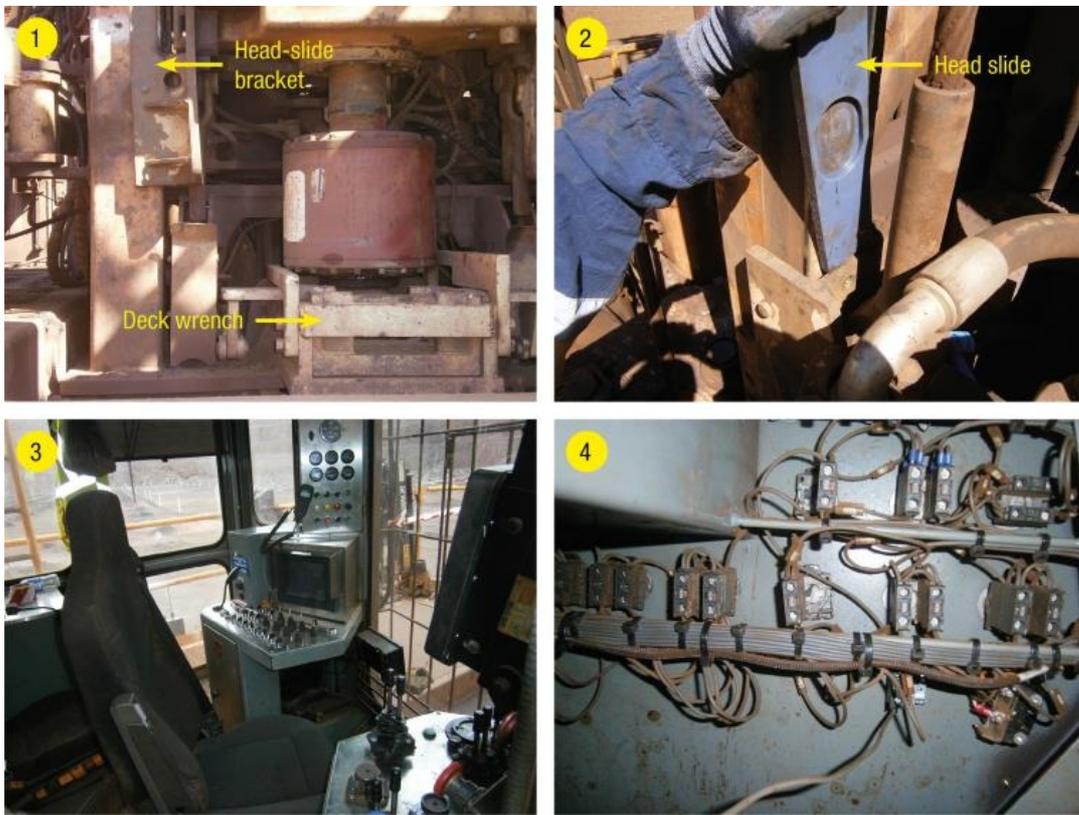
The subsequent investigation found that the head slide could not be fitted from the rig's deck due to a damaged bracket in the rotary head arrangement. When working from the deck, workers are not in the centraliser arm's 'line-of-fire', which is around two metres above deck level.

Static and dynamic testing was also conducted as part of the investigation. The static testing did not identify logic defects in the hydraulic or programmable logic controller (PLC) circuits. Dynamic testing identified that it was possible for the driller's leg to contact exposed wiring and switches under the control panel, and cause an unplanned inward movement of the centraliser arm.

1. Bent head-slide bracket shown with drill head above the deck wrench 2. New head slide did not fit between head bracket and mast 3. Driller's cabin showing seat position and control panel 4. Exposed wires and switches on the underside of the control panel.

- The drill rod centraliser arm moved unexpectedly.
- The maintainer was standing on the HOBOT in a potential crush zone.

- Isolation had not been carried out prior to conducting maintenance.
- The uncontrolled movement of the rod centraliser arm had been identified on pre-start forms the previous week, but had not been entered in the maintenance system.
- Damage to the head-slide bracket prevented the head slide being fitted from the deck.
- The drill head was raised to unthread the drill pipe, making it impractical to fit the head slide from the deck.
- As designed, the underside of the control panel was not covered. This would have prevented inadvertent contact.
- The damaged head-slide bracket was not identified during the recommissioning process.
- A written safe work procedure (SWP) had not been developed for replacing a head slide.

- Implement and enforce suitable isolation procedures.
- Confirm that workers conducting maintenance and repair work are adequately instructed, trained, assessed and supervised.
- Consider developing SWPs for repetitive tasks that have the potential to expose workers to hazards.
- Complete suitable task-based risk assessments where SWPs are not provided, and when the conditions or the scope of work changes, and assess and authorise prior to conducting work.
- Rectify defects or faults identified during equipment pre-start inspections within an appropriate timeframe.
- Conduct a thorough inspection and assessment process when recommissioning plant to identify any machine and component defects to be included in a scope of works for refurbishment.
- Check for exposed wiring and potential switch contacts that could initiate unexpected machine movements.
