Ageing electrical switchgear

Mines safety bulletin no. 156 | 19 September 2016 | Version 1

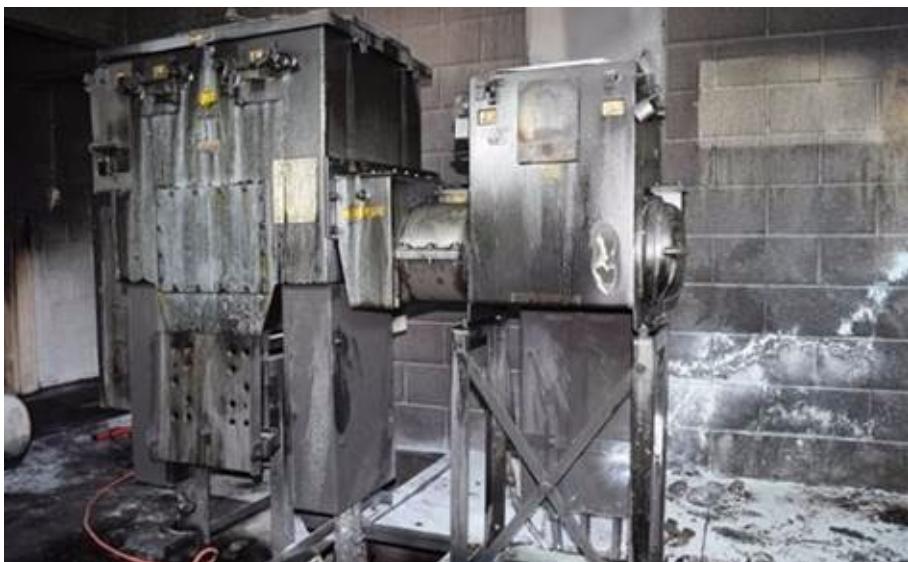
In February 2015 in Western Australia, two workers died and two were severely injured when 11kV ring main units exploded, showing the potential results of failure of ageing equipment (photo 1). Various safety bulletins were issued after that incident, while on UK websites, previous warnings had been issued about this type of equipment.

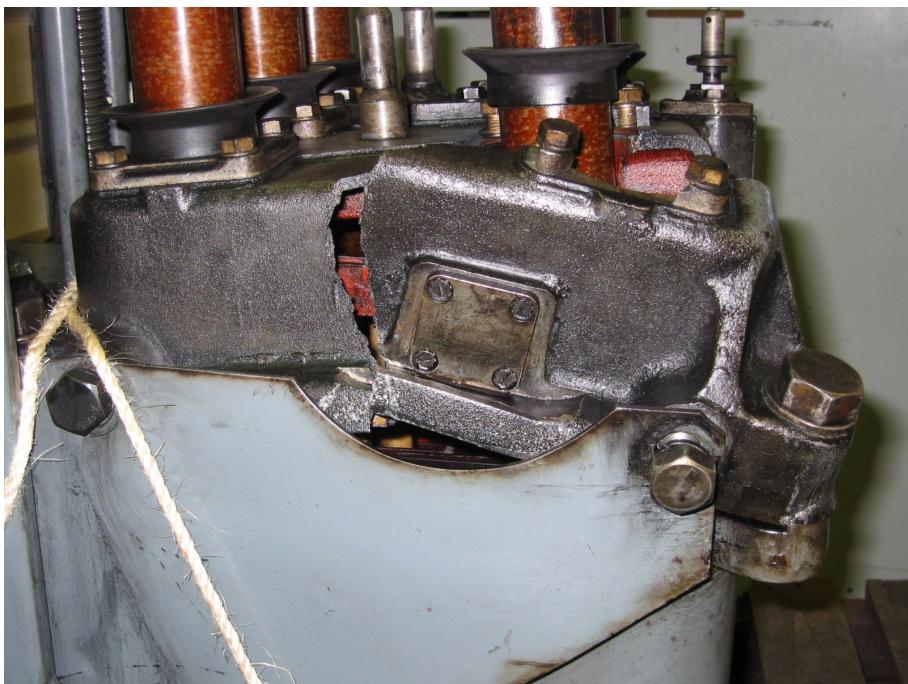
Oil filled 11kV circuit breakers have failed catastrophically causing injury (photo 2). Again, the internet has information on similar equipment failures.

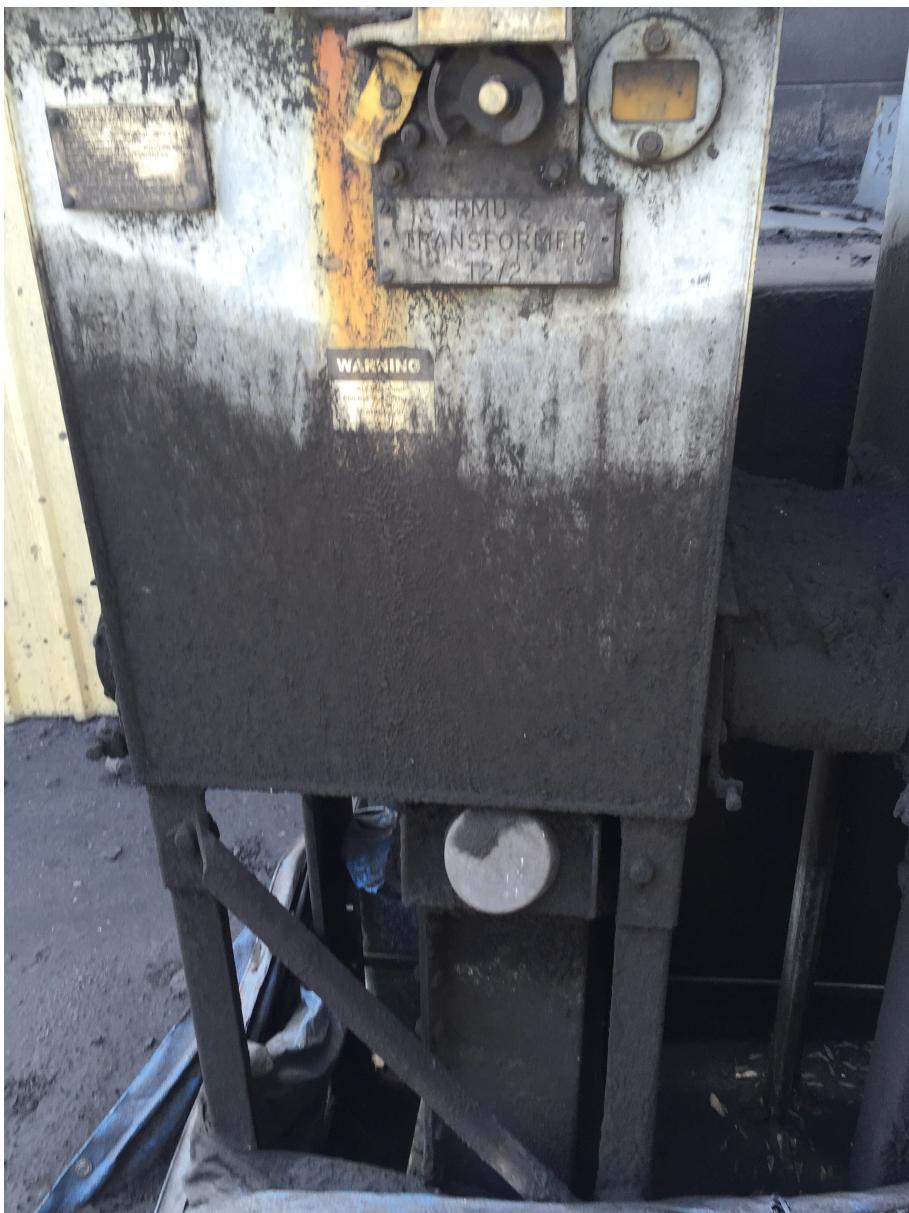
Oil filled ring main units with switch fuse tee offs have failed at some mines. There have been internal failures and cable termination fires (photo 3).
