SERIOUS INCIDENT ALERT

SERIOUS INCIDENT	Near Miss - Potential Level 4
SUBJECT	Truck rear dual wheel and axle assembly separated from truck in transit
INCIDENT DATE	21/01/2019
BUSINESS UNIT

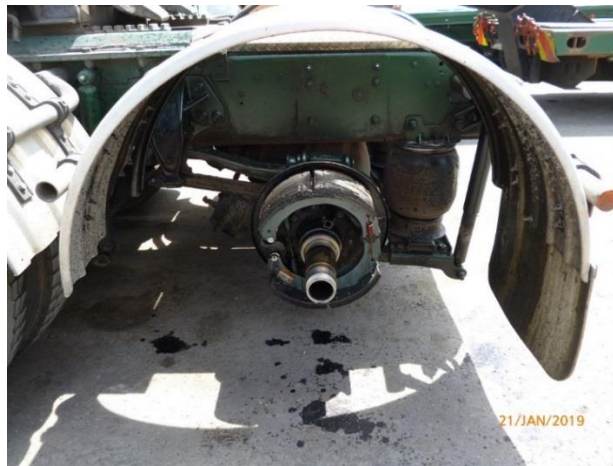
A Hino 700 series truck tractor unit was unhitched from a bulk tanker. The Truck unit (without tanker) was then driven approximately 100km. The driver completed the journey without any stops. On arrival, the left rear dual wheel and hub Assembly including axle were observed as missing and driver notified.

- The vehicle was locked out pending examination by authorities and/or internally
- Staff from both locations were mobilised to attempt to locate the missing assembly (without success) across the route taken
- Internal notifications were completed
- An ICAM investigation was commenced
- NZ Police and Work Safe NZ were notified of the incident
- National workshop review commenced regarding procedures and tooling used when conducting stub and hub assembly work, other units in Fleet re-inspected.

4. Incident learnings to be shared once investigation has been completed
5. Review hub assembly work
6. If drivers concerned during pre-start inspection or in transit stop vehicle immediately and contact workshop for assistance.
