Week ending 15 February 2019

This incident summary provides information on reportable incidents and safety advice for the NSW mining industry. To report an incident to the NSW Resources Regulator: phone 1300 814 609 24 hours a day, 7 days a week.

CM9 reference	DOC19/141418
Mine safety reference	ISR 19-07
Date published	22 February 2019

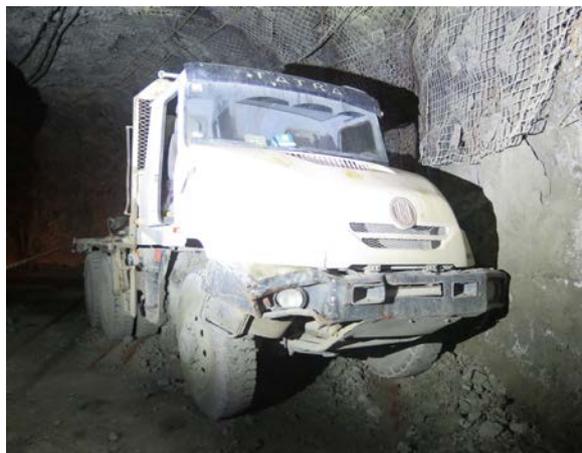
Incident type	Summary	Recommendations to industry
Dangerous incident IncNot0033899	<p>A collision occurred in an underground metalliferous mine. A haul truck was descending the decline when it collided with a rigid body truck travelling up the decline. The rigid truck was pushed two metres as a result of the collision. The driver of the rigid body truck briefly lost consciousness and suffered a head laceration.</p>	<p>Mine operators must conduct an assessment and identify areas where there is a risk of collision. When developing risk control measures, the hierarchy of controls must be considered. Positive communication requirements must be implemented where a risk of collision remains.</p> <p>The mine was issued with a s195 prohibition notice and the incident is the subject of further investigation.</p>

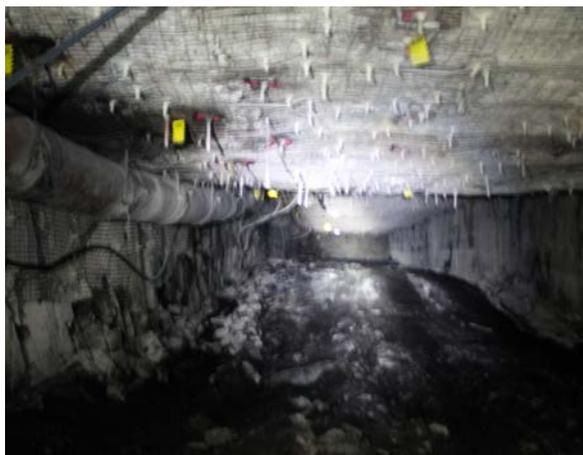
Dangerous incident
IncNot0033897

A roof fall occurred on the longwall installation face at an underground coal mine. The face line had been widened and completed and work had started flitting out the continuous miner. Signs of weighting were first reported on the night shift and the fall occurred during the day shift.

Underground mines should review the adequacy of their strata monitoring arrangements and associated trigger action response plans (TARPs) to ensure that workers are not exposed to unacceptable risks associated with strata failure.

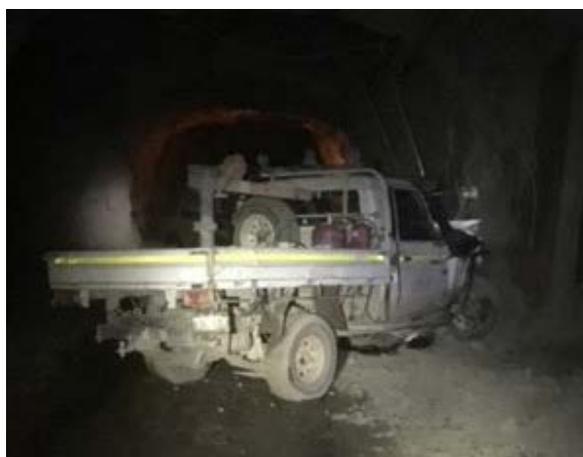
Dangerous incident
IncNot0033889

A light vehicle made heavy contact with the decline wall in an underground metalliferous mine. Maintenance activities had been completed on the vehicle's steering components earlier in the shift. The vehicle was descending in the main access to the mine when the incident occurred. The airbags deployed, and the vehicle was significantly damaged. No-one was injured.

Maintenance processes must include appropriate checks and tests to verify work. When work is carried out on a safety critical system, appropriate work verification procedures must be in place.

The mine was issued with a s191 improvement notice and the incident is the subject of further investigation.

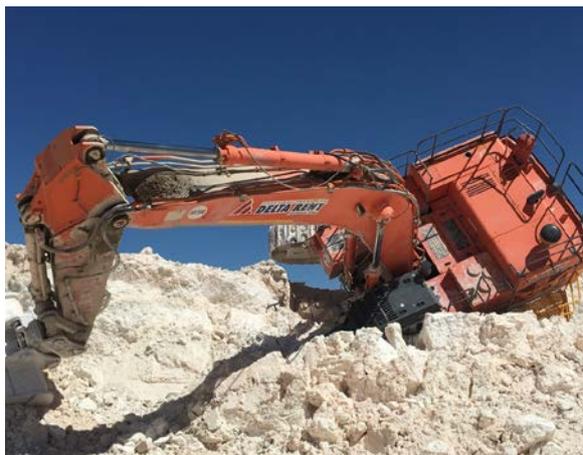
Dangerous incident
IncNot0033855

An excavator rolled in an open cut mine. The excavator was working on a 5-metre high stockpile of loose, wet material when the material under the left-hand track gave way. The operator safely exited the machine and reported soreness to his elbow.

Before starting work, supervisors and equipment operators must inspect and assess the work area to determine hazards, such as material slip. Planning for the work must include identification of hazards, risk assessment and control.

The operating environment should be examined to ensure:

- the ground beneath the working area is stable and free from faults, fractures and soft areas
- there is no moisture or water present in the earth or rock below the equipment
- work is not carried out close to the edge or in a zone of influence of an excavation or any previously disturbed ground.

All excavators should have a means of egressing the cabin if an incident occurs and the main cabin door cannot be opened.

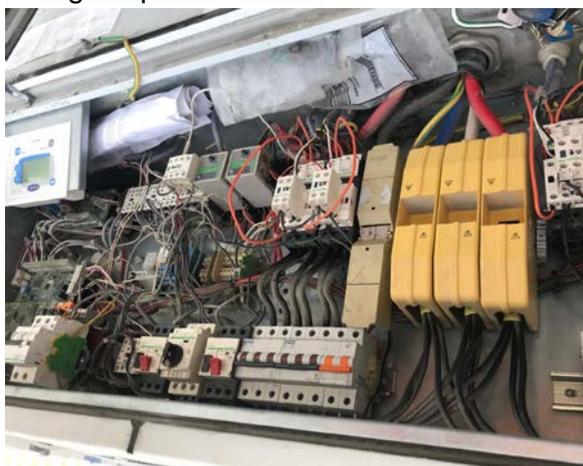
Dangerous incident
IncNot0033837

An electrician suffered an electric shock when he made contact with an 'insulated' wire in the control panel of a chiller unit in a metalliferous mine.

The electrician was resetting a circuit breaker when his finger slipped off the operating toggle and brushed against the sheath of the energised cable. A voltage of 240V was measured on the cable insulation.

The cables were found to have a conductive outer layer (semicon layer) that was in contact with the live terminals of a downstream contactor. As a result, the outer sheath of the cable was energised at voltages up to 240V AC.

Where workers are required to access electrical equipment for isolation or resetting protection devices, the equipment must be designed so that the workers cannot inadvertently make contact with energised cables or components or be exposed to a risk of arcing faults that may occur.

Cable insulation must be suitable for the intended function. Where cables are fitted with semiconductive sheaths, the cables must be installed and terminated in accordance with manufacturer's recommendations.

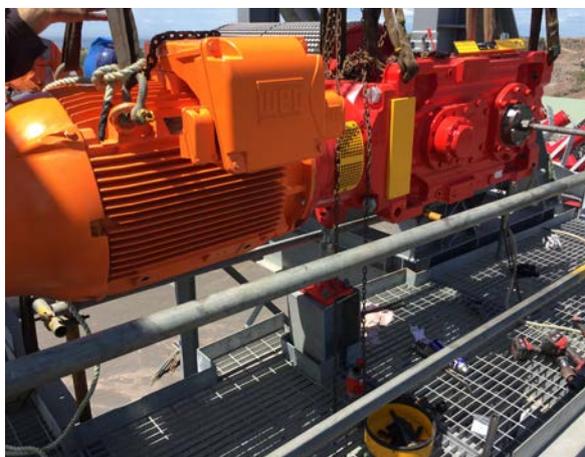
Dangerous incident
IncNot0033833

While installing a conveyor drive module, the supporting structure failed in a quarry processing plant. As the weight was removed from the crane, the support structure buckled. The site investigation revealed discrepancies between suppliers and contractors in the design and supply of steel work.

The mine was issued with a s195 prohibition notice requiring independent structural engineering assessment.

When multiple parties are involved in the procurement of plant and structures, appropriate controls and checks must be in place to ensure all relevant information is communicated between parties, and all parties involved should understand their scope.
