# Serious accident involving an articulated water cart.

## Mines safety alert no. 361

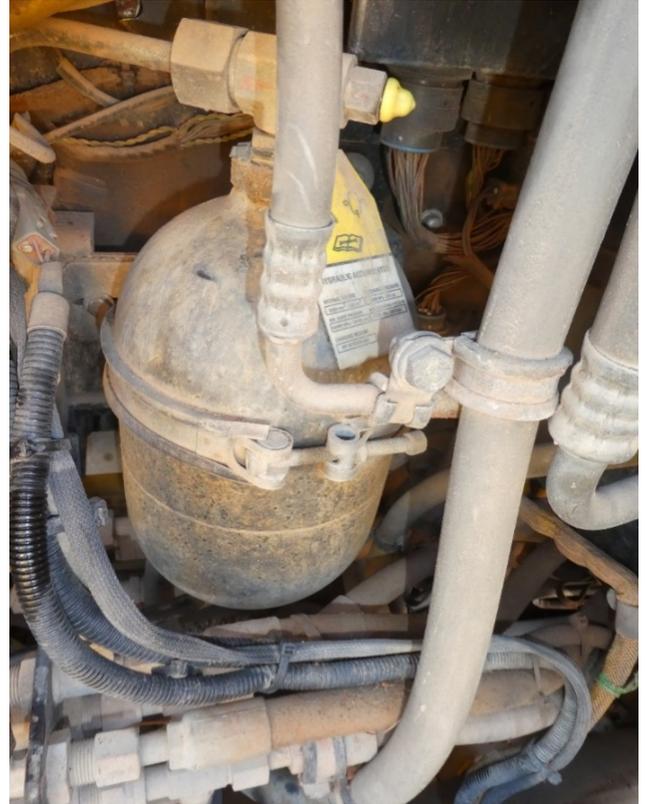
Brake Accumulator

In this instance the service brake accumulator pressure was too low to provide effective braking.

- Machines using accumulators to maintain service braking under hydraulic pump failure or engine stalling, should have accumulator dry nitrogen pre-charge pressures checked by trained personnel every 250 hours.
- In addition to usual park and service brake tests, service brake accumulator functionality should be checked daily as part of the machine prestart regime.
- Consult with the Original Equipment Manufacturer (OEM) for specific procedures on brake accumulator pre-charge and functionality testing.
- Steering system accumulators operate similarly to brake system accumulators, allowing operation of the steering hydraulic system under hydraulic pump failure or engine stalling. Steering system accumulators should be inspected and tested in accordance with OEM procedures and recommendations.
