# Underground conveyor equipment incident puts workers at risk

Causal investigation

Title: Causal investigation: Underground conveyor incident puts workers at risk

First published: December 2017

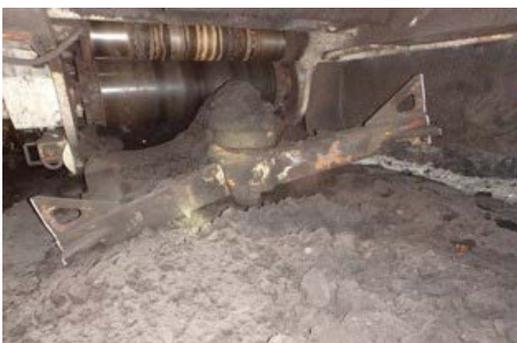
Figure 1 - Failed hitch point on DMU.

The failed connection hitch on the DMU (figure 1) and the boot end frame (figure 2) were inspected. The distance of separation was measured as 16.4m. Refer to appendix 4.

An inspection of the failed connection and the welded joints, the broken welds were all clean with no fatigue cracks, indicating a catastrophic failure of the welded joints. This was seen on all joints on the boot-end frame side shift and the DMU connection hitch.

*The failed DMU crossover slide components material met the Joy Global drawing specifications. In general the welds sizes were less than the weld sizes specified on the Joy Global drawings. The level of weld flaws present in the failed welds suggested that the welds would not meet the requirements of AS/NZS1554.1 – 2014 Weld Category SP.*

*Failure of the crossover slide had occurred through the welds on the end plate at each end of the crossover slide and through the weld securing the main bar to the tow point on one side by shear overload.*

- The OEM is to review the design of the DMU and conveyor system using standard engineering methods to assess the structural design versus the input force of the propulsion cylinders of the system and the functional safety of any interlocks taking into account scenario's that could lead to a catastrophic failure, such as multiple fatalities, during a DMU advance.

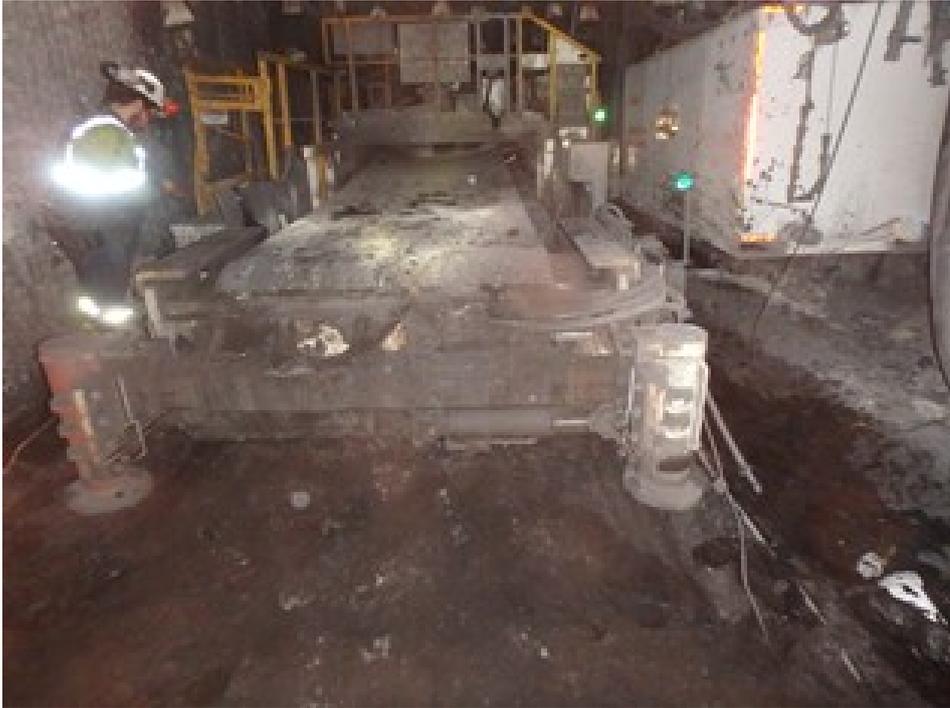
Figure 2 – Boot end frame showing where hitch was attached.

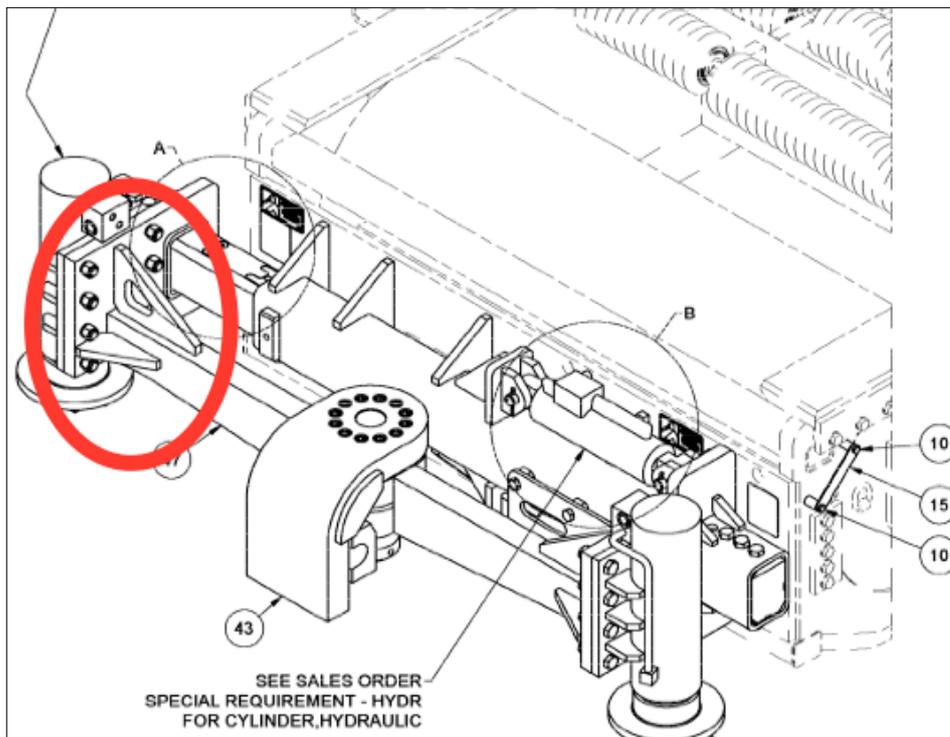
Figure 3 - Side shift mechanism GA.

The side shift mechanism on the tail end unit failed when greater than normal force was applied by advancing the DMU while the panel belt loop take-up winch was not powered. The point of mechanical failure was the welded sections in the side shift mechanism.

Due to the design change to have its own belt, a side shift mechanism was required on the boot end to allow belt alignment. This side shift mechanism became the point of failure.

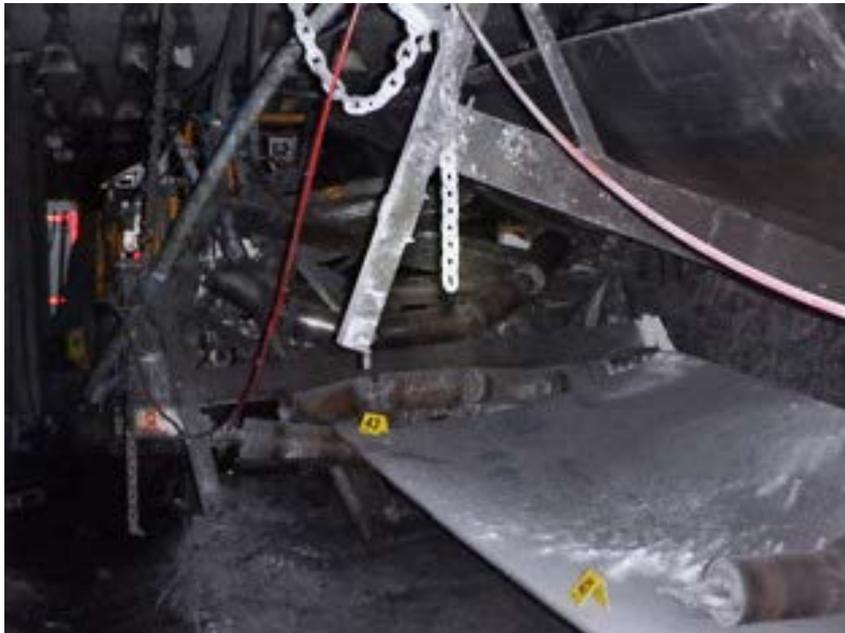
Figure 4 - Damaged conveyor structure outbye of bootend looking inbye.

The area outbye the boot end frame showed concertinaed damaged belt structure (figure 4).

Five bays of conveyor structure were severely damaged and were not reused. Various cables and hydraulic hoses were torn off because the tail end unit moved in a sudden and unintended manner.

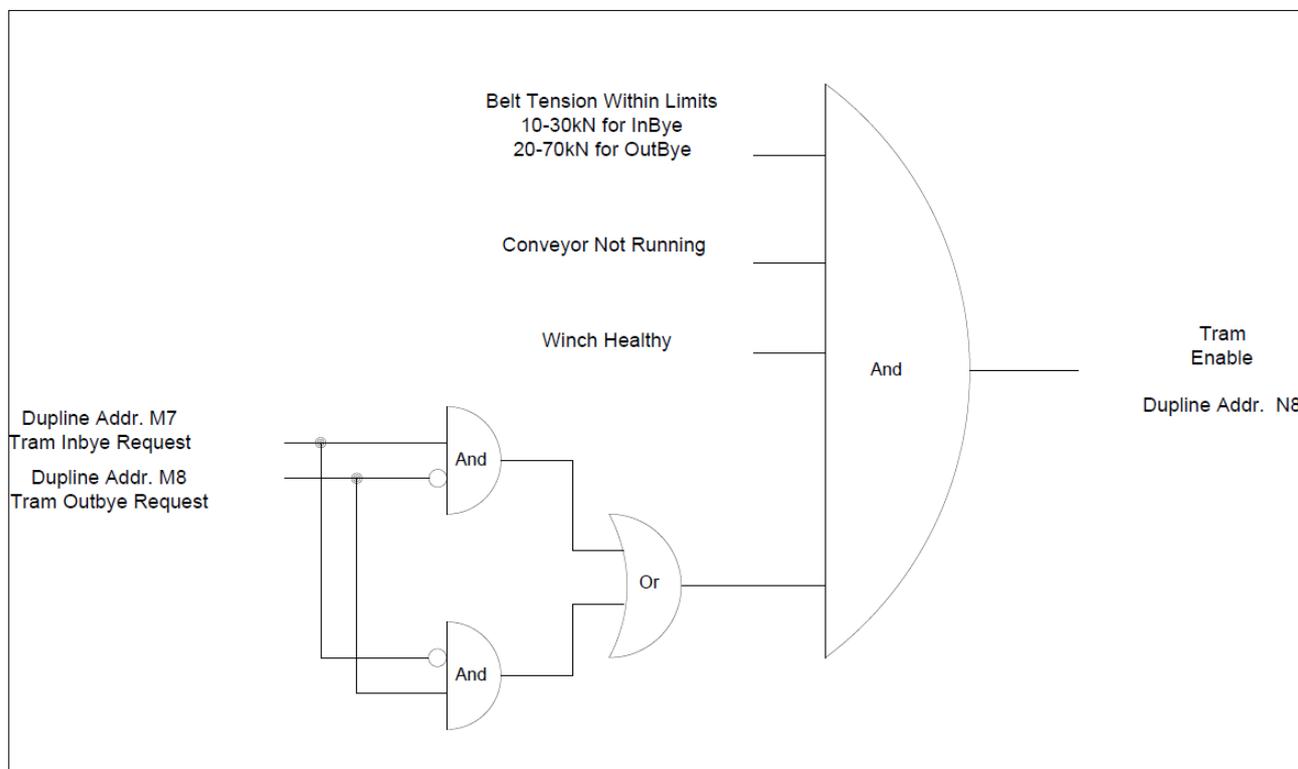
Figure 16: Conveyor software advance logic diagram.

This interlock is a typical design for conveyors but no functional safety assessment was undertaken on the design. During design risk reviews of the equipment, attended by both the OEM and site personnel, the consequences of over tension on the belt was foreseen as minor and so this interlock did not get elevated to requiring a functional safety assessment.

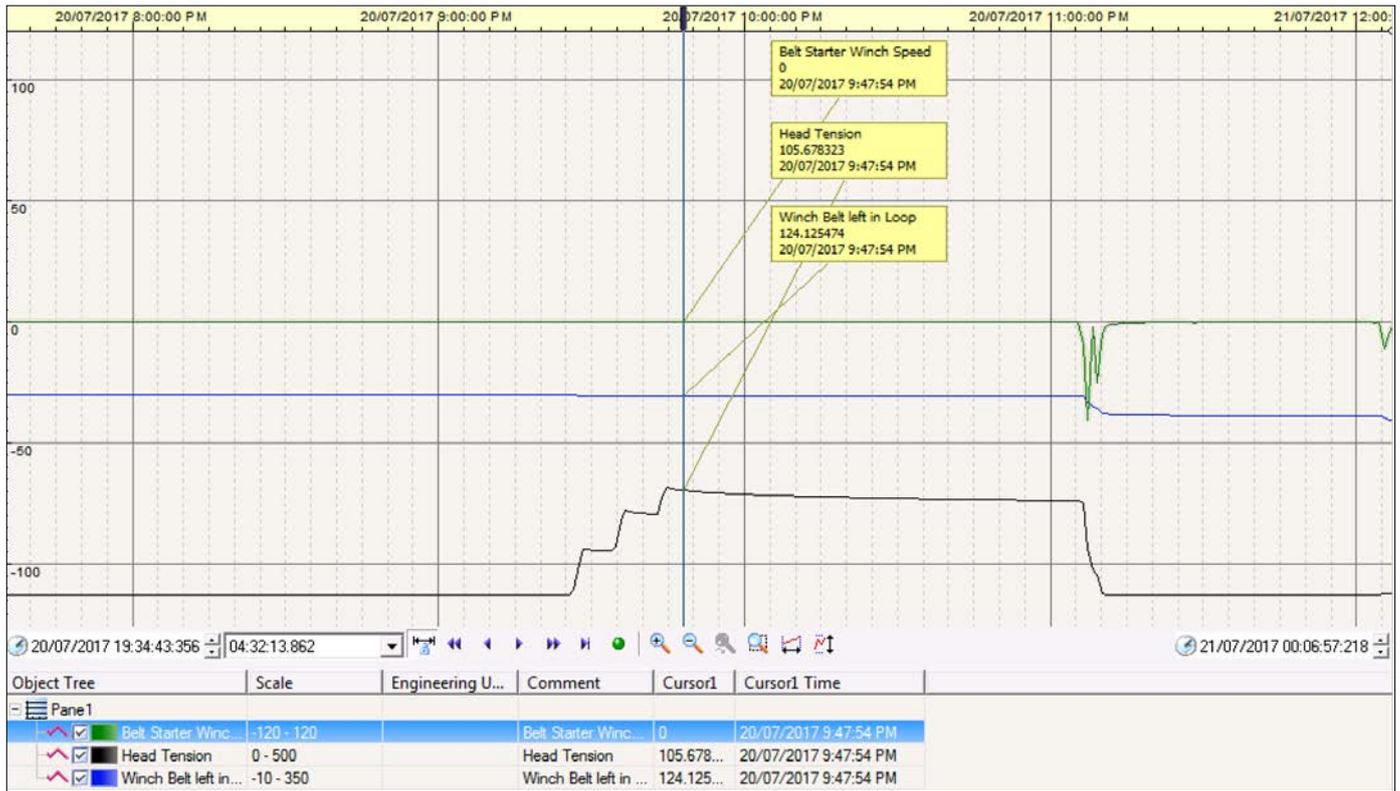
This over-tension incident on 20 July 2017 was raised verbally the next day (21 July 2017) by the operator from the previous day to mine supervisors. No formal hazard form was completed at this time. The supervisors discussed it and resolved to investigate during the next belt advance.

Figure 17: Panel conveyor trend for 20 July 2017.

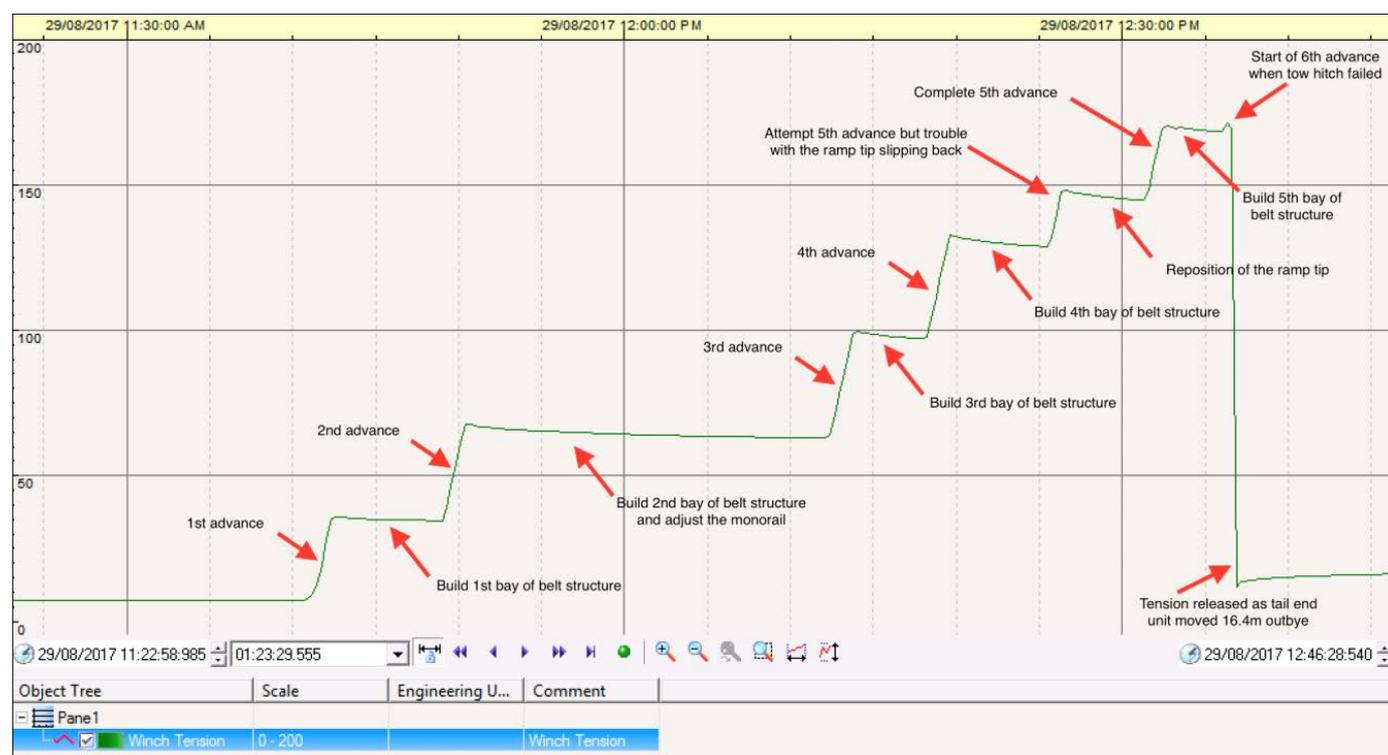
The fifth bay of belt structure was installed and the sixth advance started. During this advance, the tow hitch between the DMU and the tail end unit failed allowing the stored energy in the conveyor belting to propel the tail end unit 16.4 m outbye, in less than two seconds, crushing the five bays of structure.

**Table 9: Annotated trend diagram of panel belt winch tension. During a normal advance the winch will maintain belt tension at 12kN. On the day on the incident the winch tension achieved 181kN just before the tow hitch failed.**

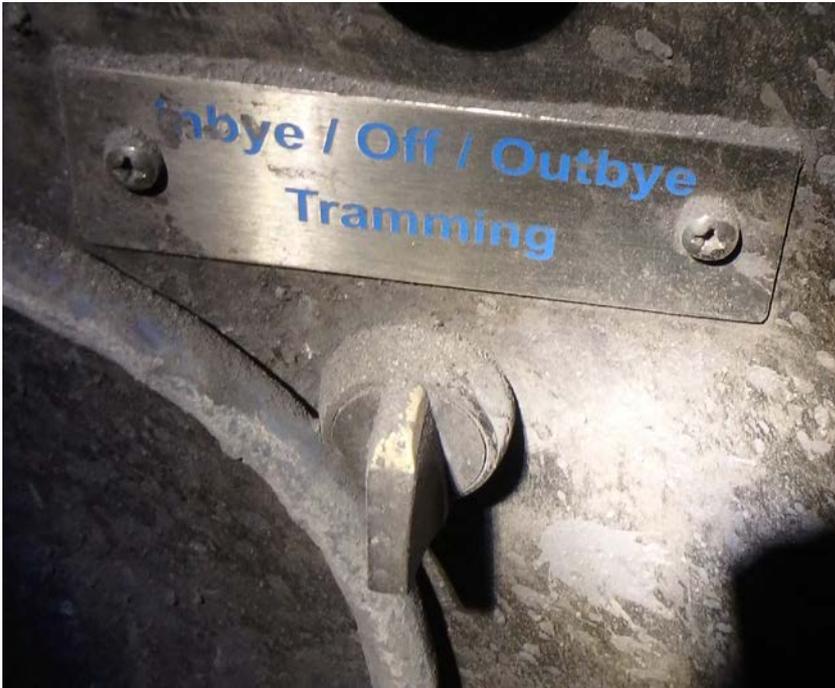
On a small electrical panel on the DMU there is a three-position switch: inbye / off / outbye. After the incident this switch was identified to be in the off position.

Figure 21: The three-position switch.

The tramming switch was found after the incident to be in the incorrect (off) position, which prevented the conveyor intercom system from broadcasting the belt tension.

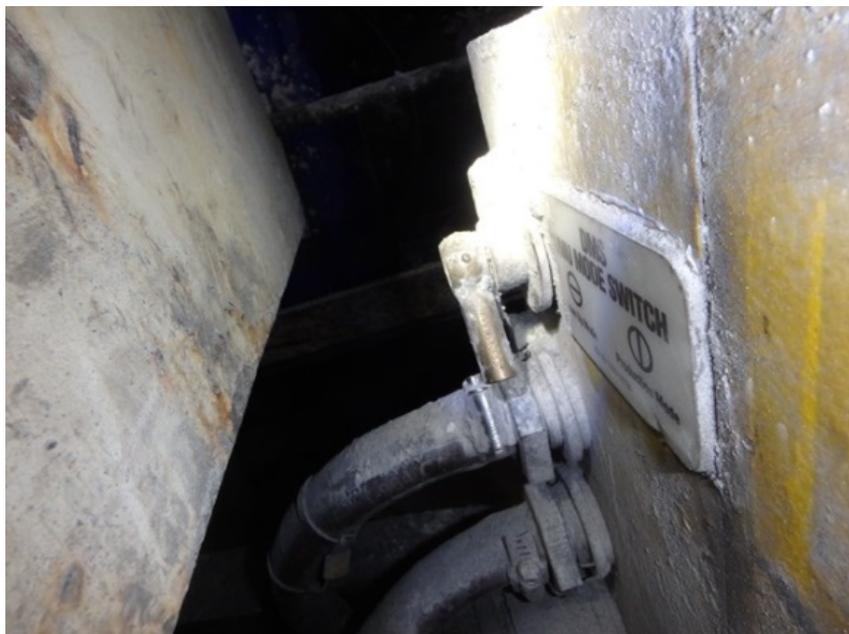
Figure 23 - Mode switch post incident.

The mode selector switch was to be placed in move-up mode (inbye) to enable belt advance (move-up). The switch was observed in the vertical position (figure 8) (production mode) on enclosure 5 on the DMU ramp area on the inbye end of the DMU. “DMS – DMU mode switch” was tested following this incident, identifying that this switch and the switch activation was firm, confirming the switch would remain in position following selection of mode.

During testing, it was identified that the switch position and switch position labels do not align. This is shown in figure 8 where the switch is in move-up mode.
