# INVESTIGATION INFORMATION RELEASE

## Collision between semi-autonomous dozer and manned excavator

**Incident date:** 27 May 2019

**Location:** Wilpinjong Coal Mine, Mudgee, NSW

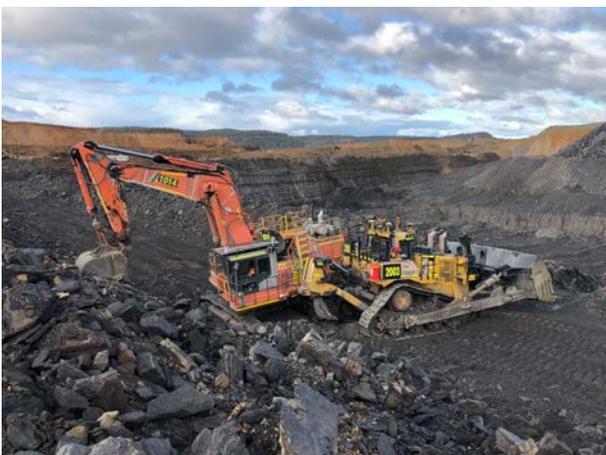
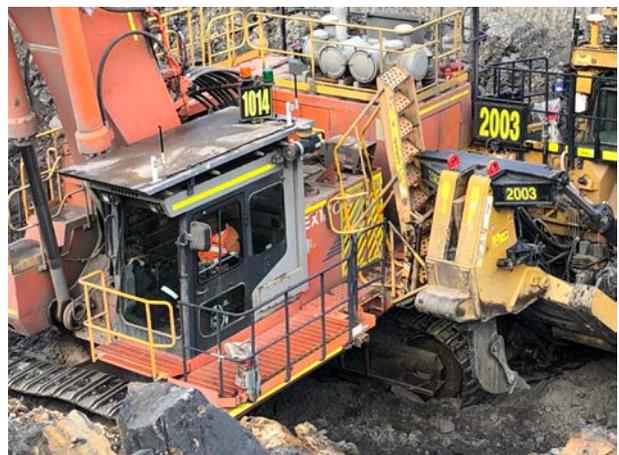
A collision occurred between a Caterpillar D11T dozer operating semi-autonomously and a manned Hitachi EX1200 hydraulic excavator at 13:40 on Monday 27 May 2019. The excavator operator was scaling a section of a highwall in the operating area of the semi-autonomous dozer fleet. The excavator travelled into an active slot, in the path of a dozer working in semi-autonomous mode, while the dozer was reversing to commence the next programmed push. When the dozer contacted the rear of the excavator, it pushed the excavator approximately 1.5 metres sideways and then began to spin its tracks. After five seconds the dozer's semi-autonomous system identified that it had experienced track slip and stopped tramming as programmed.

*Figure 1 & 2 - Incident scene immediately following the incident*

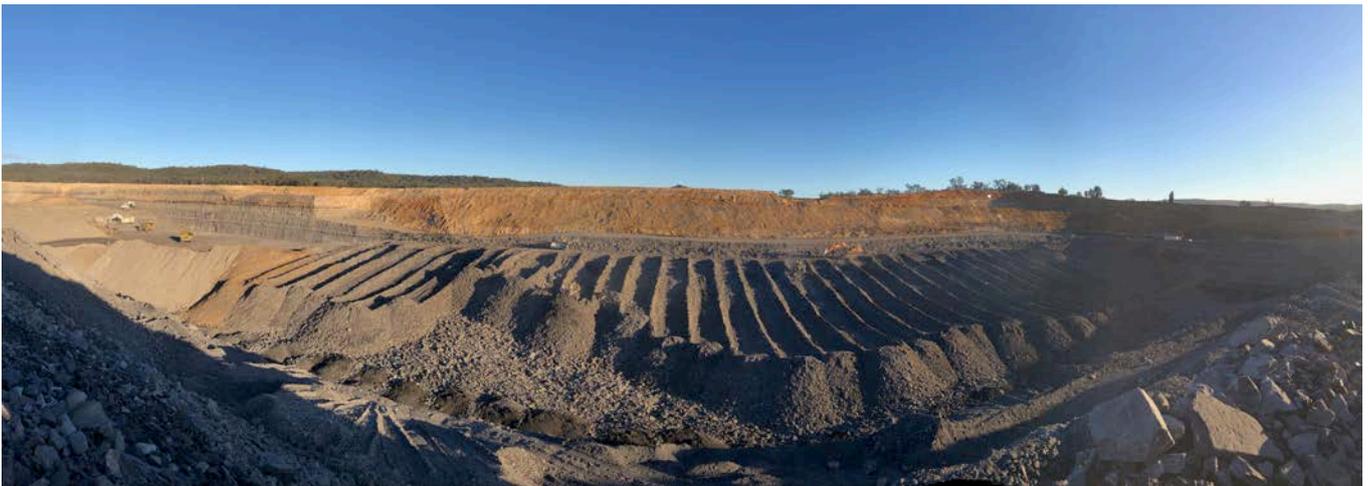
*Figure 3- The SATS operating area, taken on the morning of the incident*

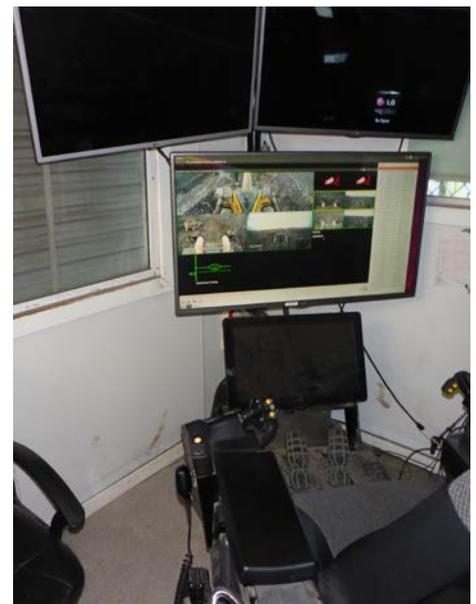
*Figure 4 - The SATS control station*

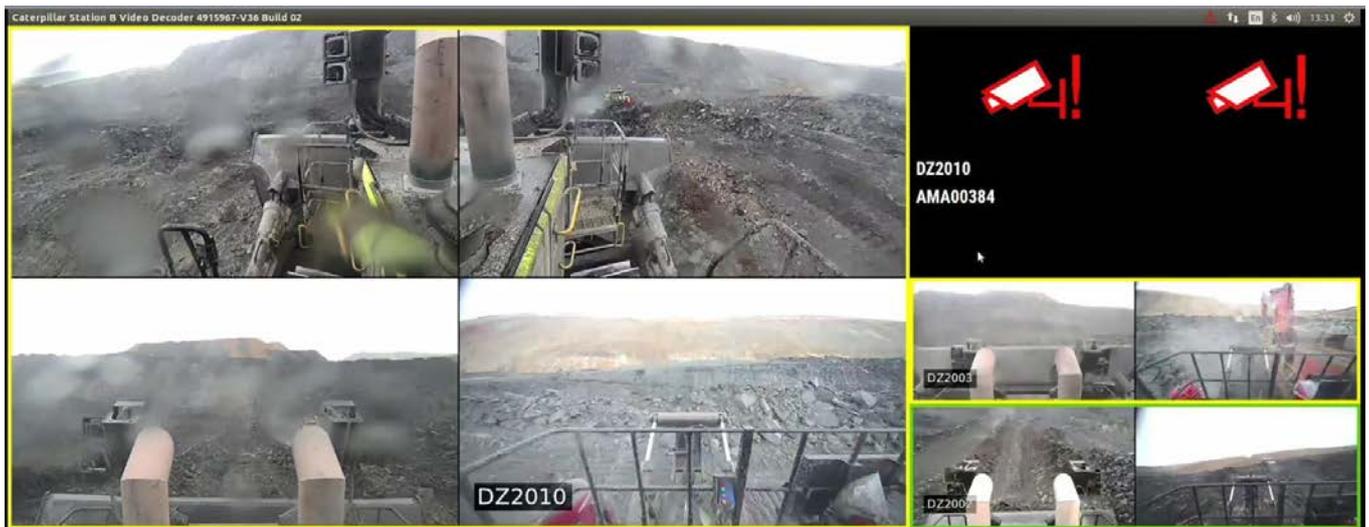
Immediately prior to the incident, the SATS operator was operating dozer 2010 that had paused because it required operator input. As EX1014 proceeded past the end of the windrow and continued scaling the highwall, dozer 2003 had completed a push and commenced reversing. The dozer was travelling in second gear at approximately 7 kilometres/hour. As the ripper box contacted the rear of EX1014, it continued to drive, pushing EX1014 sideways approximately 1.5 metres. At this point, the dozer lost traction. After five seconds of tracks slipping, SATS alarmed and stopped dozer 2003. From initial contact to dozer 2003 stopping took approximately 14 seconds.

Figure 5 - screenshot of SATS operator monitor prior to incident
