DATE: JULY 2018

Rib failures in underground coal mines

This safety bulletin provides safety advice for the NSW mining industry.

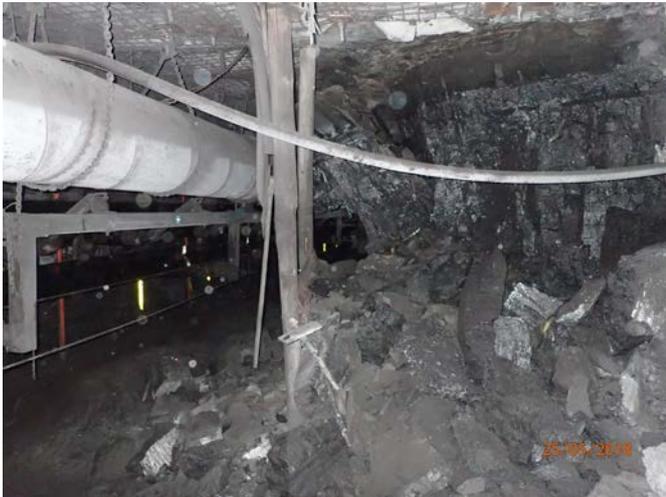
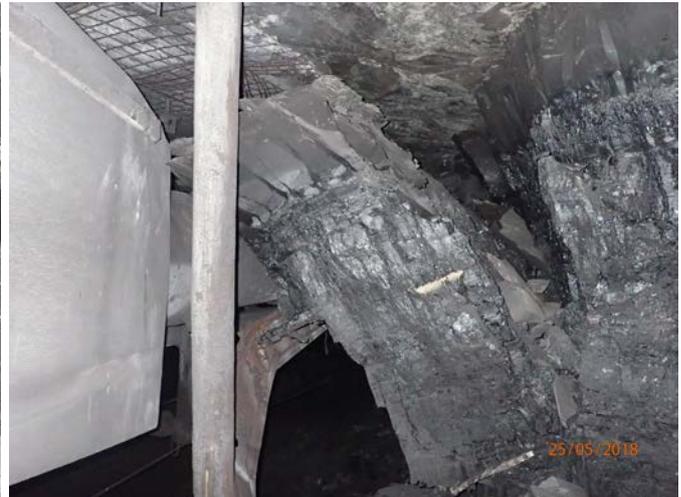
Incident 1: A rib failure was found during a routine inspection. The failure occurred on the off-walk side of a conveyor. A section of rib (one metre thick) was supported by a gas drainage pipe and smaller pieces of coal falling into the walkway. Failure was attributed to continuing deterioration due to the area being mined some time ago.

Figure 1 & Figure 2– Rib failure on the off-walk side of a conveyor (SInNot-2018/00877)

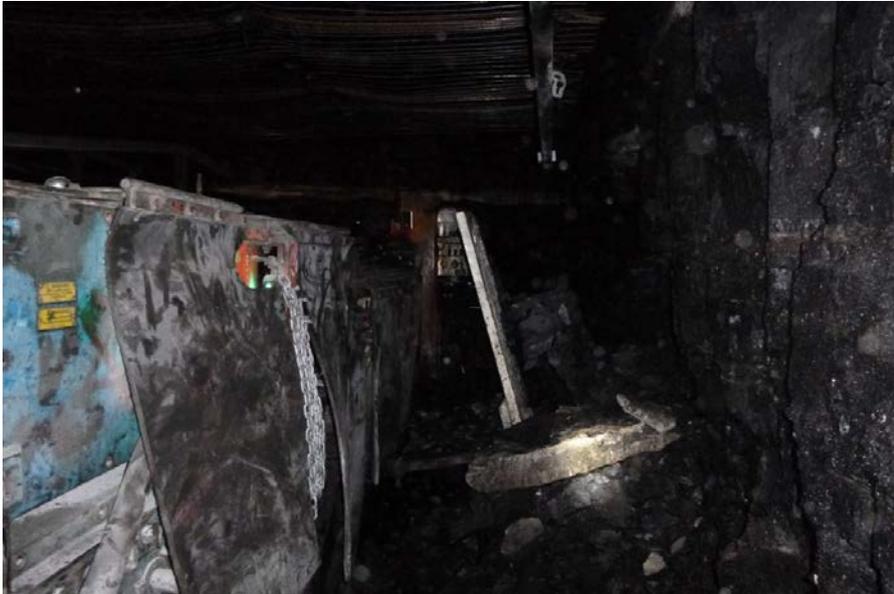
Incident 2: In a development drivage, workers were retracting the onboard rib protection on a continuous miner when a piece of rib failed, falling under the platform and pivoting the platform up. The worker had his arm briefly pinned between the rib protection and continuous miner chassis.

Figure 3 – Rib failure striking platform. Note that the platform has been rotated back down towards the normal operating position (SinNot-2018/00854). Photo courtesy of the mine.

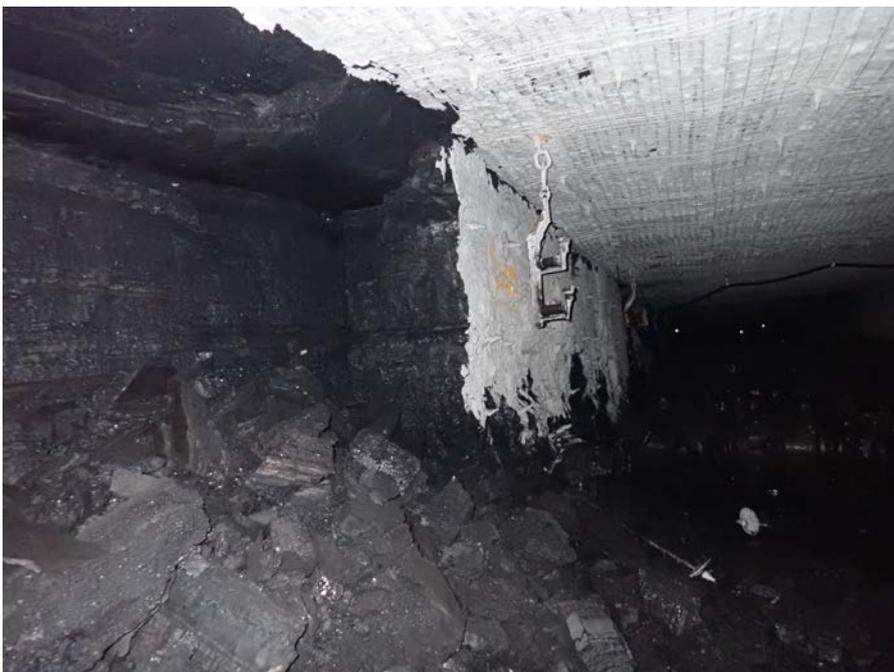
Incident 3: A mine had continuing reports of poor ribs that were rated red on the mine's trigger action response plan (TARP). A mine worker was hit with a large piece of rib that failed, breaking his ankle. The piece that hit the worker was 0.6m x 0.5m x 0.5m. Larger pieces also fell. The total fall was 4.7m long, 0.85m deep and 3m high. When the area was inspected, broken fibreglass bolts were found in the panel and deputy reports showed rib conditions had been reported as poor for some time.

Figure 3 – Failed section of rib (SinNot-2018/00638).
