Week ending 11 July 2018

This incident summary provides information on reportable incidents and safety advice for the NSW mining industry. To report an incident to the NSW Resources Regulator: phone 1300 814 609 24 hours a day, 7 days a week.

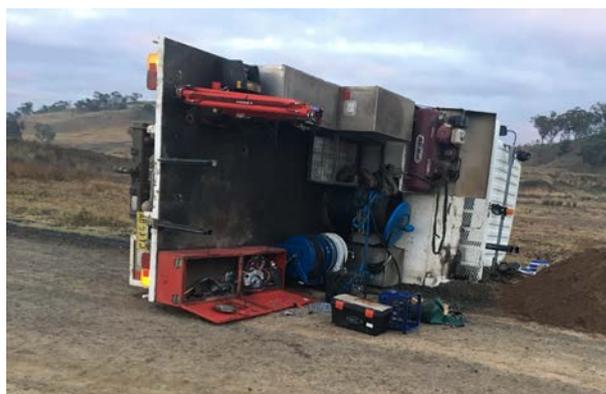
Dangerous incident
SinNot - 2018/01088

A service truck rolled while leaving a mine site. At a right-hand bend on a gravel road, the driver swerved, lost control and the truck tipped on its side. A fuel tank was fitted to the truck and was only partially filled.

When tanks are fitted to vehicles (such as fuel or water tanks), the risk of fluid movement should be considered and appropriate controls put in place including baffles and minimum/maximum fill levels.

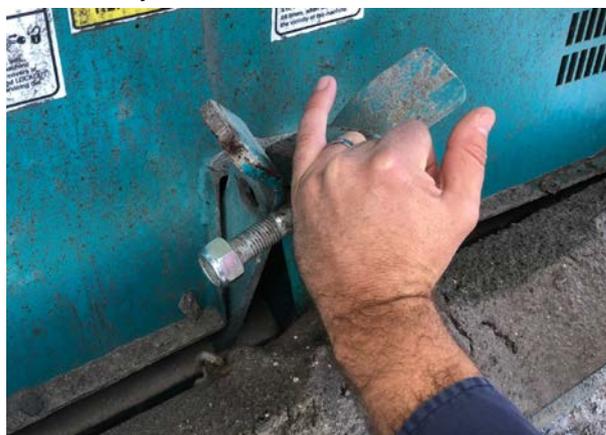
Serious injury
SinNot - 2018/01074

A tradesman had the fourth finger on his left hand amputated while preparing a mobile crusher for transport with co-workers. One worker was undoing a nut that was going to be used to secure a tail pulley. Another operator was in position on the opposite side at the controls and mistakenly thought he was given a direction to lift the pulley. The amputation occurred when the worker pulled his hand away. A retaining pin was missing and the nut and bolt were used as a substitute. Emergency procedures were not followed by the workers.

When planning tasks workers must consider:

- isolation requirements
- methods of communication
- emergency response.
