Week ending 18 July 2018

This incident summary provides information on reportable incidents and safety advice for the NSW mining industry. To report an incident to the NSW Resources Regulator: phone 1300 814 609 24 hours a day, 7 days a week.

Mine safety reference	ISR 18-28
-----------------------	-----------

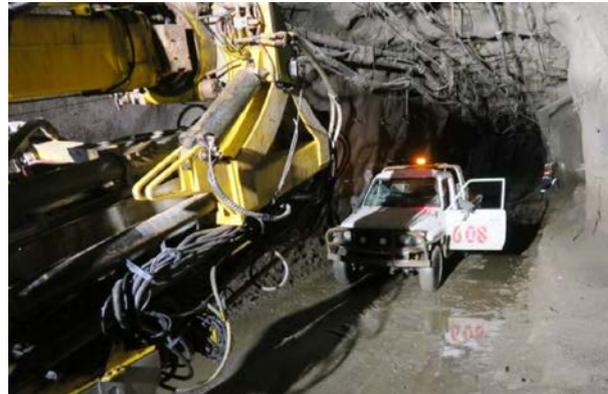
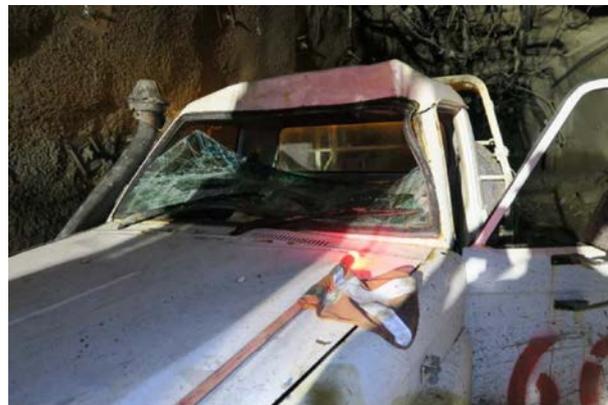
Dangerous incident
SinNot - 2018/01136

At an underground metalliferous mine, a collision occurred between a drill rig and a light vehicle. The light vehicle sustained significant damage.

As the light vehicle approached, the operator stopped but was unable to make radio contact. The drill continued to drive and the boom made contact with the windscreen. The driver and passenger in the light vehicle were not injured.

The risk of collision when vision is restricted is well documented and reasonably foreseeable. Suitable risk controls such as cameras and vehicle escorts should be used when tramming large items of plant with restricted visibility around mine sites.

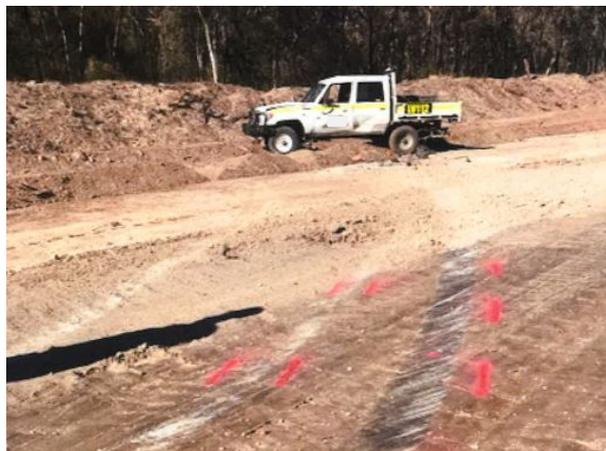
Dangerous incident
SinNot - 2018/01127

At an open cut coal mine, a light vehicle rolled after losing control on a freshly watered section of a haul road. The driver was uninjured and was put under observation in the first aid room at the mine. Drug and alcohol testing was undertaken. The scene was preserved with normal operations undertaken on an alternate circuit.

Following several similar incidents, [SB1809](#) [Overwatering of roads leads to vehicle incidents](#) was issued. Mines should review the recommendations detailed in this safety bulletin.
