Week ending 25 July 2018

This incident summary provides information on reportable incidents and safety advice for the NSW mining industry. To report an incident to the NSW Resources Regulator: phone 1300 814 609 24 hours a day, 7 days a week.

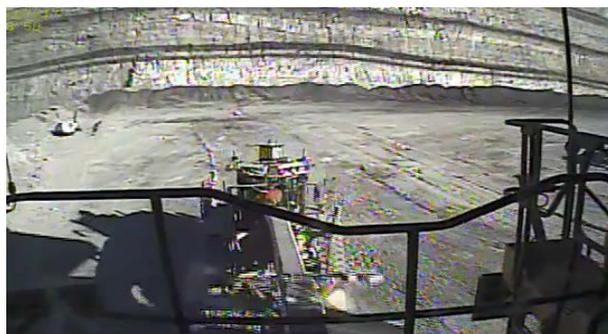
A collision occurred between a grader and a haul truck. The collision caused the grader to be pushed 15 metres from its location prior to contact. No one was injured.

Operators of mobile equipment must not place other workers at risk. Maintaining focus and attention is vital to avoiding collisions.

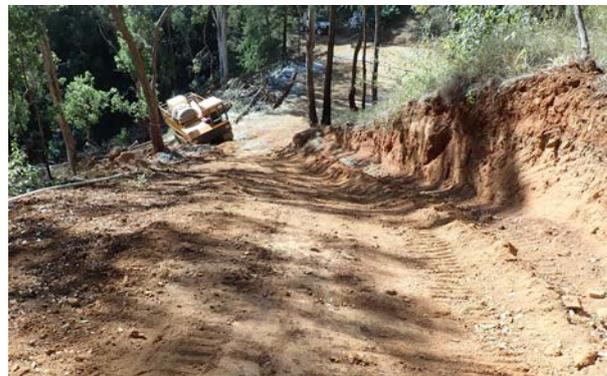
A worker received a broken leg and another worker a dislocated shoulder when they jumped from the tray of a runaway vehicle. The vehicle was climbing a steep grade when the vehicle stalled and slid down the hill. The incident was not reported immediately.

Operators must only ride in designated seats where protective devices are fitted to protect them from injury. Vehicles must be assessed as fit for the intended purpose before starting a job. Assessment must consider all operating parameters such as grade, surface, traction and loading.

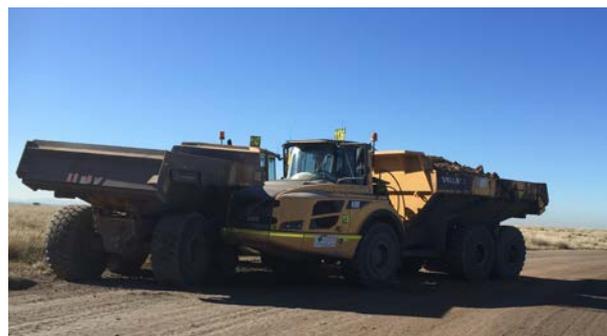
Two articulated dump trucks collided when one truck failed to negotiate a bend. It is reported that an operator had a microsleep.

When overtime shifts are allocated, workers' fitness for work, including fatigue, must be considered.

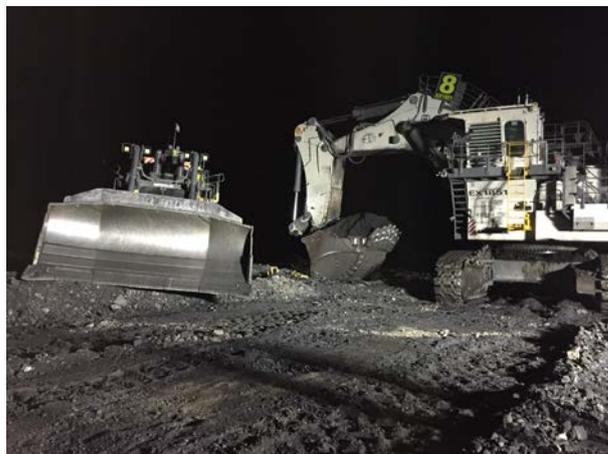
A collision occurred when an excavator slewed around, striking a dozer. The contact separated the access ladder from the dozer. The dozer operator failed to gain positive communication before entering the swing radius of the excavator. The excavator operator also failed to follow the relevant operating procedure for this task.

[SB18-06 Lack of positive communications](#) details positive communication and proximity detection and collision avoidance requirements.

Section 28 of the *Work Health and Safety Act 2011* requires workers to comply with reasonable instructions given to them, in this case a procedure.

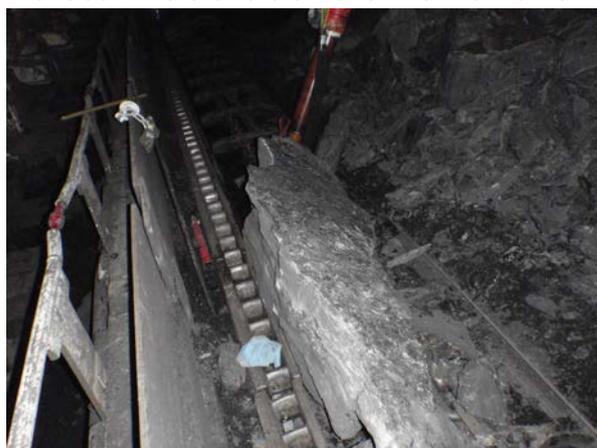
A worker injured his arm while taking evasive action to avoid being struck by falling strata. The worker was installing bolts between the roof supports when the piece of stone fell (approximately 2.9 x 0.8 x 0.6 metres) from the face. The stone did not strike the worker.

Where unsupported strata exists during longwall face bolt-up there are many operational controls that can be implemented to reduce exposure to operators. These include:

- leaving a bench to improve face stability
- pillar design and roadway rib support to improve tailgate face stability
- installation of temporary roof support
- changes to cutting horizon
- use of rapid face bolters to give operators additional protection.
