**NSW
Resources
Regulator**

INVESTIGATION REPORT

Bulga Open Cut dump truck collision

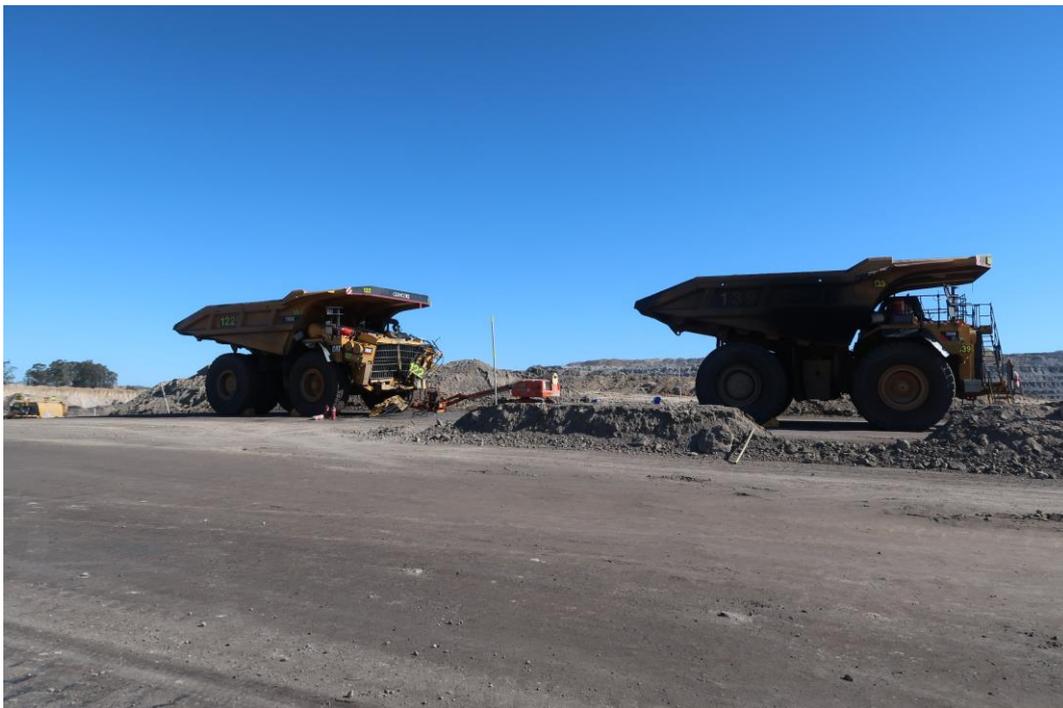
The cabin of DT122 collided with the rear edge of the tray body of DT139. This resulted in the two pillars of the operator's cabin being pushed inward toward the driver. The force of the collision shunted DT139 forward about 20 metres.

Figure 1: Final resting position of DT122 and DT139

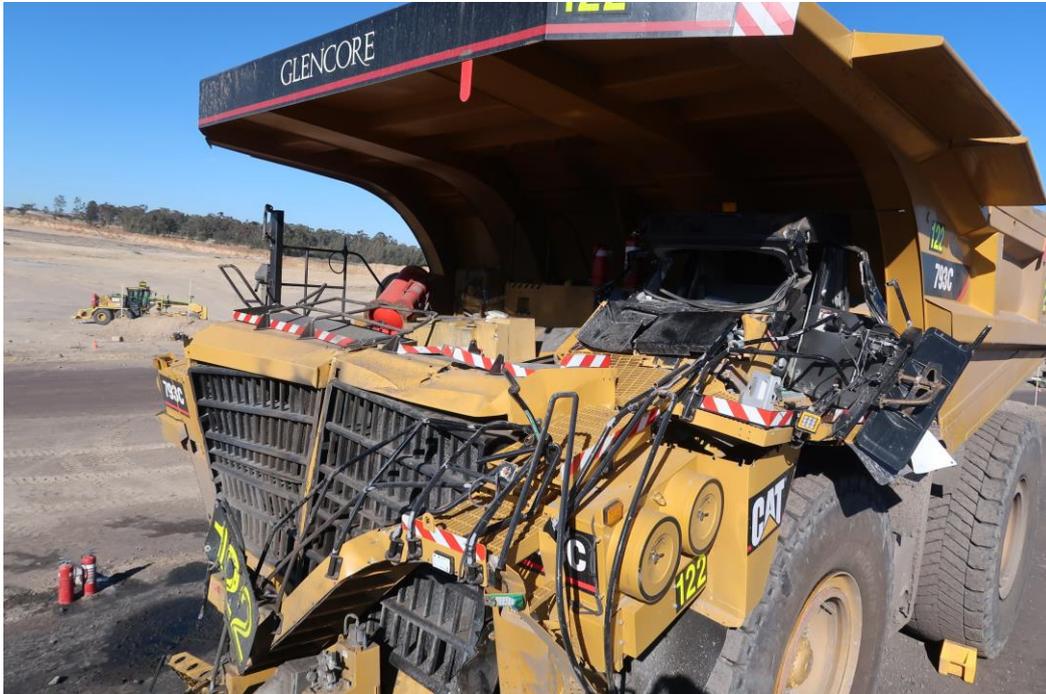
The cabin of DT122 collided with the rear edge of the tray body of DT139. This resulted in the two pillars of the operator's cabin being pushed inward toward the driver. The force of the collision shunted DT139 forward about 20 metres.

Figure 2: Damage to front and cabin of DT122

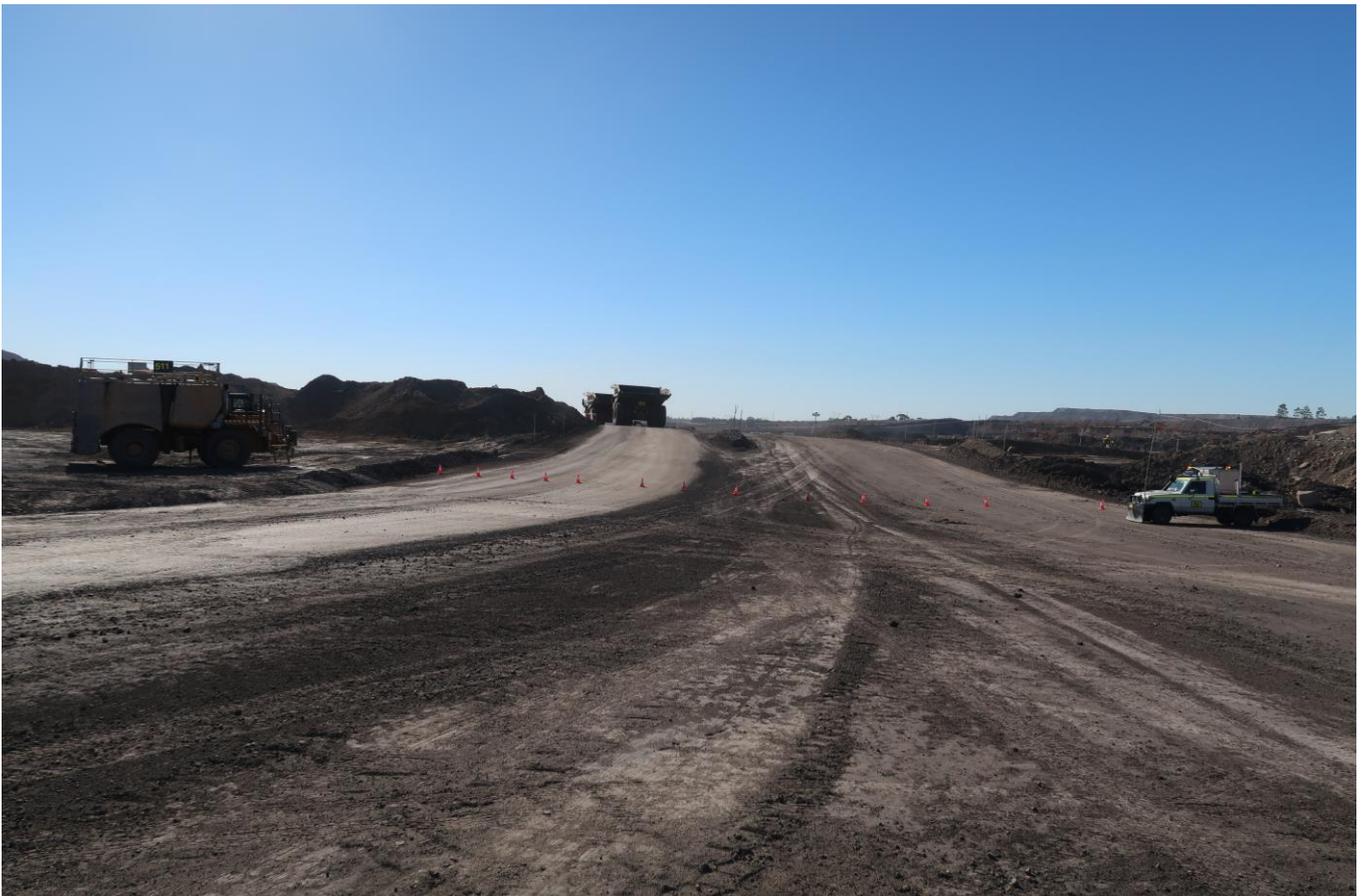
The incident occurred on a main haul road, known as Swan Lake Road. The surface roadway is of hard, compacted clay. The grade of the roadway at the point of impact was +3.5% with a cross grade of 2.0%. The photograph below is of the roadway leading to where the collision took place. The two dump trucks involved in the incident can be seen in the centre of the photograph.

Figure 1: Roadway where collision occurred
