INCIDENT ALERT

LOCATION:	AGGREGATE DREDGER	ALERT STATUS:	Normal
ACTIVITY:	MAINTENANCE & HOUSEKEEPING	DATE ISSUED:	04/07/2017 10:32:47
SUB ACTIVITY:	N/A	INCIDENT No:	01458

Lifting Operation LTI

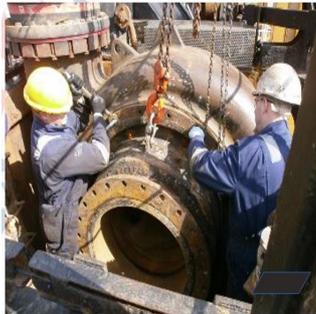
Final reassembly of the pump was being conducted. This involved using a crane on the shore to lift the pump cover back into place. The pump cover is 1.5m in diameter and weighs 1.5 tonnes. The cover must be closely guided back into position - hence the two contractors were in close proximity. A banksman was guiding the crane. Location of the cover onto the spigot was at an upward angle, due to the trim of the vessel.

Whilst attempting to fit the cover, it came off the spigot and moved unexpectedly, swinging and striking the two contractors. The cover did not drop. Both contractors were taken to hospital. One was released that evening with minor injuries and the other sustained fractured ribs and was kept in overnight (LTI).

- The cover had swung earlier in the operation. Failure to STOP & THINK. Contractors were close to completing the job and wanted to get it done.
- The contractor asked the 2nd Officer to move the ship's unloader, altering the ship trim (angle). He was unaware this could affect the job.
- Crane positioning could have been closer on the quay.
- Fine positioning is not easy using just the crane controls. A chain block should have been used to allow local control.
- Preventer studs on the pump door would allow for initial alignment to be achieved without having people in such close proximity.
