## Significant Incident Report No. 263

**Subject:** Asbestos-containing material (ACM) disturbed in power transformer

**Date:** 08 June 2018

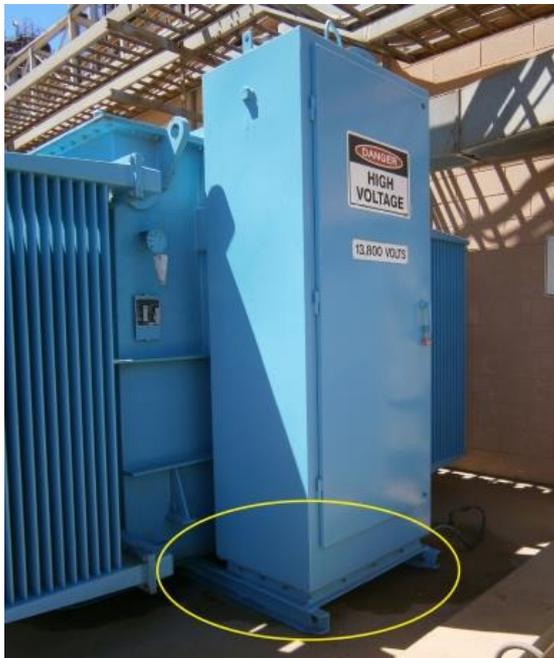
To remove cables to disconnect the transformer, the workers unbolted and removed a gland plate located at the base of the transformer's junction box. During this process, the gland plate broke into several pieces.

Left: High-voltage transformer, indicating where the gland plate was located on the inside base of the transformer's junction box. Right: Damaged gland plate.

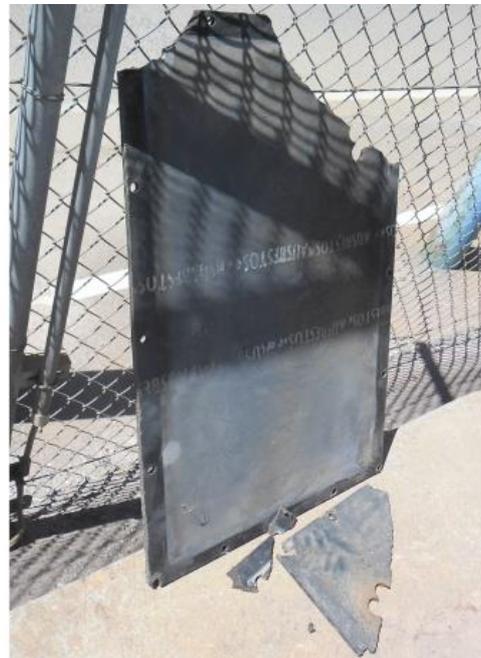
On turning the gland plate over, the workers found the words "Ausbestos" (brand name for asbestos-containing products) stencilled on the underside. The electrical workers were not wearing respirators.

The asbestos-containing gland plate was broken while being removed.

- Asbestos-containing material (ACM) in the transformer was not identified prior to the work task commencing and the transformer was not listed in the site's asbestos register.
- A safe work method to prevent damage to the gland plate was not used.

- Competent person (e.g. occupational hygienist with asbestos experience, licensed asbestos assessor) to conduct a survey of power transformers to identify possible sources of ACM.

- Record the results of the survey in the site's asbestos register.
- Provide appropriate signage and labelling to warn of the presence of asbestos.
- If ACM is to be removed, ensure competent persons (e.g. licensed asbestos removalists) conduct the removal work using appropriate safe work methods to comply with the *Code of practice for the safe removal of asbestos* (r. 9.32, Mines Safety and Inspection Regulations 1995).
