INCIDENT ALERT

Fatal 6 - Return roller nip guard on conveyor falls 4m and hits contractor

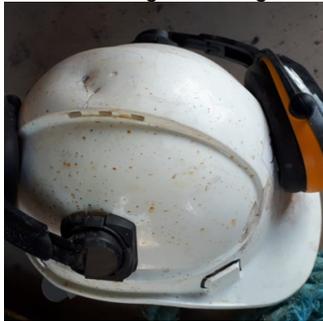
The guard weighing circa 8kg fell 4m and hit the contractor on the centre of his hard hat. Fortunately, the contractor suffered only neck and muscle strain and was able to continue working after a short period.

Hard hat with dent along back near centre

- Check to see if this type of system is present on your site
- If they are on site, amend risk assessments / safe systems of work to include the need to check how roller nip guards, rollers and scrapers are secured
- Ensure all return roller nip guards, rollers and scrapers are securely fixed before any conveyor belt replacement work commences
- Any person carrying out a task where objects or items above them could fall should wear a hard hat, not a bump hat.
- Exclusion zones should be set up in any area where equipment is being worked on overhead

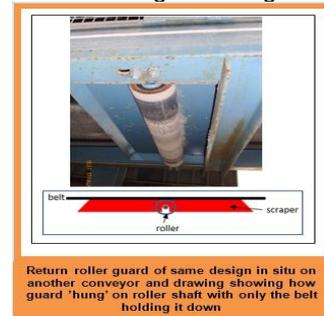
The contractor was standing under the incline conveyor belt system as he pulled the old conveyor belt through the system. During this operation an original return roller nip guard was dislodged. Investigation showed that it was designed so that it hung over the roller shaft and was only held in place by the belt and gravity.

Return roller guard of same design in situ on another conveyor and drawing showing how guard 'hung' on roller shaft with only the belt holding it down
