## INCIDENT ALERT

LOCATION:	MOBILE PLANT	ALERT STATUS:	Normal
ACTIVITY:	MAINTENANCE & HOUSEKEEPING	DATE ISSUED:	14/06/2017 13:20:57
SUB ACTIVITY:	N/A	INCIDENT No:	01457

#### Track tensioning - HSE Incident report following fatality from a hydraulic injection injury

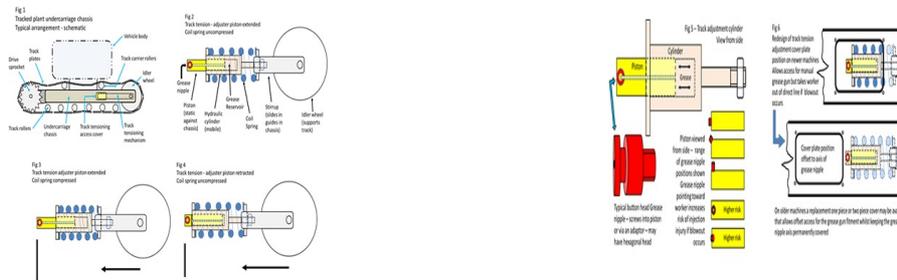
The tracks on tracked vehicles (Fig 1) are tensioned by adjusting the position of the idler wheel. On the majority of these machines a coil spring compresses or extends to take up normal small changes in track tension during operation (Fig 3). However initial set up and wear adjustment is achieved by a short stroke hydraulic cylinder filled with grease (Figs 2 & 4). The piston of this is extended using a hand held grease gun. This compresses the coil spring which in turn drives the idler wheel to the desired position and holds it there under retained grease pressure. While this operation was being carried out on the track of a piling rig, the nipple connecting the grease gun to the track mechanism detached, permitting the grease (under significant stored energy) to release, injecting the fitter and causing fatal injuries.

The precise mechanism which may cause over pressurisation has not been confirmed but is suspected to result from a sudden increase in the loading on the tensioner assembly. This is most likely to result as the track drive or idler sprocket attempts to engage with a track chain that is contaminated with debris such as stones or set concrete. These contaminants change the radius of the track/chain around the sprocket which results in a pressure increase in the tensioning cylinder. This is most severe once the coil spring has become fully compressed.

Components ejected during operation of the machine should be retained within the body of the track carriage assembly provided access hatches are correctly fitted. But there is a concern that components weakened by an over pressurisation during machine operation may fail at lower pressures during the track tensioning process when access covers are removed - with the operator of the grease gun at greatest risk. This is particularly relevant on machinery on which the grease nipple axis is perpendicular to the tensioner cylinder and not in line with it as is the case on many machines. See Fig 5.

Some manufacturers are now offsetting the hatches such that the opening is not in line with the axis of the grease nipple - so that in the event of failure, the nipple and grease jet should not be ejected outside of the track undercarriage. Some manufacturers now provide a replacement hatch cover that either contains a slot - offset from the grease nipple - to allow the grease gun to be attached and used; or has a separate, small, offset cover mounted on top of the main cover. See Fig 6.

Track tension on tracked plant must be kept within the limits set by the manufacturer. Track that loses tension repeatedly must not be over-tensioned to compensate. The cause of repeat loss of tension must be investigated by a competent person (eg experienced plant fitter) to identify and rectify the root cause. If necessary assistance should be sought from the manufacturer or their local representative.

While tracked machinery is being operated, the hatch covers which provide access to the track tensioning grease nipple must be in place and secured in line with the manufacturer's instructions.

When tensioning the tracks on vehicles where the grease nipple is perpendicular to the tensioner cylinder (ie where the axis of the nipple and/or any other parts of the tensioner assembly is pointing toward the grease gun operator), as a precaution the operator must ensure they are not positioned in front of or in-line with the nipple. This is so as to avoid injury should it break free of the tensioner assembly. On vulnerable machines, if the manufacturer provides a retrofit cover that allows the grease nipple to be permanently shielded this should be installed.

If a hydraulic component is ejected, the component must not be re-used, since it is likely to have sustained damage during such an event. Where a threaded component has detached, both the male and female thread involved must be scrapped and not reused. Partially stripped threads may not appear visibly damaged but will be unable to sustain their design load/pressure. The integrity of the union between any replacement components and the assembly must be verified by a competent person. If there is any doubt, seek advice/guidance from the original equipment manufacturer or supplier. Scrapped components should be destroyed to prevent inadvertent reuse.
