SAFETY ALERT

SUBJECT Operators Hi-Viz became entangled in rotating machinery

INCIDENT DATE 24th May 2019

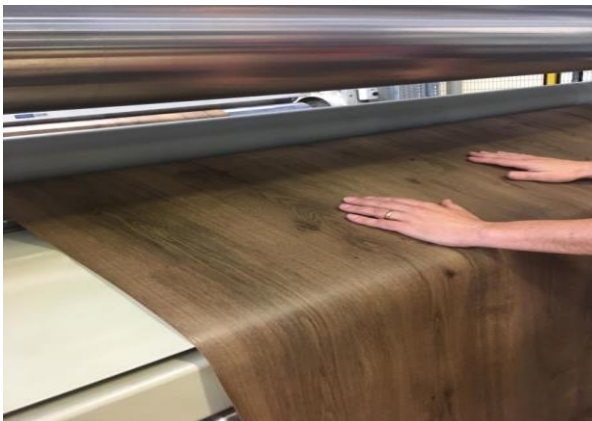
This picture shows the operator feeding material through metering unit.

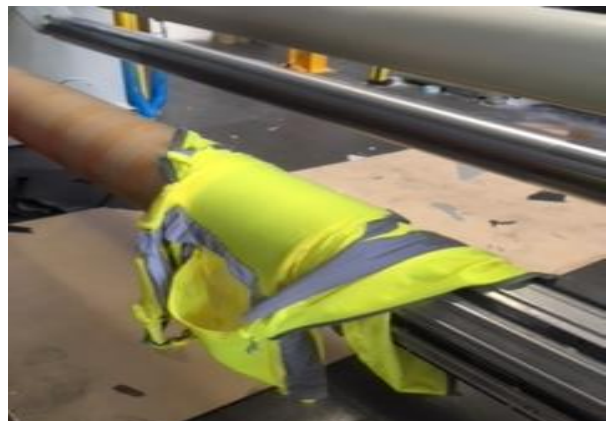
An operator was feeding décor material through the XLF 2 metering unit. The operator's hi-visibility vest came into contact with the adhesive tape on the cardboard former. The cardboard former was rotating throughout the activity, on a spindle, which the Hi-Viz vest became wrapped around. The Injured Person sustained injuries when the machinery pulled him towards the rollers. Another operator who was working with the I.P activated the emergency stop button and immobilised the machinery. The operator sustained bruising injuries to the back, arms and ribs.

This picture shows the operators vest getting stuck to the adhesive tape on the cardboard former and wrapping around the spindle.

- All work was immediately stopped and the machinery isolated
- No further re-reeling activities will proceed on this equipment until further controls are put into place.
- Operators working on any similar machinery have been briefed and informed to remove any loose items of clothing
- A full ICAM investigation is ongoing
