Week ending 13 June 2018

This incident summary provides information on reportable incidents and safety advice for the NSW mining industry. To report an incident to the NSW Resources Regulator: phone 1300 814 609 24 hours a day, 7 days a week.

Summarised incidents

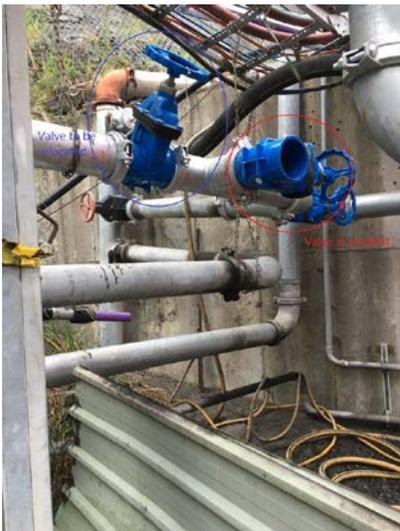
| Incident type | Summary | Recommendations to industry |
|---|---|---|
| Dangerous incident SinNot-2018/00943 | <p>When a contractor released a pipe clamp on a charged 150mm airline, the valve kicked, striking him in the lip. He received six stitches.</p> <p>The compressor had been isolated, however the connection to the ring main had not been isolated.</p> | <p>Workers should always verify their isolation by dissipating the energy and testing for dead before starting a task.</p> <p>Mine work authorisation systems should include details of the isolation requirements and provide the required information to allow the task to be carried out safely.</p> |

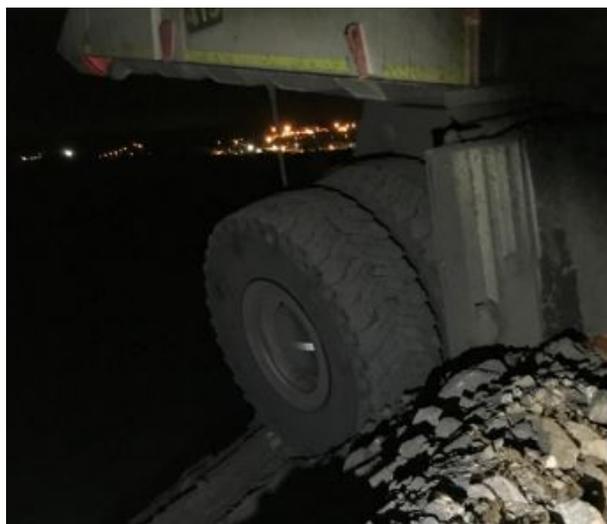
Dangerous incident
SinNot-2018/00927

A haul truck breached a windrow at a dump. The position 5 and 6 wheels breached the windrow and the operator only stopped when called by another operator. There was a 20m drop behind the windrow.

Detailed training and procedures should be provided to operators relevant to dump design and conditions at the mine.

Supervision should be in place to monitor worker understanding and compliance with procedures and training.

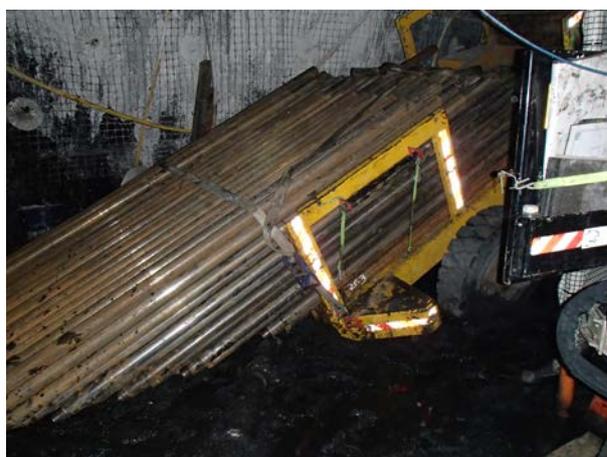
Dangerous incident
SinNot-2018/00925

A contractor was loading drill steels for a gas drainage onto a trailer when it tipped up. Two workers were next to the drill rig, away from the trailer.

Where the process of using a trailer or other load-carrying device can result in varying loads, controls should be in place to manage the risk of unbalanced, uneven and shifting loads.

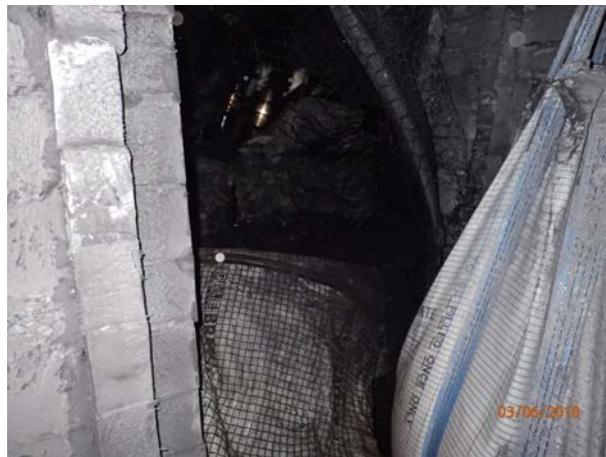
Serious injury
SinNot-2018/00916

A deputy suffered a shoulder injury after a fall. He was climbing through wire mesh and brattice in the tailgate of a longwall when his belt snagged, causing him to lose his balance, striking his shoulder on a stone dust bag.

Where workers are expected to access an area, safe access and egress should be provided. It is reasonably foreseeable that a mine worker's belt or attachments could catch on wire mesh.

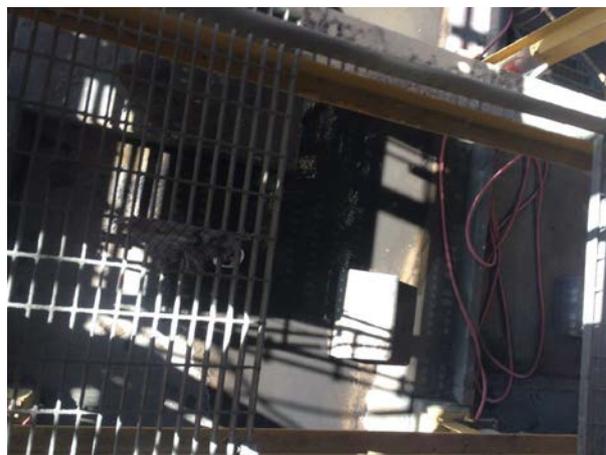
Serious injury
SinNot-2018/00903

When walking through the coal preparation plant, a piece of grid mesh fell when a worker stepped on it. The worker caught himself and avoided falling to the floor below. He sustained a broken leg and strained shoulder.

Grid mesh and clips should be considered a part of structures.

The [code of practice: mechanical engineering control plan](#) details minimum requirements for the inspection and maintenance of structures.

Routine inspections should be included in the site maintenance management systems.
