Week ending 20 June 2018

This incident summary provides information on reportable incidents and safety advice for the NSW mining industry. To report an incident to the NSW Resources Regulator: phone 1300 814 609 24 hours a day, 7 days a week.

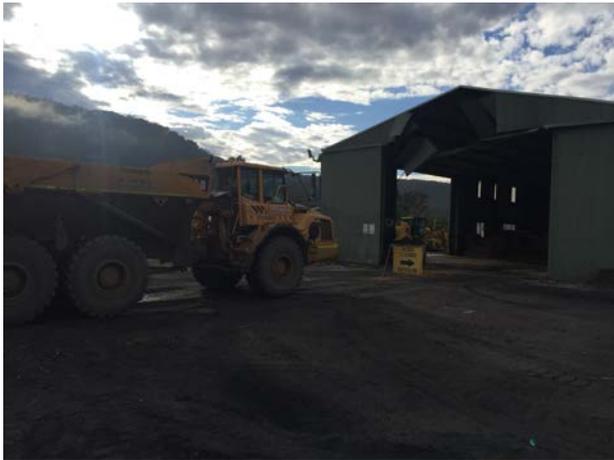
Incident type	Summary	Recommendations to industry
Dangerous incident SinNot- 2018/000971	<p>A workshop roof was damaged when an articulated truck hit it. After completing the pre-use inspection, the tub was still raised and the operator tried to drive through the workshop.</p>

<p>Driving through confined areas should be avoided if alternatives exist.</p> <p>The risk of trucks operating with raised bodies should be addressed in the operational risk assessment and suitable controls put in place. The hierarchy of controls should be considered when developing controls.</p>
Serious injury SinNot-2018/00970	<p>Three workers were injured when the transport vehicle they were passengers in hit a sled. A load haul dump (LHD) vehicle was towing the sled out of the mine when the incident occurred. The LHD pulled to the side</p>	<p>Trailers and attachments should be checked so they are visible to operators of other vehicles.</p>

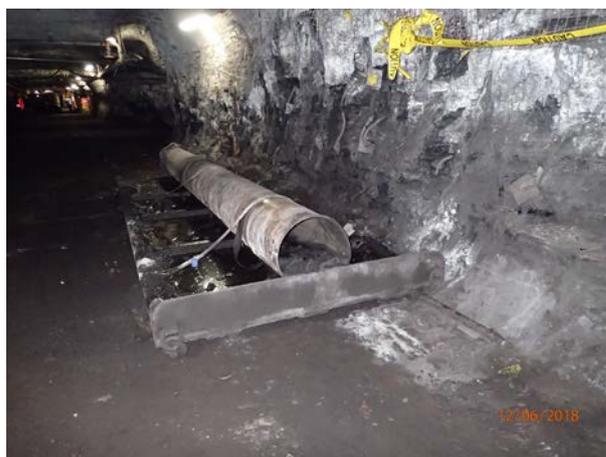
of the road to allow several transports driving into the mine to pass. As the second transport passed the sled, the left hand rear wheel hit the sled and the workers made contact with the roof of the vehicle.

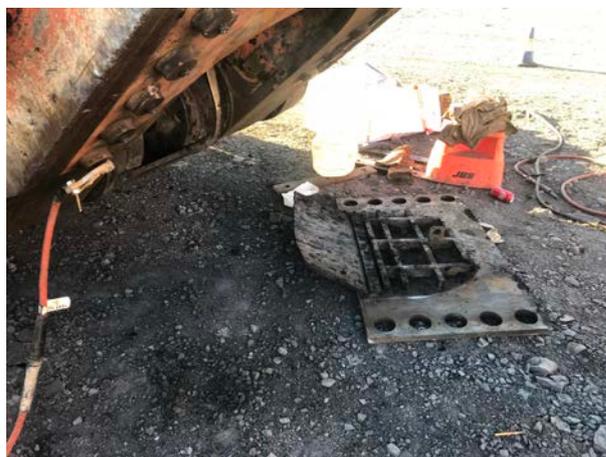
Dangerous incident
SinNot- 2018/000964

A boilermaker suffered a fractured foot. The boilermaker was cutting a steel plate from an excavator bucket when the steel plate fell to the ground. The steel plate bounced on the ground and hit the boilermaker's foot.

Work planning should include the requirements for loads to be supported during removal and lowered in a controlled fashion. This applies not only to tasks involving hot work but loads retained by mechanical means.

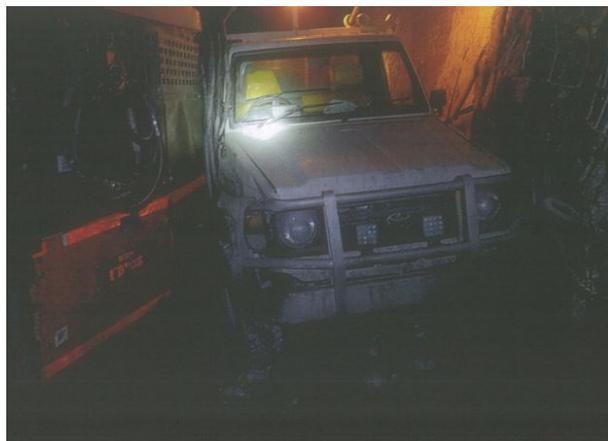
Dangerous incident
SinNot- 2018/000961

A collision occurred when a light vehicle rolled into a Jumbo. The light vehicle was parked in the decline. After leaving the vehicle it rolled forward and wedged between the Jumbo and the rib.

Ongoing monitoring of compliance with site park-up procedures should be included as part of the duties of supervisors.

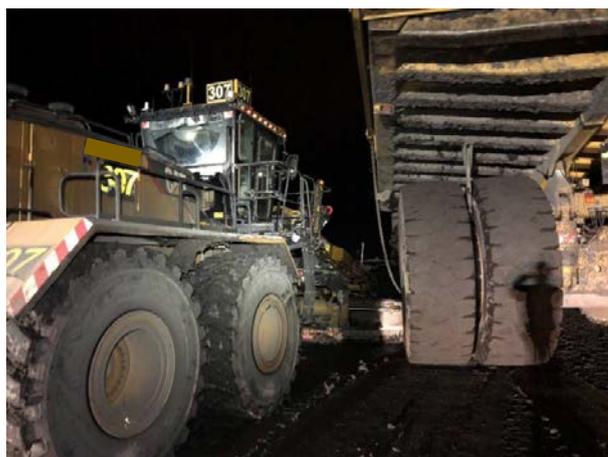
Dangerous incident
SinNot- 2018/000959

A haul truck was trying to pass a grader when it slid towards the grader and made contact. The grader was cleaning a haul road following rain.

Operators should drive to conditions and always manage separation distances. When starting operations following rain, additional caution should be taken.
