# INVESTIGATION INFORMATION RELEASE

## Worker injured releasing jammed conveyor chain

**Incident date:** 5 February 2019

**Location:** Springvale Colliery, Lithgow, NSW

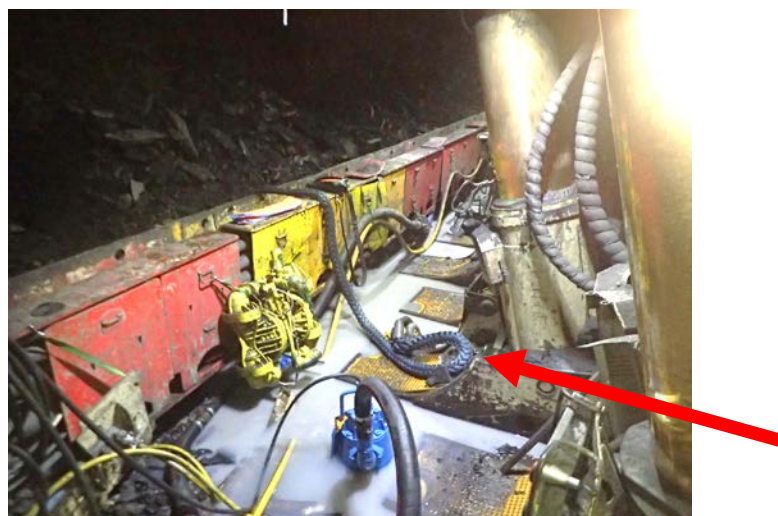
A shearer operator was injured in the process of releasing a jammed armoured face conveyor (AFC) chain using the shearer on a longwall. The injury occurred when an eight-tonne working load limit (WLL) Rud link, located on the shearer ranging arm, failed due to overload. The shearer operator was hit on the leg by recoiling components of the tow rope assembly when the Rud link failed. The worker was in the roof support walkway at the maingate end of the longwall, approximately 22 metres (15 roof supports) from the failed connection point on the shearer.

Figure 1: Location of worker struck by the recoiling shackle and blue Amsteel® rope

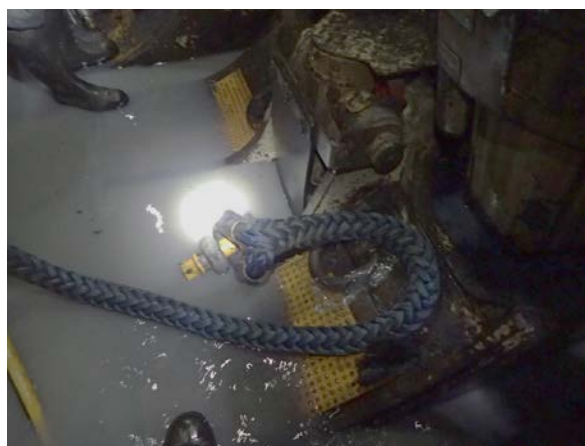
Shortly after the load was applied to the towing assembly by the shearer, the Rud link failed, the bow shackle and rope recoiled back towards the three workers located at the maingate. The bow shackle struck the shearer operator on the lower right leg. The connection point on the shearer was located approximately 22metres (15 roof supports) from where the injured shearer operator was located.

Figure 2: The 35t WLL bow shackle and blue Amsteel® rope on the roof support pontoon

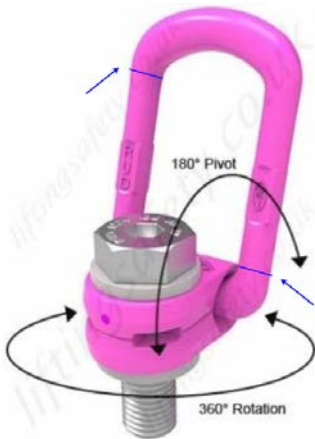
- The Rud link was as Rud VLBG, 8t lifting capacity with an M36 Property class 10.9 bolt.
- The Rud link had fractured transversely at two diagonally opposite corners. (refer figures 3 & 4)

Figure 3: Similar Rud bolt on lifting point. Location of fracture indicated by blue arrows (source [www.liftingsafety.co.uk](http://www.liftingsafety.co.uk))

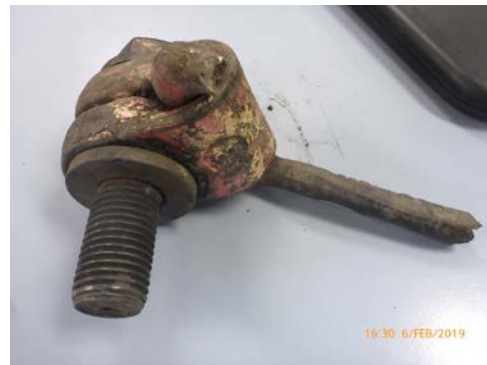
- Both fractures exhibited overload fracture over the entire fracture surface. There was no evidence of fatigue or other pre-existing cracks on either fracture surface.

Figure 4: The failed incident 8t Rud link (source NSW Resources Regulator)

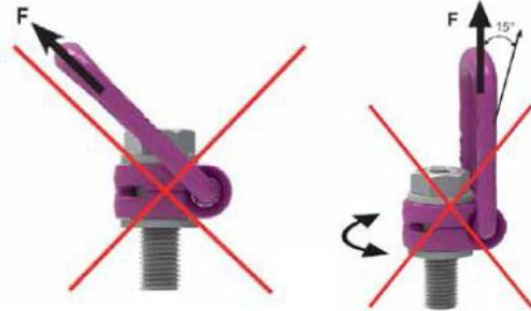
- The bolt on lifting point assembly was designed to rotate about the bolt as well as the lug to pivot through 180°. However, the OEM recommends that the lifting lug not be pivoted back over the bolt and clamp assembly or that the assembly not be rotated while loading in a direction parallel to the bolt axis. (refer figure 6)

Figure 6: Lifting configurations not recommended by Rud (source Rud website)
