## Significant Incident Report No. 251

**Subject:** Worker seriously injured while operating a block-making machine

**Date:** 24 February 2017

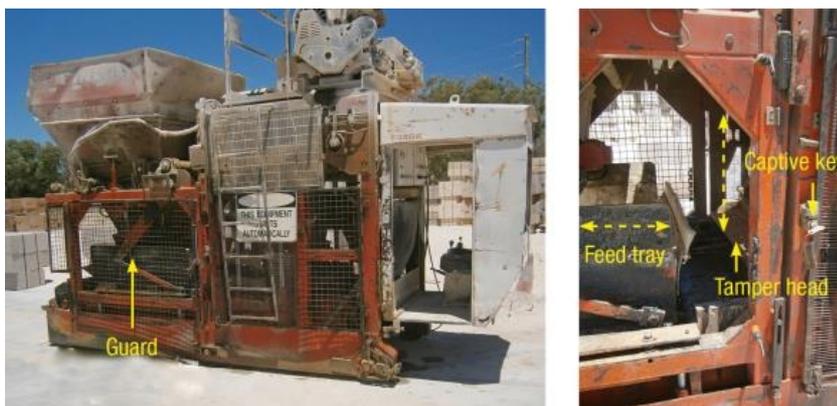
Left: Block-making machine showing the safety guard that was opened. Right: Area between the feed tray and tamper head, dashed arrows indicate direction of movement. Captive key in guard's interlock unit.

The scene examination identified that two captive keys were actually in place on the machine at the time of the incident. One of these was located in the safety guard locking arrangement (interlock unit), which was used to open the guard, while the other was in the start switch, which left the machine operating in auto mode.

- The operator entered the guarded area of the block-making machine while the machine was not isolated and set to operate in auto mode.

- The block-making machine had been set up prior to the incident to operate in auto mode.
- The machine's main electrical isolation switch was not functional.
- Both captive keys were in interlock units at the time of the incident, allowing access to the guarded area while the machine remained under power in auto mode.

- Implement and enforce suitable isolation procedures for plant and machinery.
- Implement and enforce a suitable system of control for captive keys and confirm access to the second key is adequately controlled.
- Undertake a documented risk assessment of all mobile plant in the workplace to identify, assess and control all hazards to which workers are likely to be exposed.
- Implement a suitable maintenance system, including periodic inspections by competent persons, to ensure plant are maintained and are in a safe condition.
