# SAFETY ALERT

May 2019

## NZ TRANSPORT AGENCY URGING FURTHER CHECKS OF NISSAN TRUCK PARK BRAKE CONTROL

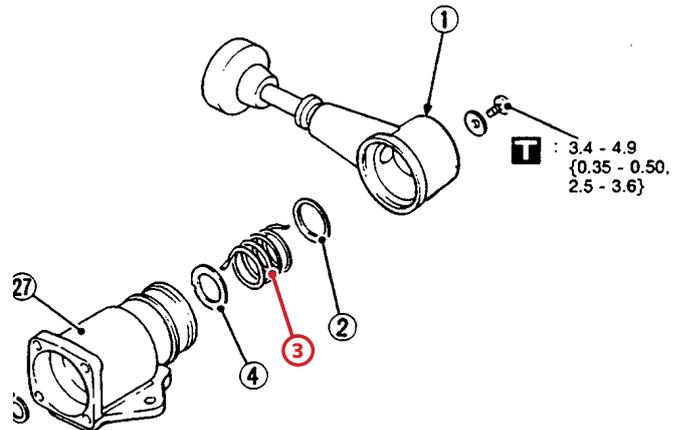
- When rotating the hand control handle it should move freely and should be spring loaded to the OFF position (Figure 1, item 3: rotational spring).
- The release handle lock must move freely up and be spring loaded down to the lock position.
- With the hand brake applied and in locked position it should not be able to be released (rotated) without lifting the release handle.

Figure 1. Handle lift to release (spring loaded to lock down)

**If there are faults found with the above checks the valve must be inspected/replaced before the vehicle is put into service.**

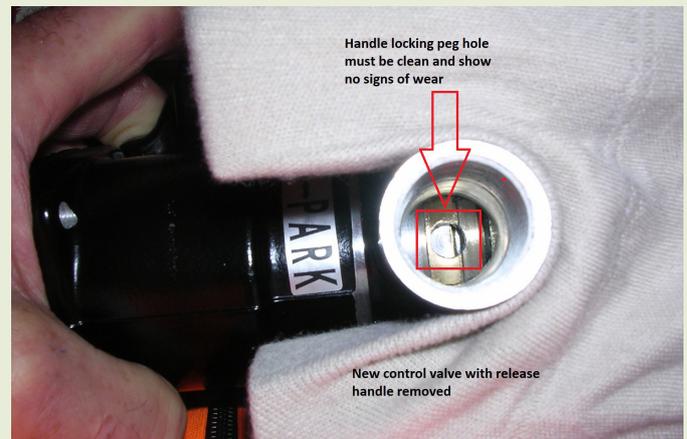
The areas that require a close inspection if you are looking to repair this valve are in the illustrations below (new valve shown).

Locking peg hole

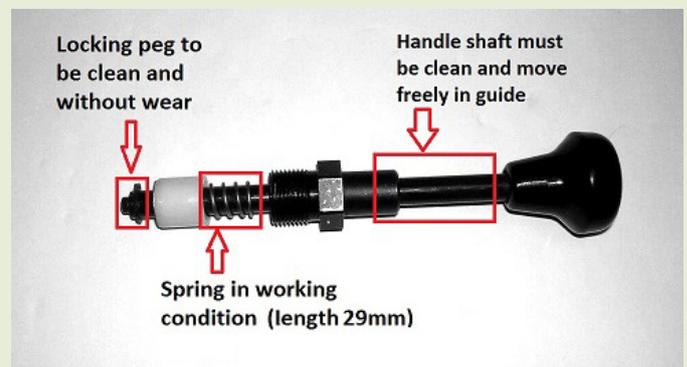
Locking handle removed
