WEEKLY INCIDENT SUMMARY

Week ending Friday 17 May 2019

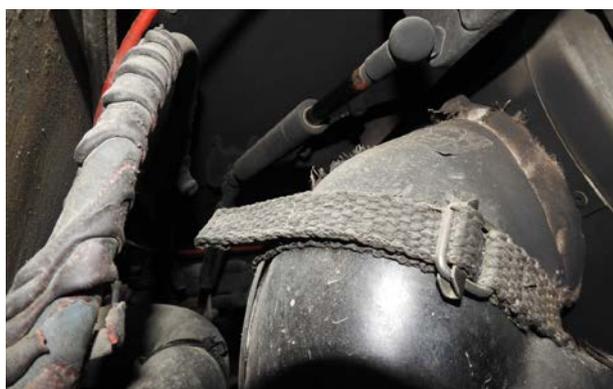
| INCIDENT TYPE | SUMMARY | RECOMMENDATIONS TO INDUSTRY |
|---|---|--|
| Dangerous incident IncNot0034587 | A fire occurred on an integrated tool carrier in an underground metalliferous mine. The fire occurred within the turbocharger and was extinguished by the onboard fire suppression system. The cause of the fire has been attributed to a turbocharger oil line failure and is being investigated by the original equipment manufacturer (OEM). | The failure of oil and fuel lines near exhausts and turbo chargers are well known causes of fire. Maintenance systems must account for this when setting inspection frequencies. |

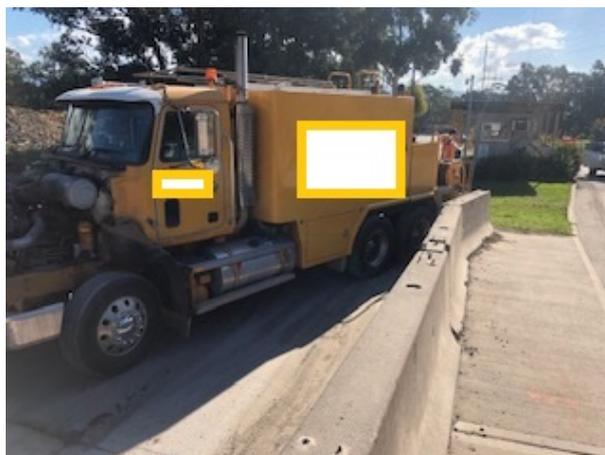
A fuel truck rolled away while a worker was on top of the tank in a quarry.

The worker had climbed onboard to dip the tank, when the truck rolled away. The worker jumped from the truck before it came to rest against a barrier. The truck rolled about 150 metres. The driver was not injured.

Mine operators should ensure machines are stable, the parking brake is applied and wheels are chocked before climbing on board to complete inspections or maintenance tasks.
