Significant Incident Report No. 260

Subject: Autonomous truck significantly damaged by lightning strike

Date: 02 May 2018

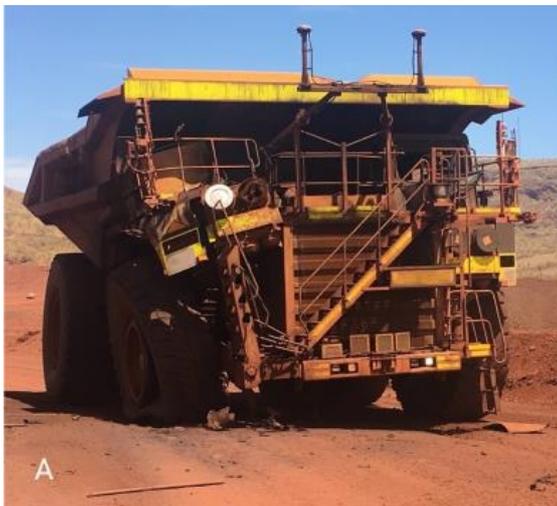
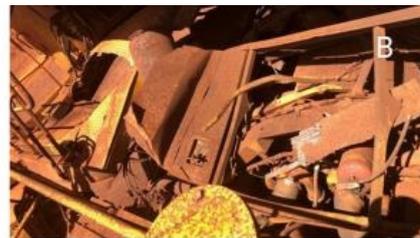
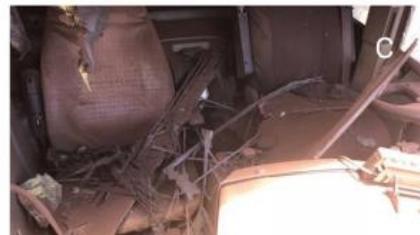
In January 2018, an unloaded autonomous truck was ascending a ramp when it was struck by lightning. The strike caused the position 2 tyre (front right) to explode, resulting in extensive damage to the upper structure of the truck including the deck, autonomy cabinet, engine and cab.

Note: Preliminary findings from a tyre specialist concluded that the explosion was caused by extensive pyrolysis (chemical decomposition by heat). There was no pre-existing tyre damage that contributed to the event.

Autonomous truck struck by lightning. A. Exterior and structural damage. B. Extensive damage to deck and associated equipment. C. Interior of truck's cabin.

- Lightning struck the truck, causing pyrolysis of the tyre (resulting in an explosion).

- The hazards associated with lightning were not identified (e.g. working during periods of likely lightning activity, the potential effects of a lightning strike on a vehicle).

- Review the risk assessments for the use of all vehicles (manned and autonomous) during storms, or where there is a possibility of lightning strikes, and confirm they identify the hazards and risks to workers and equipment from lightning strikes.
- Adequately control the hazards and risks relating to lightning strikes, to reduce the exposure of workers to potential harm.
- Review the work procedures relating to working when there is a potential for exposure to lightning, to confirm the procedures are in line with the outcomes of risk assessments.
