# WEEKLY INCIDENT SUMMARY

Week ending Friday 29 November 2019

This incident summary provides information on reportable incidents and safety advice for the NSW mining industry. To report an incident to the NSW Resources Regulator: phone 1300 814 609 24 hours a day, 7 days a week.

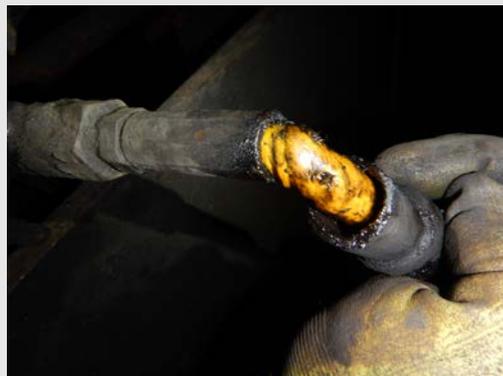
Dangerous  
incident  
IncNot0036153

While checking the chain tension on the AFC, at the tail gate of a longwall, a hose to the Porta-power burst. A fitter, who was approximately 30 centimetres away, was hit on the left wrist and hand through his overalls and cut 2 rated gloves.

The mine adds a fluorescent dye to hydraulic oil. When exposed to blue light, the dye glows, indicating the presence of oil. The blue light was used to confirm a fluid injection injury and the worker was transported to hospital. During surgery, the blue light was also used to minimise the extent of the surgery.

The Porta-power had previously been damaged.

All portable tools should be subject to pre-use inspections and used by trained competent persons.

Workers are to be instructed not to use equipment that has been damaged or that could affect safety.

Workers should be reminded to position themselves out of the line of fire when completing tasks that involve high pressures.

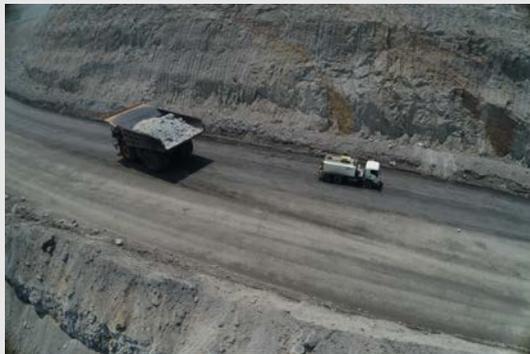
Dangerous  
incident  
IncNot0036161

A fully laden dump truck, coming down a ramp, lost control and drifted. The driver turned towards the middle of the road to regain control, where a water truck, which was travelling in the opposite direction

came to a halt. There was no collision or injuries.

Following the incident an inspector attended and identified speed as a major contributing factor.

The start of shift safety briefing topic the day before was ramp speed and a maximum speed of 40kph.

The haul truck had a crest speed of 57kph and it was found that all trucks were travelling at similar speeds.

The incident is still under investigation  
Mine site speed limits must be enforced and should consider use of smart technologies that notify

operators and supervisors when speed limits are exceeded.

Supervisors and managers continually accepting non-compliances to site rules contribute to mineworkers breaching safe systems of work and putting themselves and others at risk.

Speed limits of trucks are in place for a reason and must be complied with.

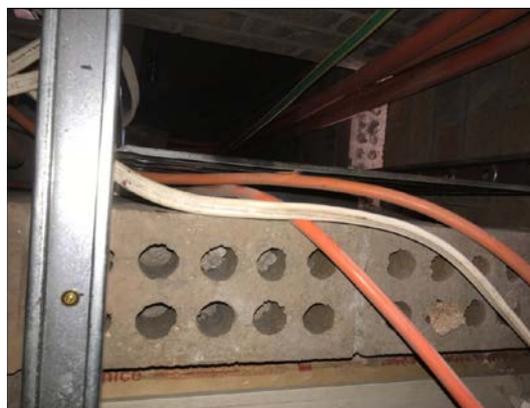
IncNot0036165

An electrical contractor, working within the roof space of a bathhouse, was drilling a hole when the back of his hand contacted an adjacent cable tray causing an electric shock. He was taken to hospital for an ECG.

On investigation a 30mA RCD protecting an air conditioner circuit had tripped and the cable supplying the air conditioning unit had damaged outer insulation.

When working in confined areas like roof spaces where electricity is present, an engineering risk assessment must be completed and all energy sources need to be identified and appropriate isolation controls implemented.
