INCIDENT ALERT

LOCATION: ASPHALT/COATING PLANT
ACTIVITY: TRANSPORT / DELIVERY
SUB ACTIVITY: LOADING

TITLE

FEL Contact with Customer Vehicle

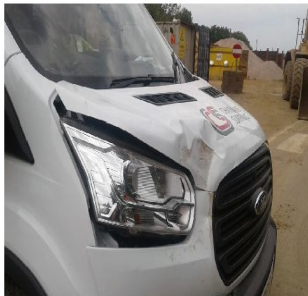
The driver went to drive around to the front of the plant when he noticed an arctic coming towards him. He reversed to allow the arctic to pass, not noticing the collect customer in a transit van who had driven up behind the FEL. The counter weight of the FEL came into contact with the customer vehicle causing minor damage to the vehicle.

Collect Customer Van

- Ensure hauliers who are new to site have an induction / orientation to warn of site hazards and that this is recorded.
- Review Vehicle/Pedestrian Management Plan to ensure that, wherever possible, site vehicles are separated from road vehicles on site.
- In restricted plants consider adopting a '5+2' rule where a 5m exclusion zone is enforced in front and behind a vehicle and 2m either side.
- Share this brief with staff showing the dangers of not checking behind adequately when reversing.
- Verify that VMS / Radar systems on mobile plant have been subject to risk assessment and have been calibrated to the working area and is effective.
- Review daily mobile plant inspections to ensure that all defects are being reported as required.

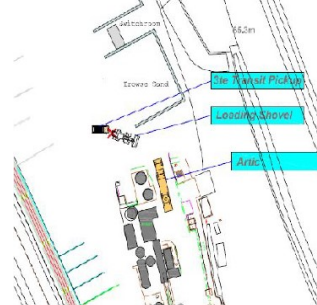
- Formal familiarisation was not given to the lorry driver who attempted to drive under the plant that would have alerted him to the height restriction. The driver was familiar with another asphalt plant where it is possible to drive straight under the plant.
- The FEL had been subject to the standard risk assessment for reversing radar and the system fitted provided a warning but was not full VMS.
- Although not identified as a cause the convex mirrors on the FEL were clouded and obscured. This had not been noted as a defect on the daily defect inspection process.
- The FEL operative failed to adequately check for dangers whilst reversing.

Position of Vehicles
