SAFETY ALERT

POTENTIAL CLASS 1 – Concrete Agitator Truck Overturn

W2B Program – Portion A 02-10-2019 Impact Reference 33439

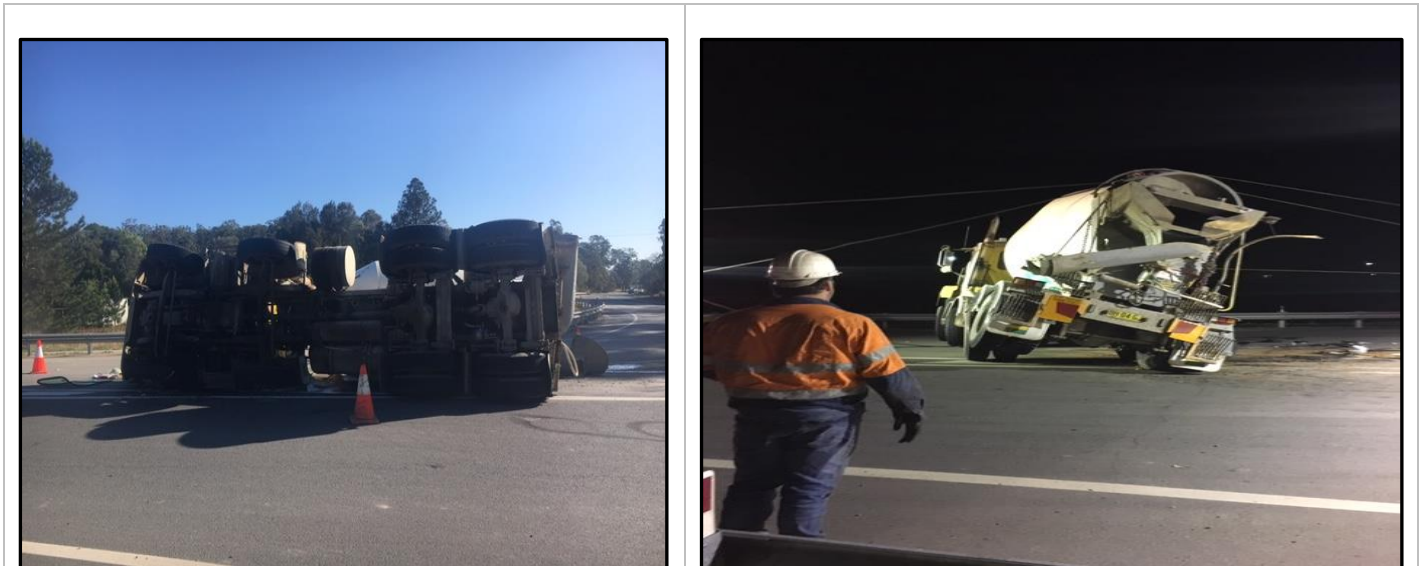
A concrete agitator truck fully loaded with kerbing mix has overturned onto its side exiting the Pacific Highway and entering Bensons Lane (Tyndale compound approach road.) As the agitator has overturned onto its side, the agitator bowl has made contact with to the rear trailer off an oncoming truck and trailer combination. The operator of the agitator truck has sustained an injury to the ear and possible concussion and been escorted for further medical assessment. There were no other injuries sustained or persons exposed to injury during the event.

All workplaces should review their current and planned Plant Operation activities to ensure appropriate controls are in place and working effectively, in particular relating to the risks of vehicles overturning;

- Loads in Agitator Trucks may move or stick to the bowl, altering the centre of gravity
 - This may be exacerbated when cornering,
- Mandatory safety devices such as seat belts are important but do not prevent all injuries,
- Risk controls must be communicated to all operators.
