WEEKLY INCIDENT SUMMARY

Week ending Friday 4 October 2019

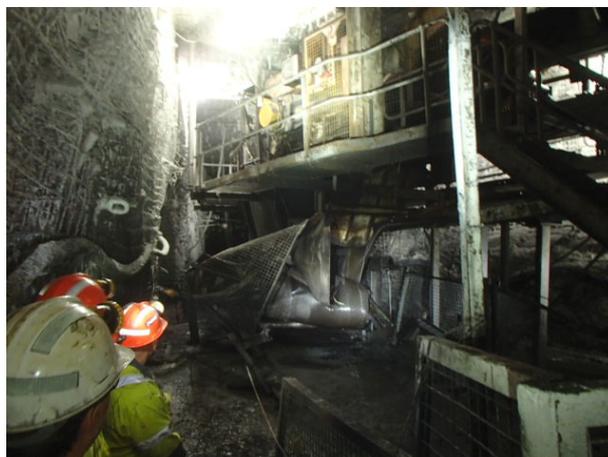
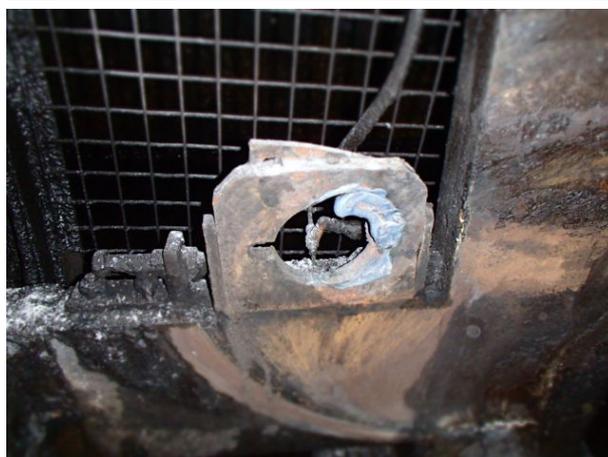
INCIDENT TYPE	SUMMARY	RECOMMENDATIONS TO INDUSTRY
Dangerous incident IncNot0035710	<p>A tail pulley of a mains trunk conveyor catastrophically failed at an underground coal mine. The bearing seized resulting in heat and the pulley being partially ejected (2-3 metres) from the confines of the conveyor boot end.</p> <p>The incident was seen on the CCTV that monitored the conveyor transfer. The mine had live temperature monitoring and had completed monthly vibration inspections. No workers were in the vicinity when the incident occurred.</p>	<p>Mine operators should review maintenance procedures, including lifecycle management, in accordance with the manufacturer's recommendation. Where temperature monitoring is used, it should be confirmed that it is set to the correct level to warn (or trip) of an impending failure.</p>

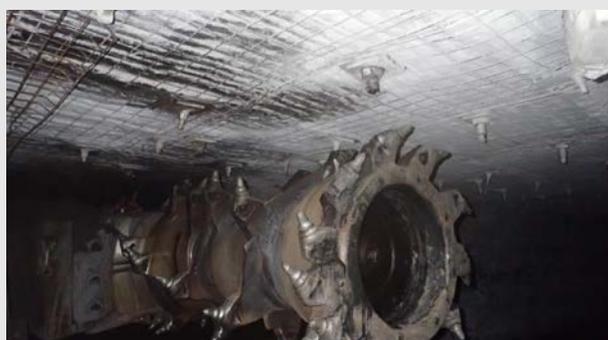
While widening a longwall installation face at an underground coal mine, the cutter head of a continuous miner hit a mega bolt tail. The nut from the bolt hit a worker in the face. The worker suffered a fractured sinus bone and was treated in hospital.

Mine operators must assess the risk for tasks and consider the clearance required to operate equipment. The risk assessment must also consider where workers are located during the cutting cycle.
