Week ending 24 October 2018

This incident summary provides information on reportable incidents and safety advice for the NSW mining industry. To report an incident to the NSW Resources Regulator: phone 1300 814 609 24 hours a day, 7 days a week.

Summarised incidents

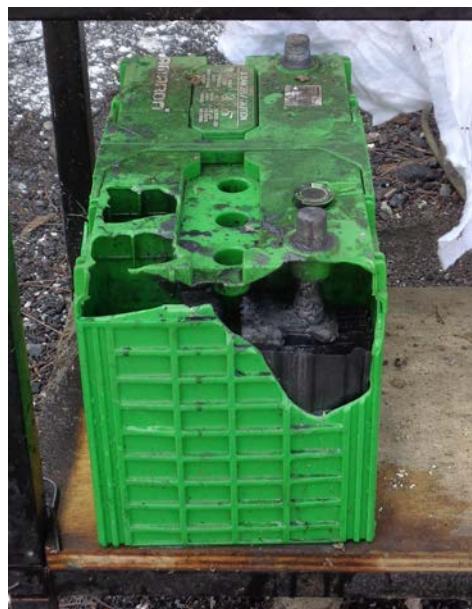
Incident type	Summary	Recommendations to industry
High potential incident SinNot-2018/01753	Subsidence on an opal claim has developed and is creating an impact on a neighbouring claim.	Miners and prospectors must manage subsidence and other mining-related impacts from posing a safety risk to people on their title, on adjoining areas or members of the general public.
Dangerous incident SinNot-2018/01747	A lead acid battery was charged and reinstalled on a diesel fire pump. When trying to start the fire pump, it exploded. The battery exploded out onto the opposite side to the worker.	Safety bulletin SB16-02 Exploding lead acid batteries was issued previously. This bulletin must be reviewed by mines to determine if the risk is present at their operation.

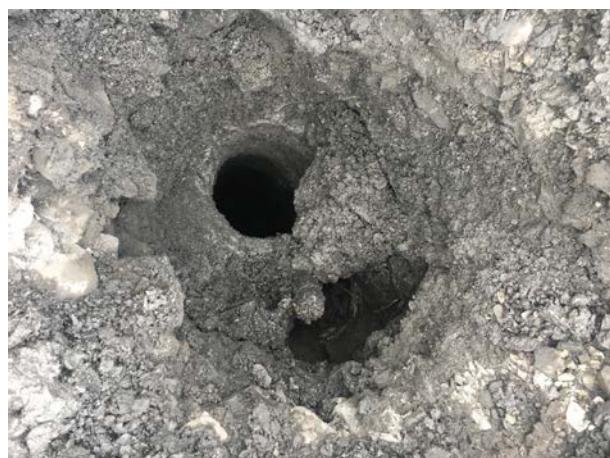
High potential incident
SinNot-2018/01741

While drilling a new shot pattern, a drill rig inadvertently drilled a new hole about 300 mm from an unknown misfire in the previous shot pattern.

The procedure for locating and mapping out blasting patterns should include controls to prevent misalignment or overlap of patterns with previously shot ground. Additionally, blasting procedures should include inspections to identify misfired holes and the logging and communication to all relevant workers the location of these misfires.

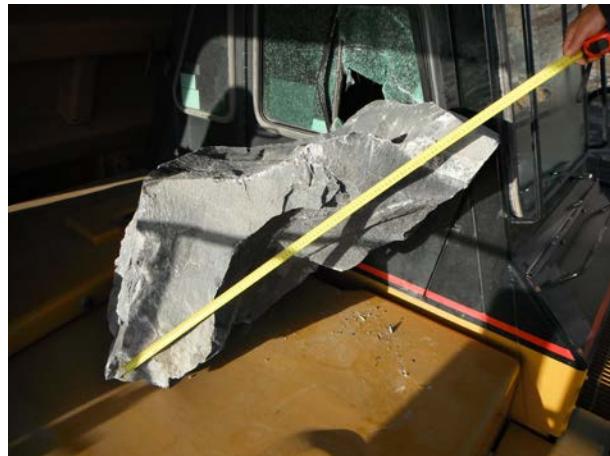
Dangerous incident
SinNot-2018/01740

A loader was putting rock into a dump truck when a large rock slid across the head board and fell. The rock bounced off a handrail and back onto the passenger's side window, smashing it.

Truck operators should always stay within the cab during loading activities. Trucks should not be overloaded and loads should be distributed appropriately.

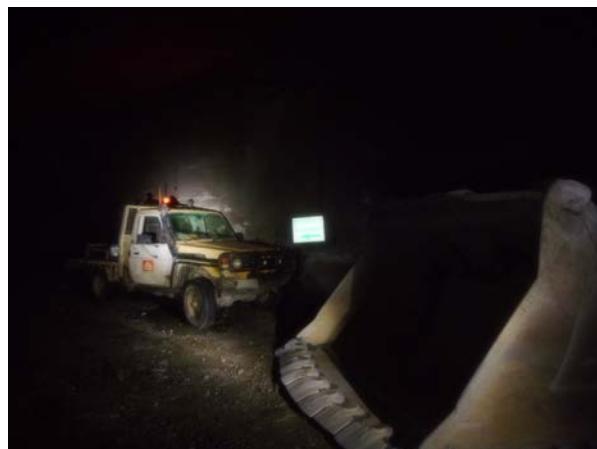
Dangerous incident
SinNot-2018/01736

At an underground metalliferous mine, a worker was sitting in a parked light vehicle with the lights and beacon on. An underground loader entered the same level and when it turned right it clipped the light vehicle. No workers were injured and minimal damage was reported.

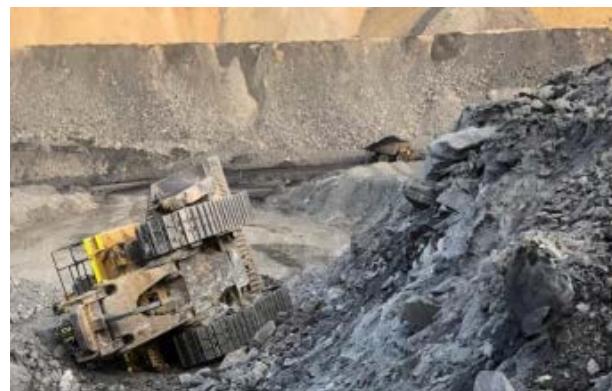
Dangerous incident
SinNot-2018/01730

A dozer rolled on its side in an open cut coal mine at night. The dozer was reversing from the push at which time the left track moved over an embankment and the dozer slid backwards about 6.5 m coming to rest on the left track. The operator removed himself from the plant unassisted but suffered pain from the seat belt.

[Schedule 1 of WHS \(M&PS\)](#)
[Reg 2014](#) requires mines to implement controls to manage mobile plant including operator vision in *The principal hazard management plan for roads or other vehicle operating areas*.

The hierarchy of controls places higher value on controls such as collision avoidance and proximity detection systems than procedural controls.

Suitable controls must be put in place to allow equipment operators to determine the safe limits of their work area. Deferring tasks to daylight hours or installing appropriate lighting should be considered when risks are present due to a lack of visibility.

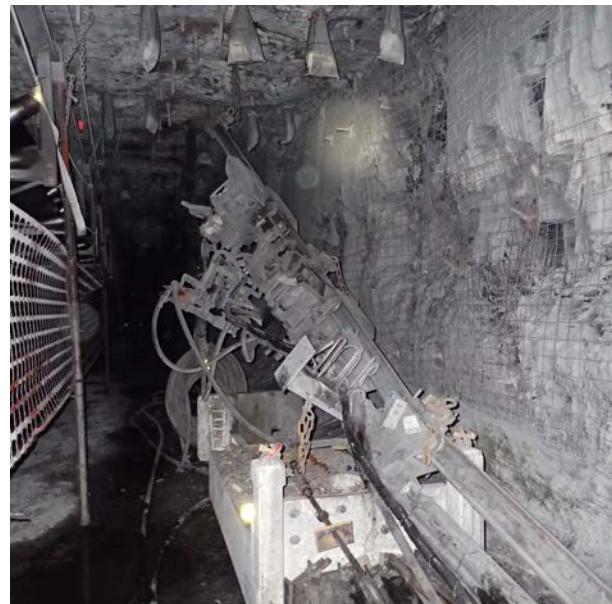
Dangerous incident
SinNot-2018/01728

Two workers fell when the platform they were working on dropped 1 metre to the floor. The workers were on a platform suspended off a monorail (Malibu) in an underground coal mine. Three roof bolts suspending the monorail pulled from the roof. There were no injuries reported.

Workers installing support must be trained to identify poor strata conditions that affect the integrity of roof bolts. This can include:

- ‘jumping’ drill steels
- loss of chemical
- changes in expected conditions.

Procedures should direct mine workers to seek supervisor assistance and direction when encountering these conditions.
