## Weeks ending 3 & 10 October 2018

This incident summary provides information on reportable incidents and safety advice for the NSW mining industry. To report an incident to the NSW Resources Regulator: phone 1300 814 609 24 hours a day, 7 days a week.

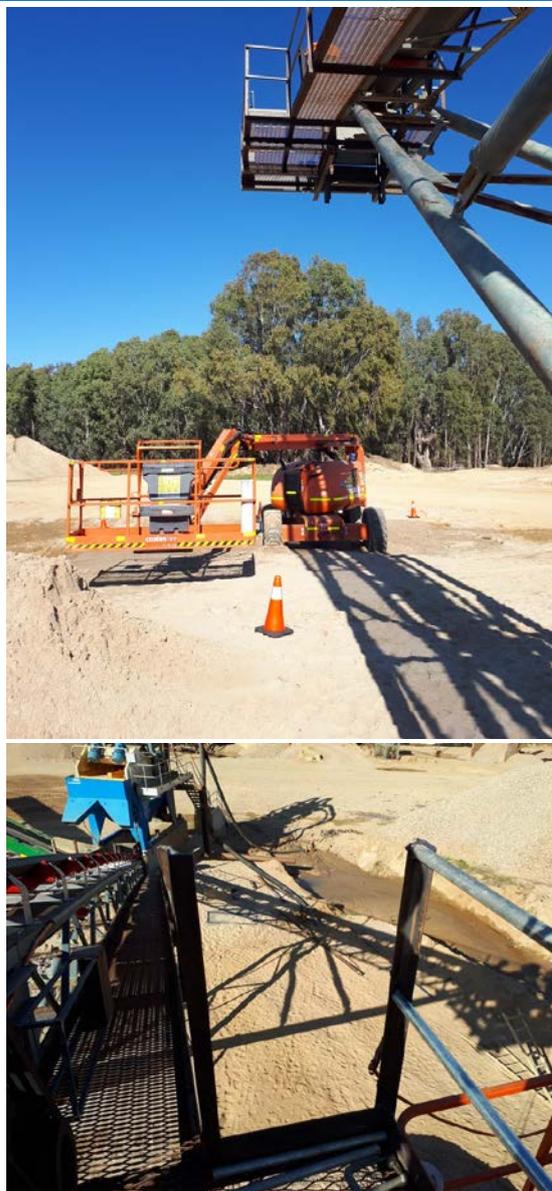
| Incident type | Summary | Recommendations to industry |
|---|---|---|
| Dangerous incident<br>SinNot-2018/01591 | <p>A worker fell 6 metres from a conveyor gantry he was working on at a quarry. The boilermaker had tack welded handrails in place. When a worker leaned on a hand rail it gave way and the worker fell onto a small sand stock pile. The worker landed face down. The worker did not lose consciousness.</p> | <p>When modifying or installing hand rails, stairs and walkways suitable controls must be in place to stop people falling from height. The hierarchy of controls must be considered when developing controls such as barricading, temporary hand rails, personal protection equipment (PPE such as harnesses, fall arrest devices).</p> <p><a href="#">Work Health and Safety Regulations 2011 Part 4.4</a></p> |

SafeWork NSW have published [managing the risk of falls at workplaces](#) code of practice.

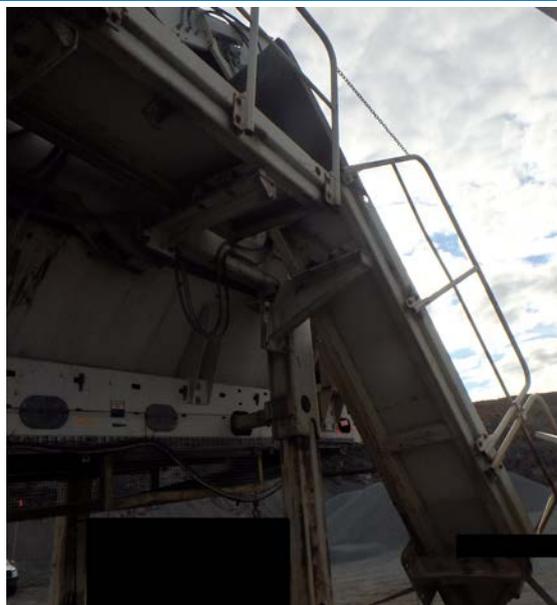
| Incident type | Summary | Recommendations to industry |
|---|---|---|
| <p>Dangerous incident<br/>SinNot-2018/01651</p> | <p>A worker's shoulder was dislocated and he suffered fractures when he fell from a mobile crusher at a quarry.</p> <p>The worker had unbolted one end of a platform. As the worker walked onto the platform it pivoted and when it stopped he fell to the ground.</p> | <p>When conducting work on platforms, walkways and stairs, procedures must be in place to determine what impacts each task/step will make to the stability of the item.</p> <p>Controls must be in place to prevent workers from accessing platforms, walkways and stairs while work is being conducted</p> |

that affects the integrity of the structure.

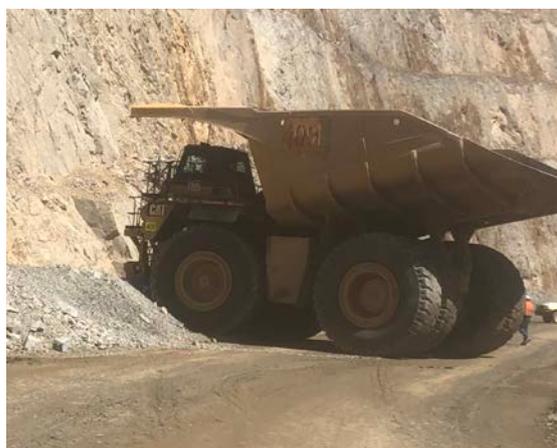
A haul truck lost control at a metalliferous mine. The truck was descending a ramp when it lost traction, spun and made contact with a windrow, bringing the haul truck to a halt.

Overwatering of mine roadways decreases tyre traction (skid resistance) and therefore increases braking time.

With the onset of summer and increased watering, the recommendations from [Safety Bulletin SB18-09 - Overwatering of roads leads to vehicle incidents](#) should be reviewed and fully implemented.
