# Earthmover tyre and rims

Mines safety alert no. 334 | 06 December 2016 | Version 1

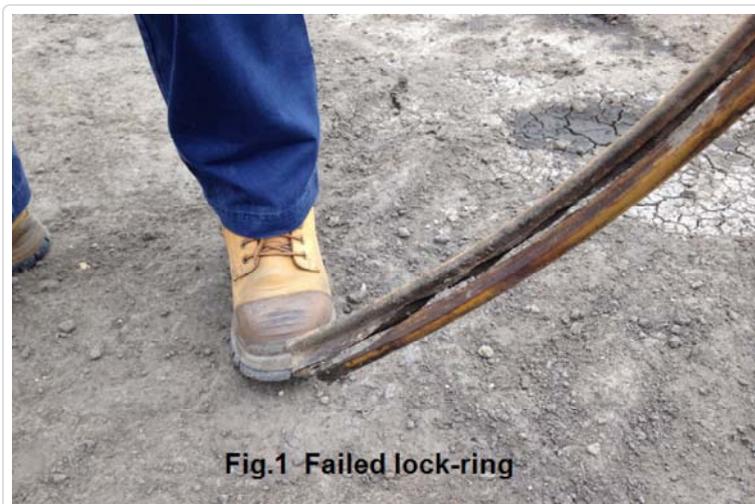
A CAT 992 front end loader left the tyre bay after a new O-ring had been fitted to the position one wheel. After travelling for about 100 metres, the assembly failed catastrophically, resulting in parts being propelled from the loader. No injuries occurred.

The lock-ring cracked circumferentially through the thinnest section (refer Fig. 1), resulting in two rings that were no longer able to keep the assembly together. Investigations including wear limits (refer Fig. 2) of mating components and metallurgical assessments are ongoing.

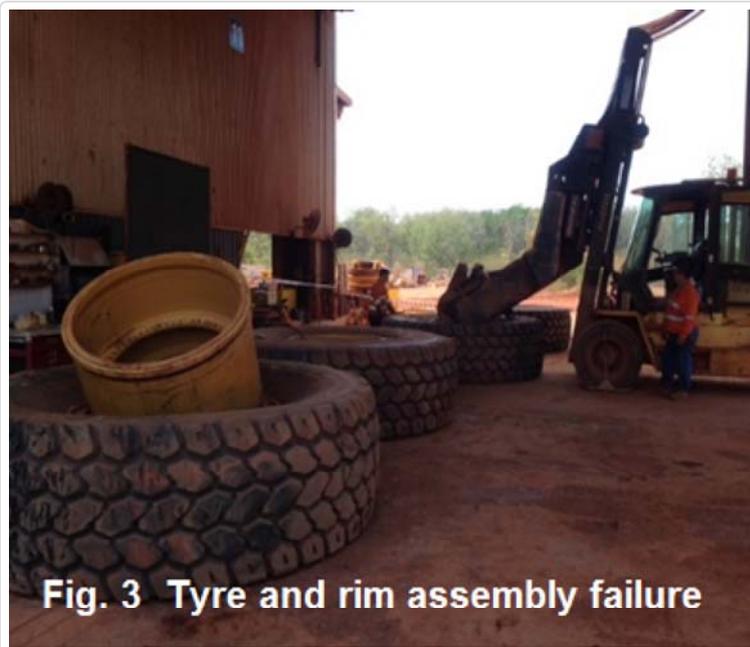
A maintenance section was assembling four 36.00 trailer tyres (refer Fig. 3). Two tyres had been assembled and inflated to 10-15 PSI as per site procedures. During this process the tyre had been manipulated by the tyre handler. Approximately 20 minutes after inflating the first tyre (and while personnel were working on the third tyre) the lock-ring of the first tyre let go. The rim was projected vertically so that the bottom of the rim was roughly one metre above the top of the tyre at its highest point. At the time the tyre let go, two workers were at the third tyre, which was eight metres away. Procedures in place at the time of the incident required the tyres to be inflated from a remote location, however, once inflated workers are required to reach over the tyre and rim assembly to disconnect the airline.

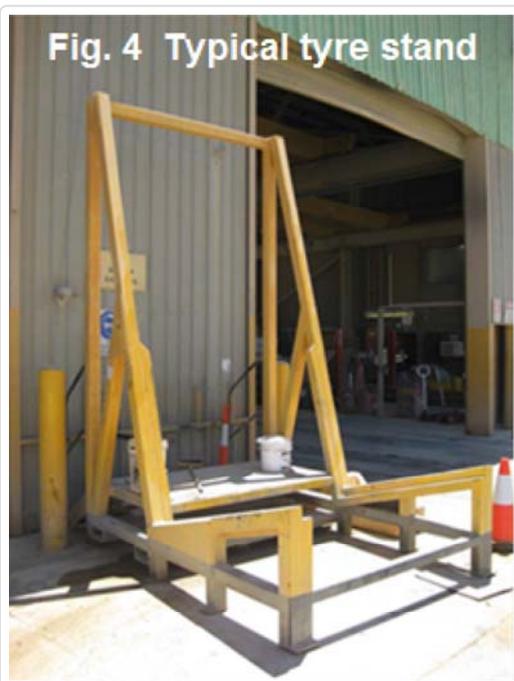
A rear dump truck went to the workshop to have a position 6 flat tyre replaced. The dual rear wheel assemblies were fitted with double gutter rim components. The flat tyre and rim assembly was removed from the truck and placed in a vertical tyre inspection stand (refer Fig. 4). Personnel working on the assembly left the area and on their return a bead seat band, with a mass of 230 kg, had fallen off the rim assembly into an area where personnel stand to inspect and assemble the tyre and rim.
