## SAFETY ALERT

### SKID PLATE FAILURES ON REFRIGERATED SEMI-TRAILERS

**This safety alert applies to all refrigerated semi-trailers.**

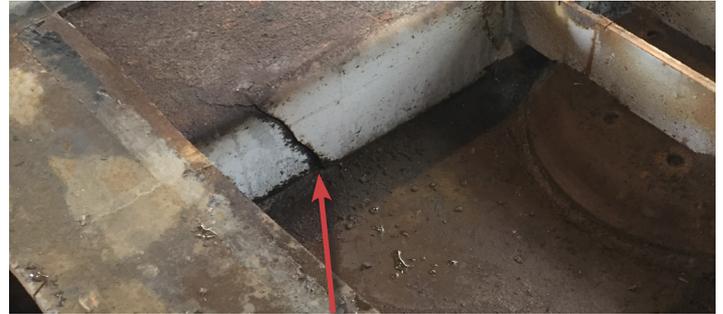
Structural cracks on a cross-member in the skid plate / king pin assembly of a refrigerated trailer (found after the flooring was removed to reveal an internal chamber).

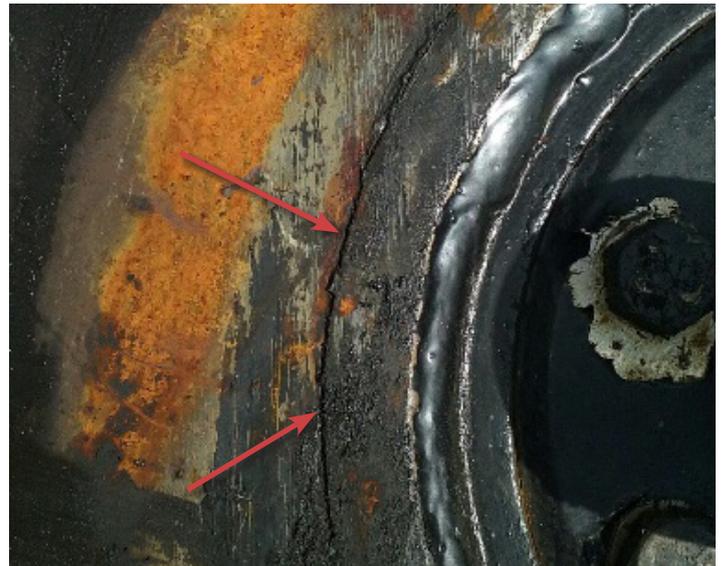
Failure of the internal cross members can lead to externally-visible cracks around the welds between the king pin retention plate and the skid plate.

- Contact the trailer manufacturer/specialist certifier with your refrigerated semi-trailer's VIN. They will be able to provide you with specific instructions on where your maintenance personnel can safely add inspection ports. Please keep in mind that incorrectly positioned inspection ports may be detrimental.
- After 300,000kms, borescope inspections by skilled maintenance personnel should be performed at intervals of every 50,000kms travelled.
- If there is any sign of cracking, do not use the trailer and contact the manufacturer or a specialist certifier.
- Do not attempt to repair the cracks as the skid plate assembly must be replaced.
- Questions related to this should be directed to the manufacturer or the Transport Agency on 0800 699 000.

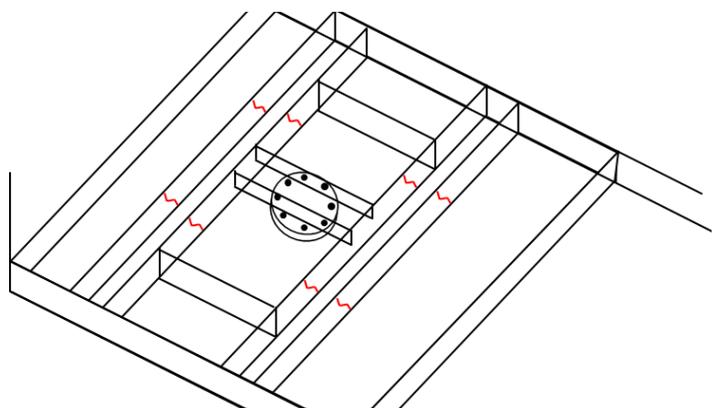
Cracks form on cross-members in the skid plate / king pin assembly. Because the welded-in cross members are 'sandwiched' between the skid plate and the trailer floor, cracks are often impossible to identify without using a borescope through an inspection port.
