## CAUSAL INVESTIGATION PRELIMINARY REPORT:

# Catastrophic engine failure in underground coal mine

- **Incident date:** 4 July 2017
- **Event:** Catastrophic failure of diesel engine system
- **Location:** Wongawilli Colliery, Wollongong, NSW

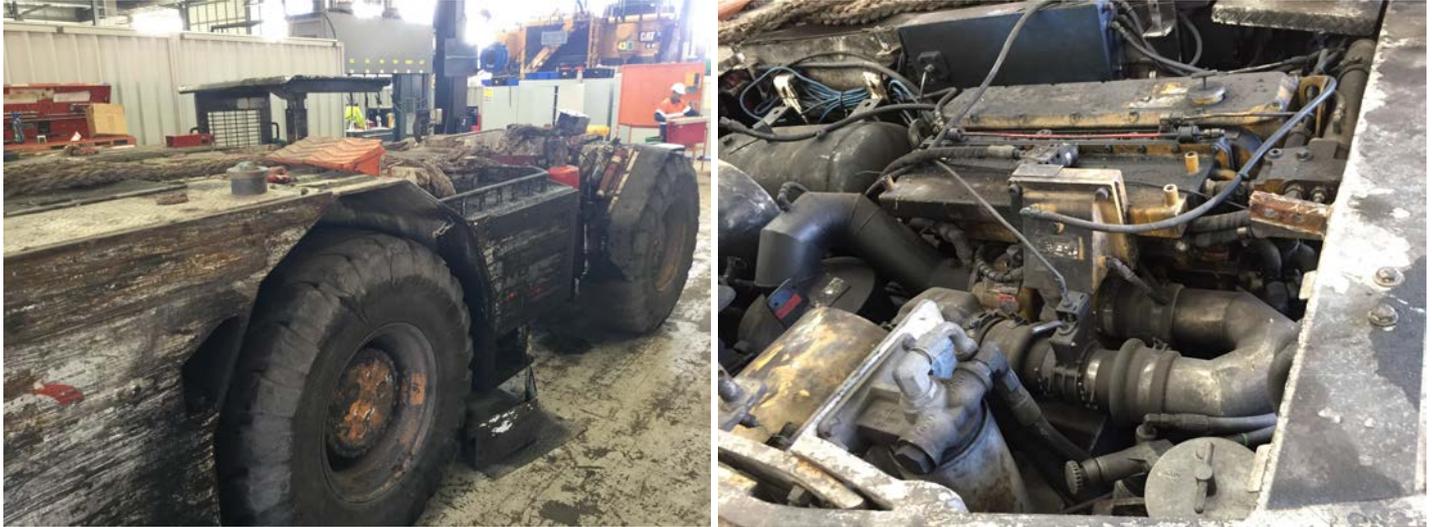
**Engine failure:** The FBL10 involved in the incident (left), and internal engine components (right). Photos: Resources Regulator.

A scene preservation notice was issued and the machine was seized. It was removed off-site for inspection by an independent assessor. Visual inspections indicated a damaged oil supply pipe. This may have been a result of the engine failure or it may have been a precursor to the engine block failure. The causal investigation will seek to identify the exact causes of the failure.

- mine operators ensure maintenance of diesel engine systems and inspection and testing of the safety-related components and systems be carried out in accordance with recommendations of the vehicle original equipment manufacturer, the engine manufacturer and the ExDES registration holder.
- when designing explosion-protected diesel engine systems, it is essential that rare malfunctions causing ignition hazards are considered during the design risk assessment process. Refer to [MDG 43 Technical Standard for the design of diesel engine systems for use in underground coal mines](#).
