Week ending 12 September 2018

This incident summary provides information on reportable incidents and safety advice for the NSW mining industry. To report an incident to the NSW Resources Regulator: phone 1300 814 609 24 hours a day, 7 days a week.

CM9 reference	DOC18/682079
Mine safety reference	ISR 18-35
Date published	21 September 2018

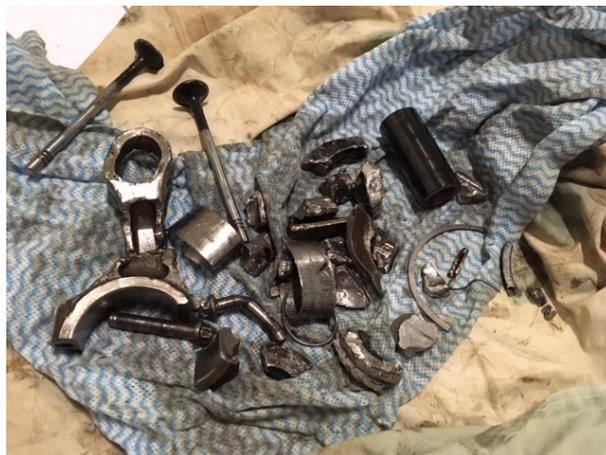
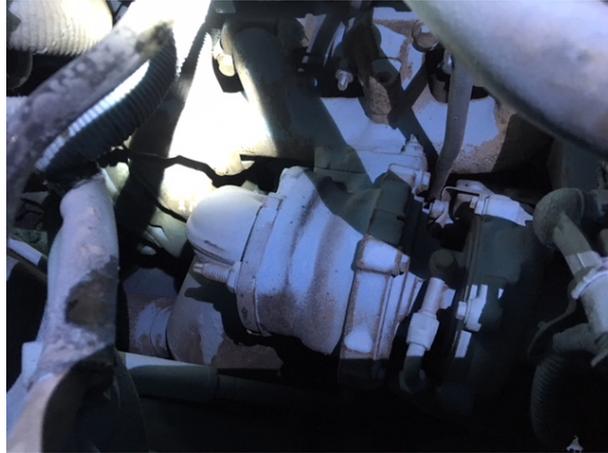
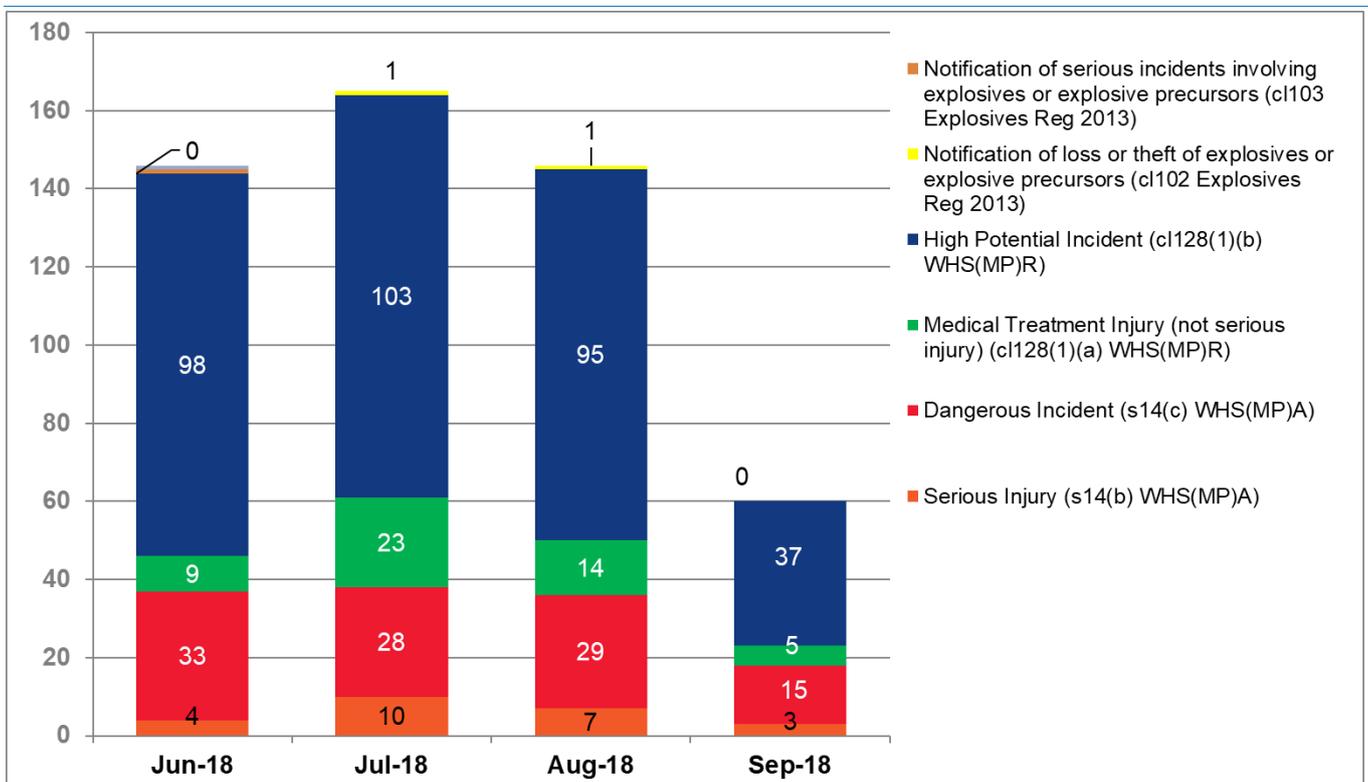
Dangerous incident
SinNot-2018/01433

While driving up a decline at an underground metalliferous mine, a light vehicle began revving heavily. The operator released the accelerator and attempted to shut the vehicle down but it continued to rev hard.

Flames were seen coming from the front driver's side wheel arch. The driver activated the vehicle's fire suppression system and rolled the vehicle off the decline.

Once stopped, the operator lifted the bonnet and used a hand-held fire extinguisher to put out a flame in the engine bay.

An inspection identified a failed turbo and catastrophic engine failure.

Light vehicles must be included when assessing the risk of fires on mobile plant.

Component failure where oil can become an uncontrolled fuel source for the engine (such as a turbo failure), should be considered when developing maintenance schedules.
