# NZ Safety Alert

March 2019

## Stockpile tip hazards

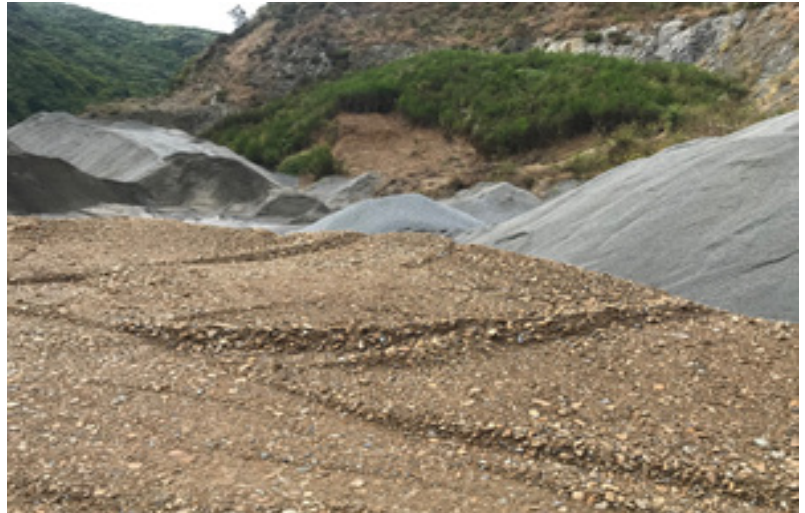
On inspection of the stockpile area, a supervisor observed a ramp and stockpile tip area that had inadequate side berms and no stop bund at the top of the stockpile tipping edge. On further inspection it appeared from the tyre marks that edge tipping had occurred. A contractor used the loader the day before to clear the stockpile ramp to create more room for when they next needed to cart material to this area. In doing so he pushed the berms over the tipping edge. He was called away to do other work and left the stockpile edge with no berm in place.

Photo: No berm on the tipping edge

The angle of repose from the tipping edge was approximately 8 metres.

Access to the stockpile ramp was immediately barricaded off to stop further tipping.

1. Adequate stop bunds are in place when edge-tipping on ramps, benches or dumps.
2. Ramp edges are adequately bunded to reduce the risk of falls and edge failure.
3. Regular workplace inspections are conducted to identify fall hazards, including inspection of slopes and tip areas prior to tipping commencing.
4. All workers are trained and assessed as competent in safe stockpiling operations.
