Near miss involving ruptured pressure vessel at demolition site

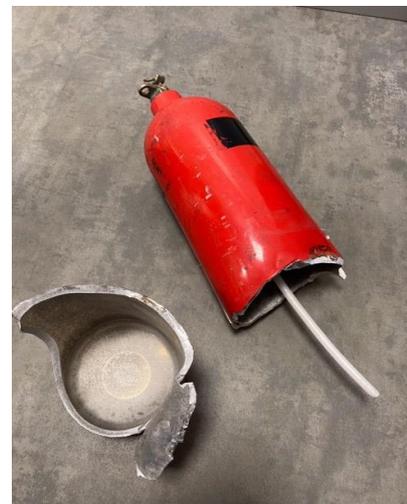
The operator did not see the pressurised fire extinguisher and cut it in half. The bottom section of the extinguisher travelled through the air and crashed through the roof of a warehouse approximately 300 metres away. It landed in a laydown area that was not being used at the time. No one was injured.

- The fire extinguisher had been mixed in with the fire suppression pipes, which were similar in colour and diameter.
- No system was in place to check scrap metal for pressure vessels.
- The fire extinguisher was a pressurised vessel.

Ruptured fire extinguisher recovered from site.

1. Ensure that systems of work are in place to ensure pressurised vessels are not mixed with general scrap metal.
2. Ensure employees are trained to recognise pressurised vessels and the requirement to remove them from general scrap metal.
3. Ensure employees are aware of the consequences if pressurised vessels are ruptured.
