INVESTIGATION INFORMATION RELEASE

Causal investigation - partial collapse of a ventilation shaft

Incident date: 3 May 2020

Location: North Wambo Coal Mine, NSW

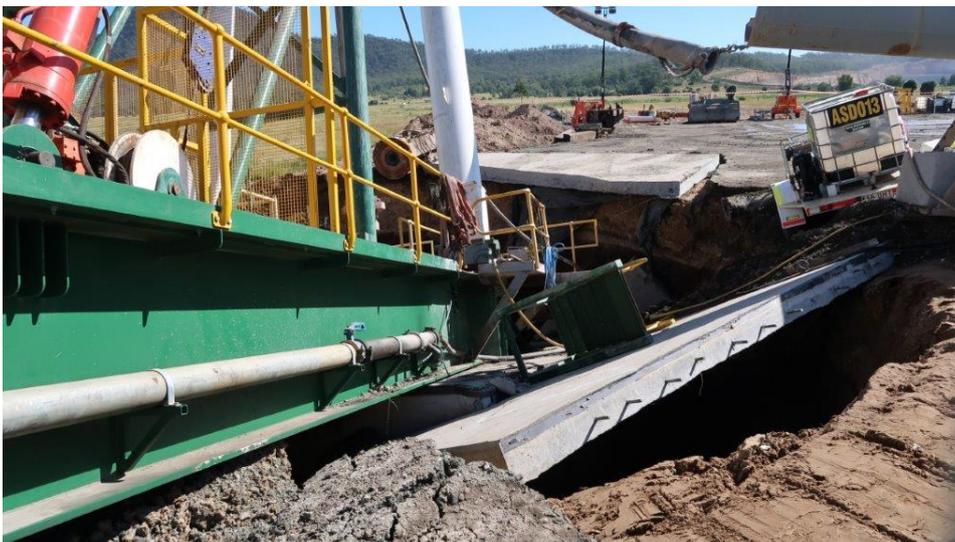
The failure of an underground bulkhead seal during shaft boring operations led to a surface sinkhole being created beneath a drilling rig, causing workers to take evasive action and the drilling rig to partially descend into the void. No one was injured.

Figure 1: Fan shaft collar collapse

At around 8:15am, at a drilling depth of 59.3 metres, a three metre diameter bore shaft was being drilled toward an existing development roadway underground. The drillers on the surface reported a loss of drilling mud from within the shaft. At this point, the bulkhead seal had catastrophically failed, causing the drilling mud to enter into the underground workings. Drilling operations were approximately 500 millimetres above the underground roadway. Within minutes, the alluvial materials close to the surface began to collapse into the shaft void, due to the rapid loss of confinement pressure.

A sinkhole rapidly developed and the drill rig personnel moved to a place of safety, prior to both the drilling rig and pad partially descending into the sinkhole.

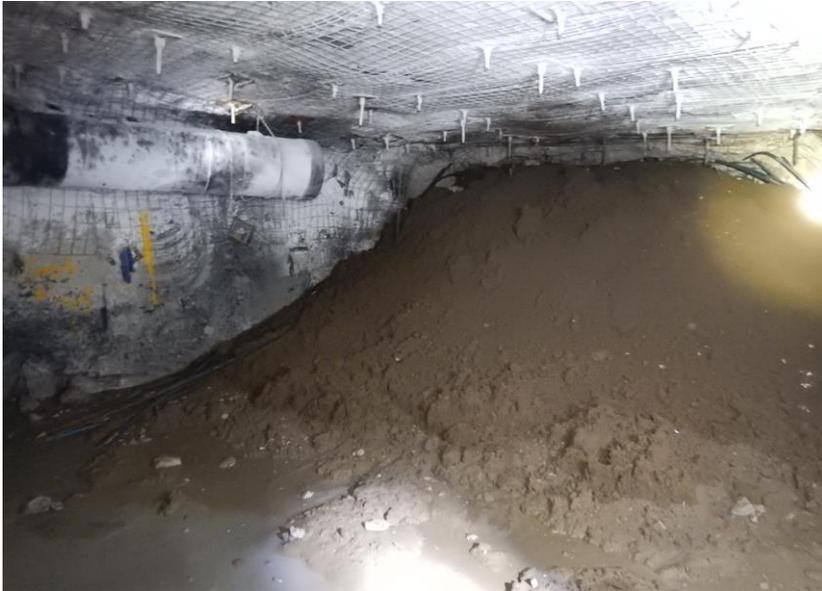
On 3 May 2020 at approximately 8:15am, there was a rapid loss of drilling mud from a blind bore drilling shaft, caused by a catastrophic failure of an underground bulkhead seal.

An engineering designed underground bulkhead seal was installed directly beneath the blind bore drilling project, where the shaft was to intersect the roadway underground. The purpose of this bulkhead seal was to confine the drilling mud to within the shaft column for the duration of the drilling project, and to prevent interaction with the underground workings. The design strength of the bulkhead seal was intended to reach 7.6 megapascal (mPa), however after three weeks of curing time, the average strength of the bulkhead seal was determined, through sample core testing to be approximately 2.5mPa.

The mine contacted the design engineer to seek his opinion on how the lower strength material would perform compared to the original design. A revised factor of safety was introduced to the seal, along with the understanding that the seal may show signs of cracking and/or leaking, however would not catastrophically fail.

Subsequently, an underground inspection was undertaken by mining supervisors, who confirmed that there was clear evidence that the bulkhead had catastrophically failed, and that no further source of ground instability was identified.

Figure 2: Bulkhead seal failure

- The loss of confinement pressure in the shaft due to the catastrophic failure of the bulkhead had not been considered in respect to the impact on the integrity of the unlined shaft, and consequently no controls were identified. The assumption maintained throughout the risk assessment process was that the drilling mud would remain insitu until the drilling had been completed.

- Design risk assessments should be carried out prior to the commencement of construction activities.
- Operational risk assessments should consider the findings from within the specified design risk assessment and implement appropriate risk controls to effectively reduce the risk, to as low as reasonably practicable.

- Critical controls identified in both design and operational risk assessments should be accompanied with a system of work to verify the effectiveness of the critical controls, along with prescribed actions to be completed if deficiencies are identified.
