WEEKLY INCIDENT SUMMARY

Week ending Friday 29 May 2020

Mine safety reference ISR20-22

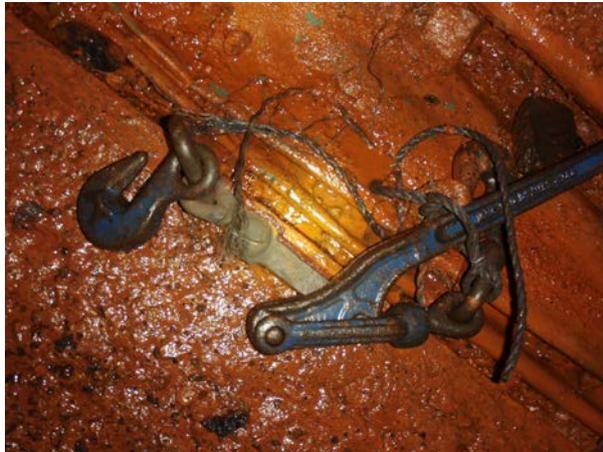
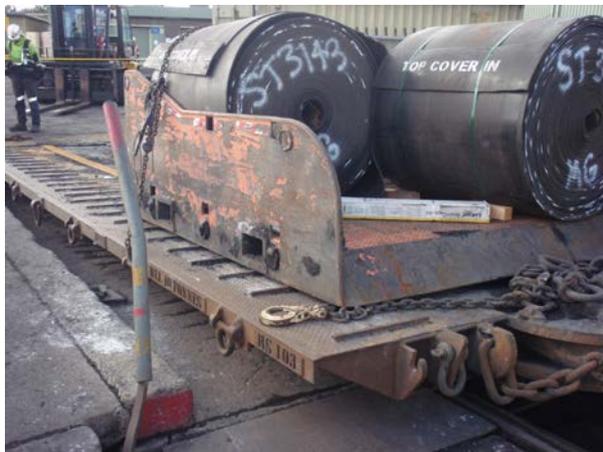
<p>A dolly car at an underground coal mine was travelling down the drift with three ducksbills loaded on a flattop. The front ducksbill was secured to the flat top, but detached and slid off. The second ducksbill was unsecured and also slipped off the flattop. The dolly car was about 500 metres into the drift at the time of the incident. The first ducksbill slid to the bottom of the drift (approx. 1100m) while the second one stopped after about 150 metres. There was no one in the drift at the time of the incident.</p>	<p>Investigation of this incident by the Regulator is ongoing and further information may be published later.</p> <p>Procedures, relating to transporting loads via a drift conveyance, should be clear about the use of headboards and the proper securing of loads.</p> <p>Operators should ensure risk assessments for dolly car operations include all known hazards and that</p>

adequate controls have been implemented for identified risks.

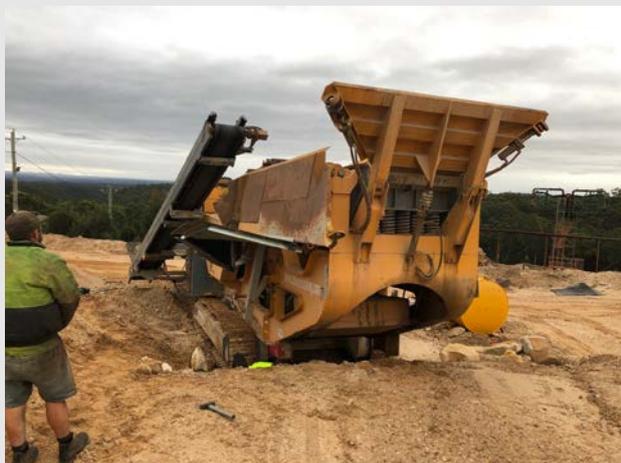
An apprentice was injured by a falling hopper wing on a mobile impact crusher. The crusher was being prepared to float to another location and when a hydraulic cylinder was pressed out, it was noticed that it was broken. The apprentice climbed up to assist in aligning a component, when the wing dropped and hit the apprentice on the back of the head and shoulder. The apprentice sustained a broken scapula and a gash to the back of his head.

No-go zones should be identified during risk assessments for the dismantling of plant.

Under no circumstances should any no climb on plant where securing pins and wedges have been removed during the dismantling process.
