SAFETY ALERT

DATE: 9 June 2020

QDS pods fall off dolly car flat top and slide down drift

| Mine safety reference | SA20-06 |

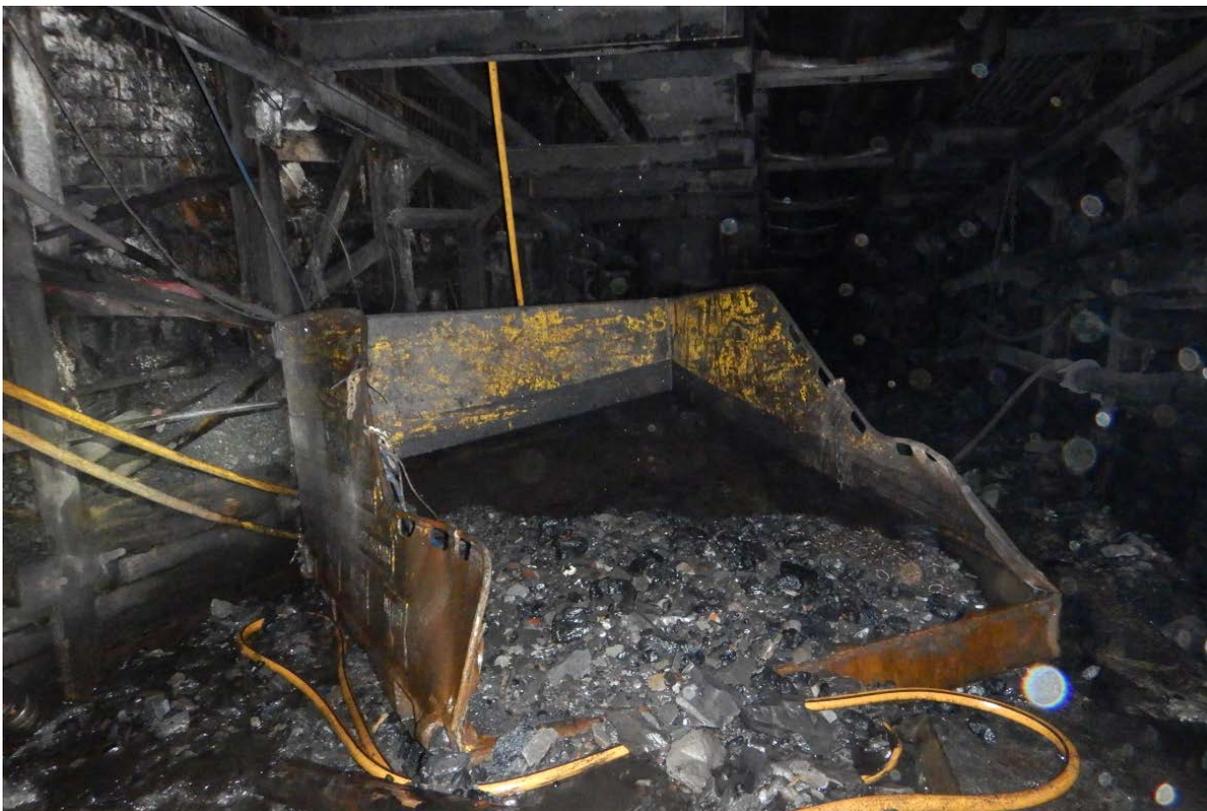
Whilst transporting three QDS pods (ducksbills) into the mine on a rail flat top attached to the dolly car two of the pods detached and slid uncontrolled down the drift. There was no one in the drift at the time of the incident and no one was harmed.

Figure 1 QDS pod arrested by spillage near drift bottom. It had travelled past the pit bottom shunt

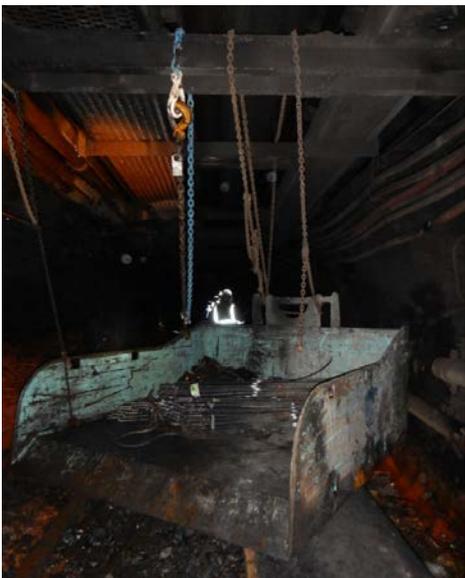
When the dolly car braked to a stop the middle pod also slipped off the flat top and slid down the drift to 32 man hole, where it hit the right hand rib and separated a main water pipe at a joint. The dolly car driver contacted the pit bottom shunt on the radio and advised that they had lost a load in the drift, and then walked down to the pod at 32 man hole.

Figure 2 middle pod had separated water pipe at connector when it wedged against right hand rib at 32 man hole

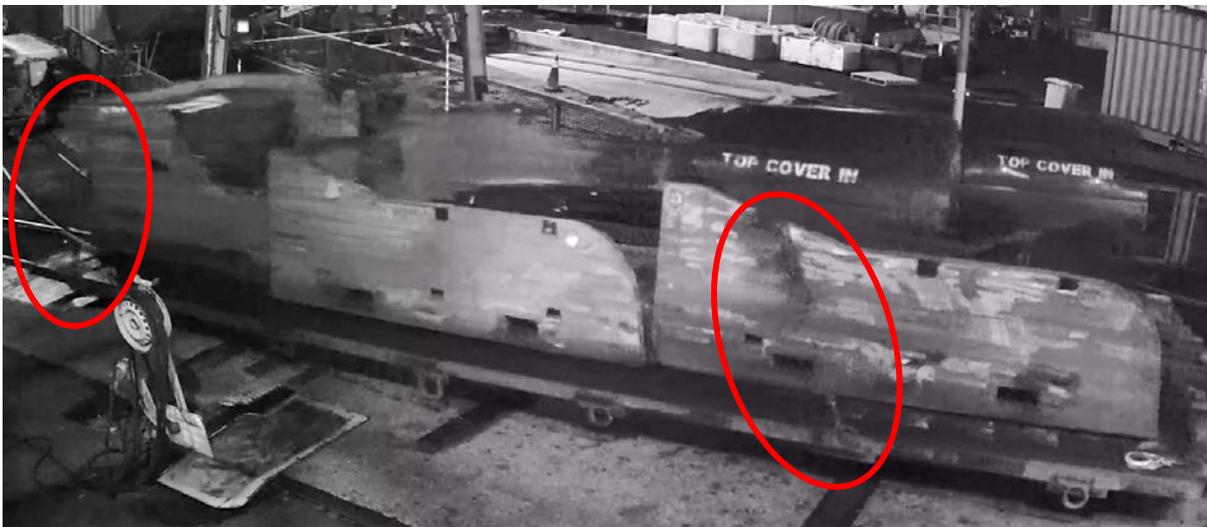
Figure 3 video footage confirmed the inbye and outbye QDS pods were chained, the middle pod was not.

- The inbye pod had damaged rib mesh, water pipes, conveyor access ladder, walkway support beams, conveyor support beams, turning sheave at pit bottom, a concrete wall, and approximately 40 dolly car rope rollers
- The pod at 32 man hole had damaged the main water pipe
- A lever action chain binder (dog) found approximately 8 metres inbye 28 man hole, shown in Figure 4, appeared to be in a useable condition, and had not come undone as the rope securing the lever to the body of the binder was intact
- The chain securing the inbye pod to the flat top was still attached to the left side of the flat top, but the grab hook for the right hand side was missing its spring safety latch. It is not known if this occurred during the incident
- There was no securing chain placed on the middle QDS pod, and it was seen to slide off the flat top once the dolly car brakes were applied

- It is the dolly car operator's responsibility to check the security of the load before operating the dolly car
- The use of secondary methods of securing loads should a securing mechanism fail,
- Adequately securing all items of plant and equipment
- The use of head boards on the inbye end of rail flat tops to minimise the potential for equipment dislodging from the flat top and sliding down the drift

- Procedures for securing loads are clear, and include securing requirements for transporting multiple loads on a flat top
- Training competence packages that address securing loads operating on steep grades
- Retraining frequency for workers directly involved in securing loads on equipment operating at steep grades.

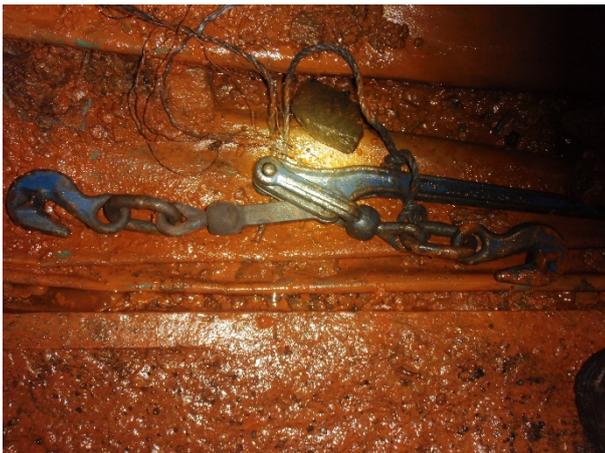
Figure 4 chain dog found 8m inbye 28 man hole
